Remediation Summary and Soil Closure Request

ETC Texas Pipeline, Ltd. Fullerton 16H

Lea County, New Mexico
Unit Letter N, Section 35, Township 22 South, Range 37 East
Latitude 32.428298 North, Longitude 103.134562 West
NMOCD Reference No. pending

Etech Environmental & Safety Solutions, Inc.
3100 Plains Highway
Lovington, New Mexico 88260

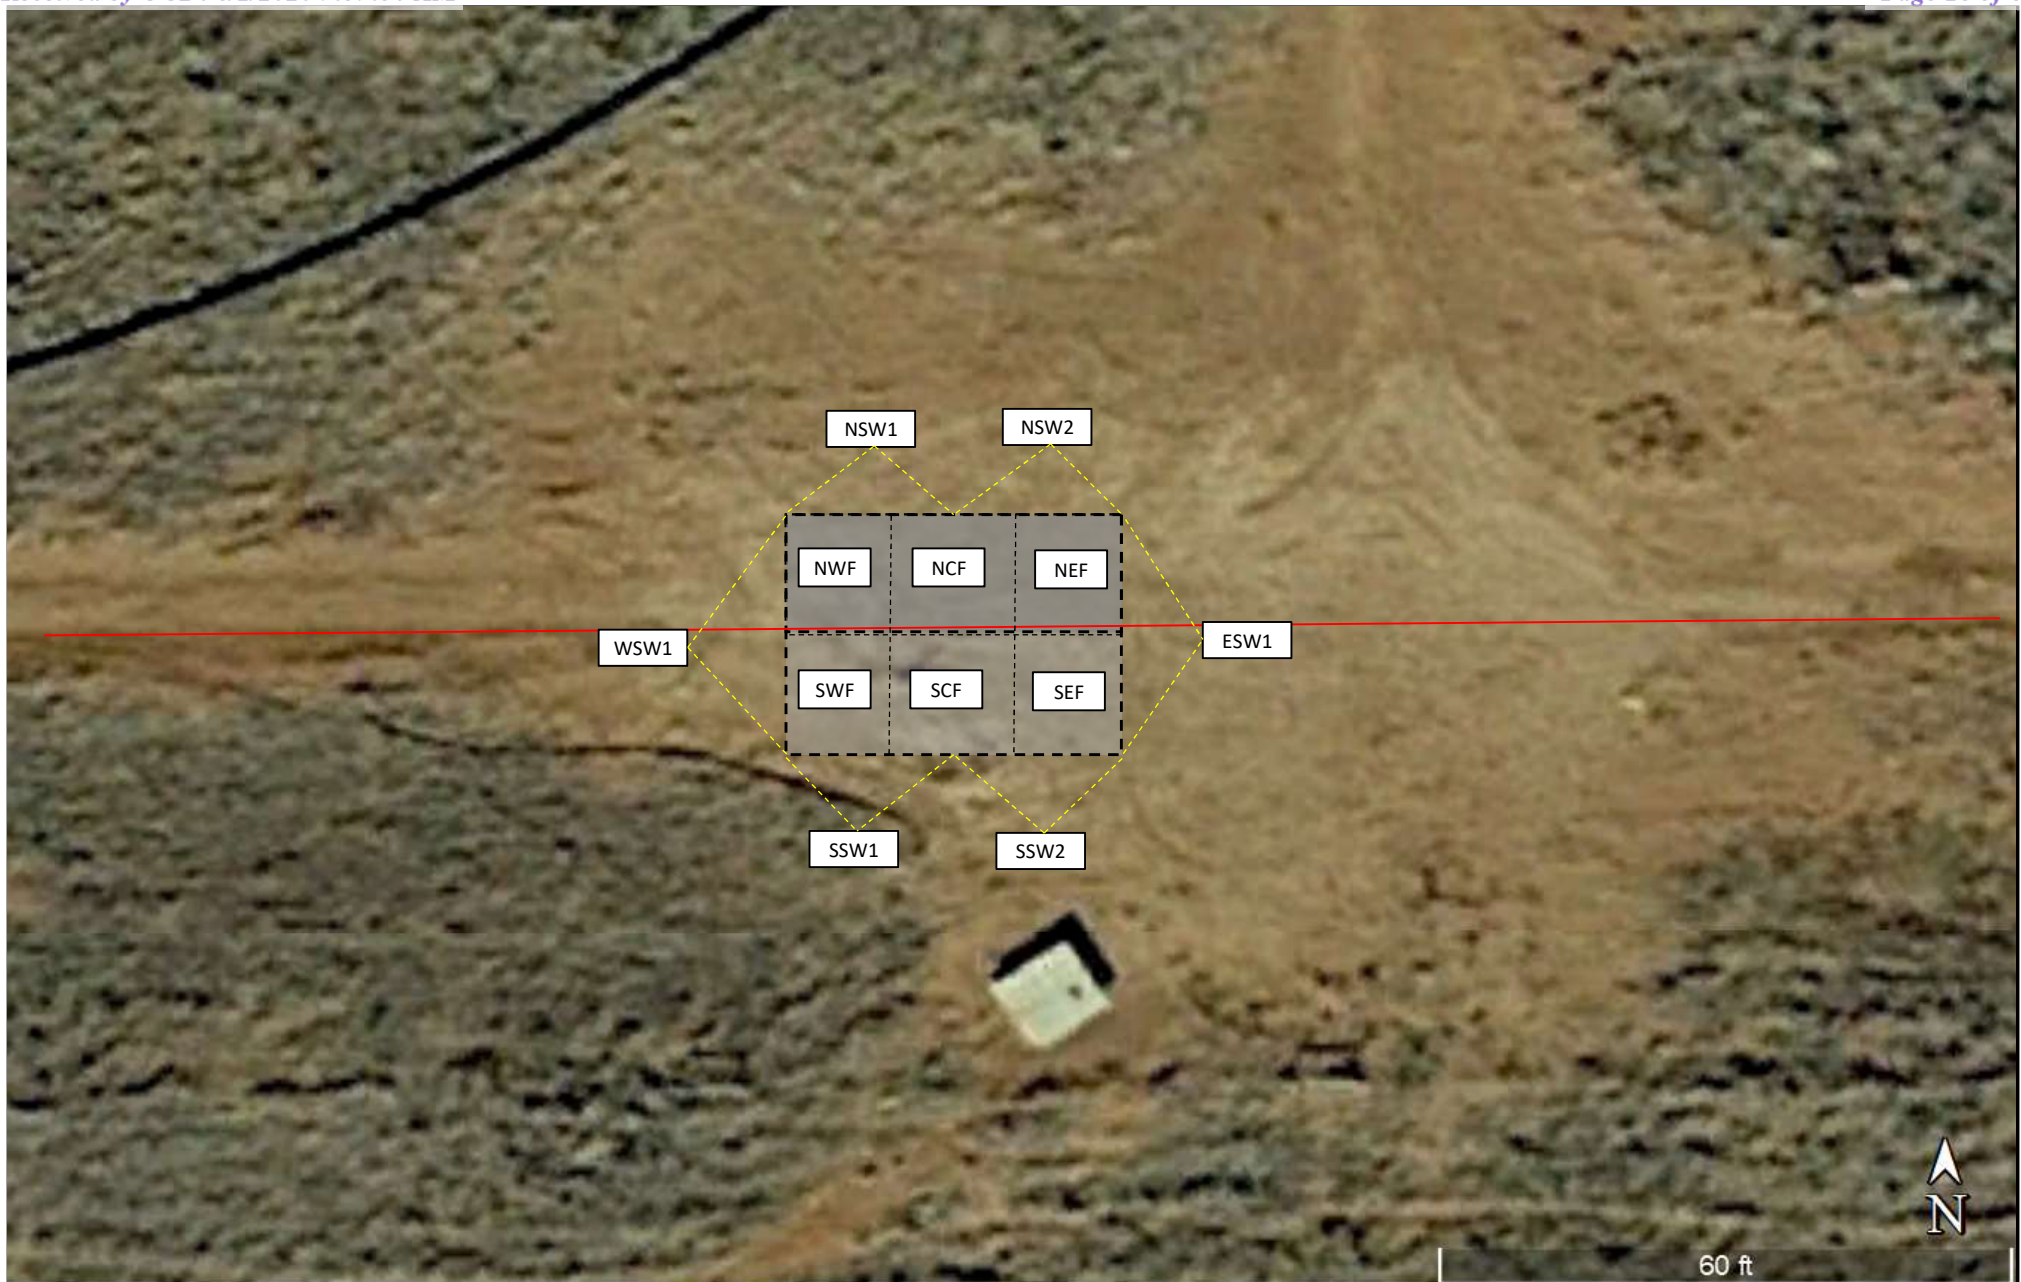
Figure 3

Site and Sample Location Map

- NSW1 Sample Location
— Buried Polyline
--- 10' Excavation
--- 8' Excavation

Site and Sample Location Map
ETC Texas Pipeline, Ltd.
Fullerton 16H
GPS: 32.428298, -103.134562
Lea County

A "Site & Sample Location Map" is provided as Figure 3. A "Soil Chemistry Table" is provided as Table 1. Laboratory Analytical Reports are provided in Appendix C. Field data and soil profile logs, if applicable, are provided as Appendix B.

The final dimensions of the excavated area were approximately 37 ft. in length, 27 ft in width and ranged from 8 to 10 ft. in depth. During the course of remediation activities approximately 312 cubic yards of impacted soil were transported to an NMOCD-approved surface waste facility for disposal.

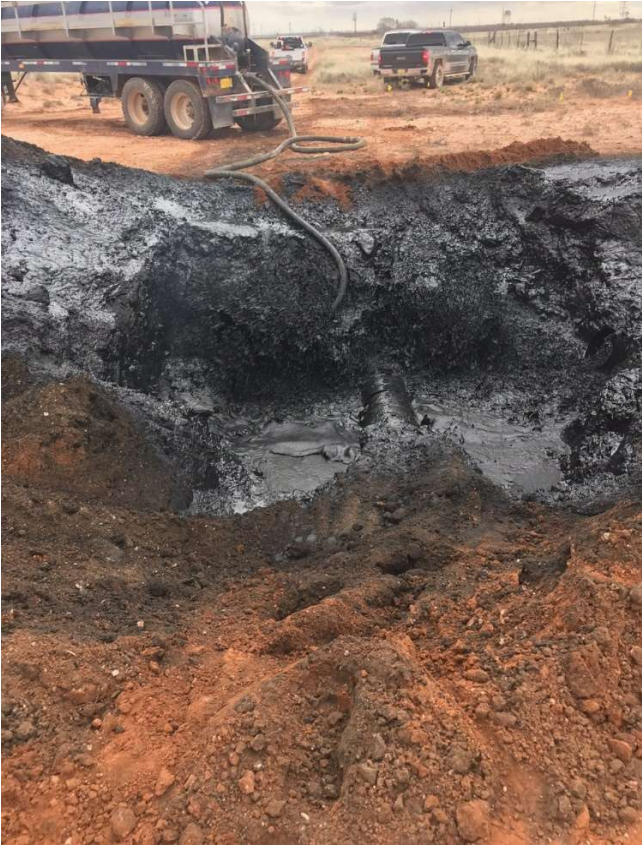
Photo Number: #1

Photo Direction: East	
Photo Description: View of initial release

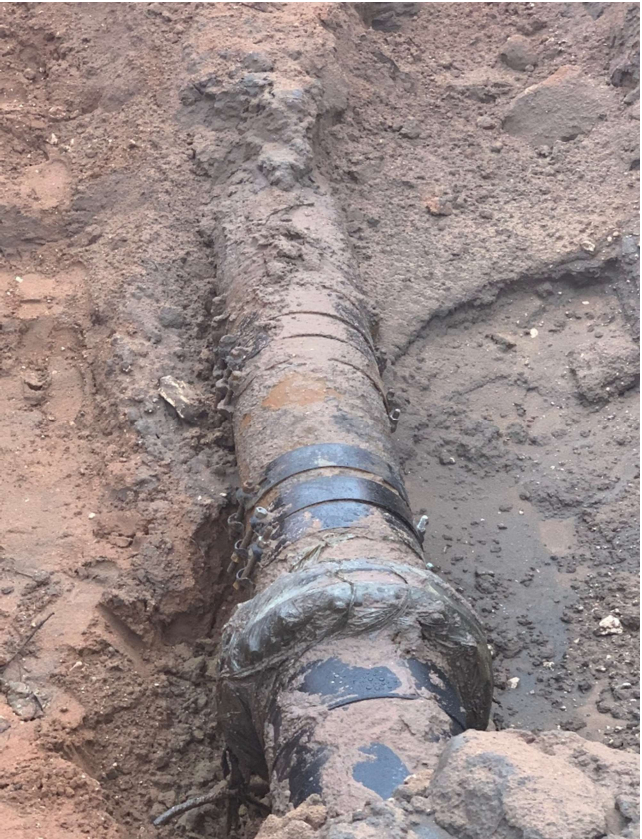
Photo Number: #2

<input type="checkbox"/> Crude Oil	Volume Released (bbls)	Volume Recovered (bbls)
<input type="checkbox"/> Produced Water	Volume Released (bbls)	Volume Recovered (bbls)
	Is the concentration of total dissolved solids (TDS) in the produced water > 10,000 mg/L?	<input type="checkbox"/> Yes <input type="checkbox"/> No <input type="checkbox"/> N/A
<input type="checkbox"/> Condensate	Volume Released (bbls)	Volume Recovered (bbls)
<input checked="" type="checkbox"/> Natural Gas	Volume Released (Mcf) 188.5	Volume Recovered (Mcf) 0
<input checked="" type="checkbox"/> Other (describe) Oil & Condensate Mix	Volume/Weight Released 13.09 bbls	Volume/Weight Recovered 65 bbls (also contained rain water)
Cause of Release: Attributed to corrosion of pipeline segment.

Photo Direction: West	
Photo Description: View of initial release and clamp

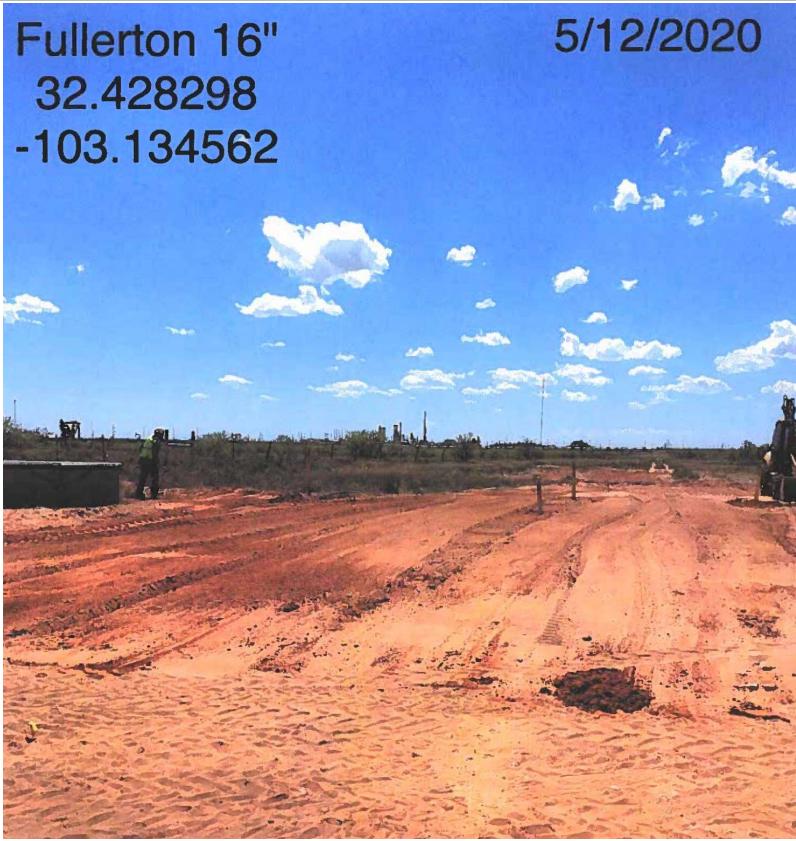
Photo Number: #5	<div>Fullerton 16" 5/12/2020 32.428298 -103.134562</div>

Photo Direction: South	
Photo Description: Backfilled

Upon receiving laboratory analytical results from confirmation soil samples, excavated areas were backfilled with locally sourced, non-impacted "like" material placed at or near original relative positions. The affected area was contoured and/or compacted to achieve erosion control, stability and preservation of surface water flow to the extent practicable. Affected areas not on production pads and/or lease roads will be reseeded with an agency and/or landowner-approved seed mixture free of noxious weeds during the first favorable growing season following closure of the site.
