Pima Environmental Services, LLC (Pima) has conducted a site assessment, soil sampling and has prepared this Closure Report on behalf of Devon Energy Production Company (Devon) for the Regulus 26 Federal #4H. These incidents were assigned 2RP-5166 and NRM2015053388 by the New Mexico Oil Conservation Division (NMOCD).

Regulus 26 Federal #4H
API 30-015-40041
Eddy County, NM
Location Map

Appendix E:
Photographic Documentation

Regulus 26 Fed #4H Liner Photos

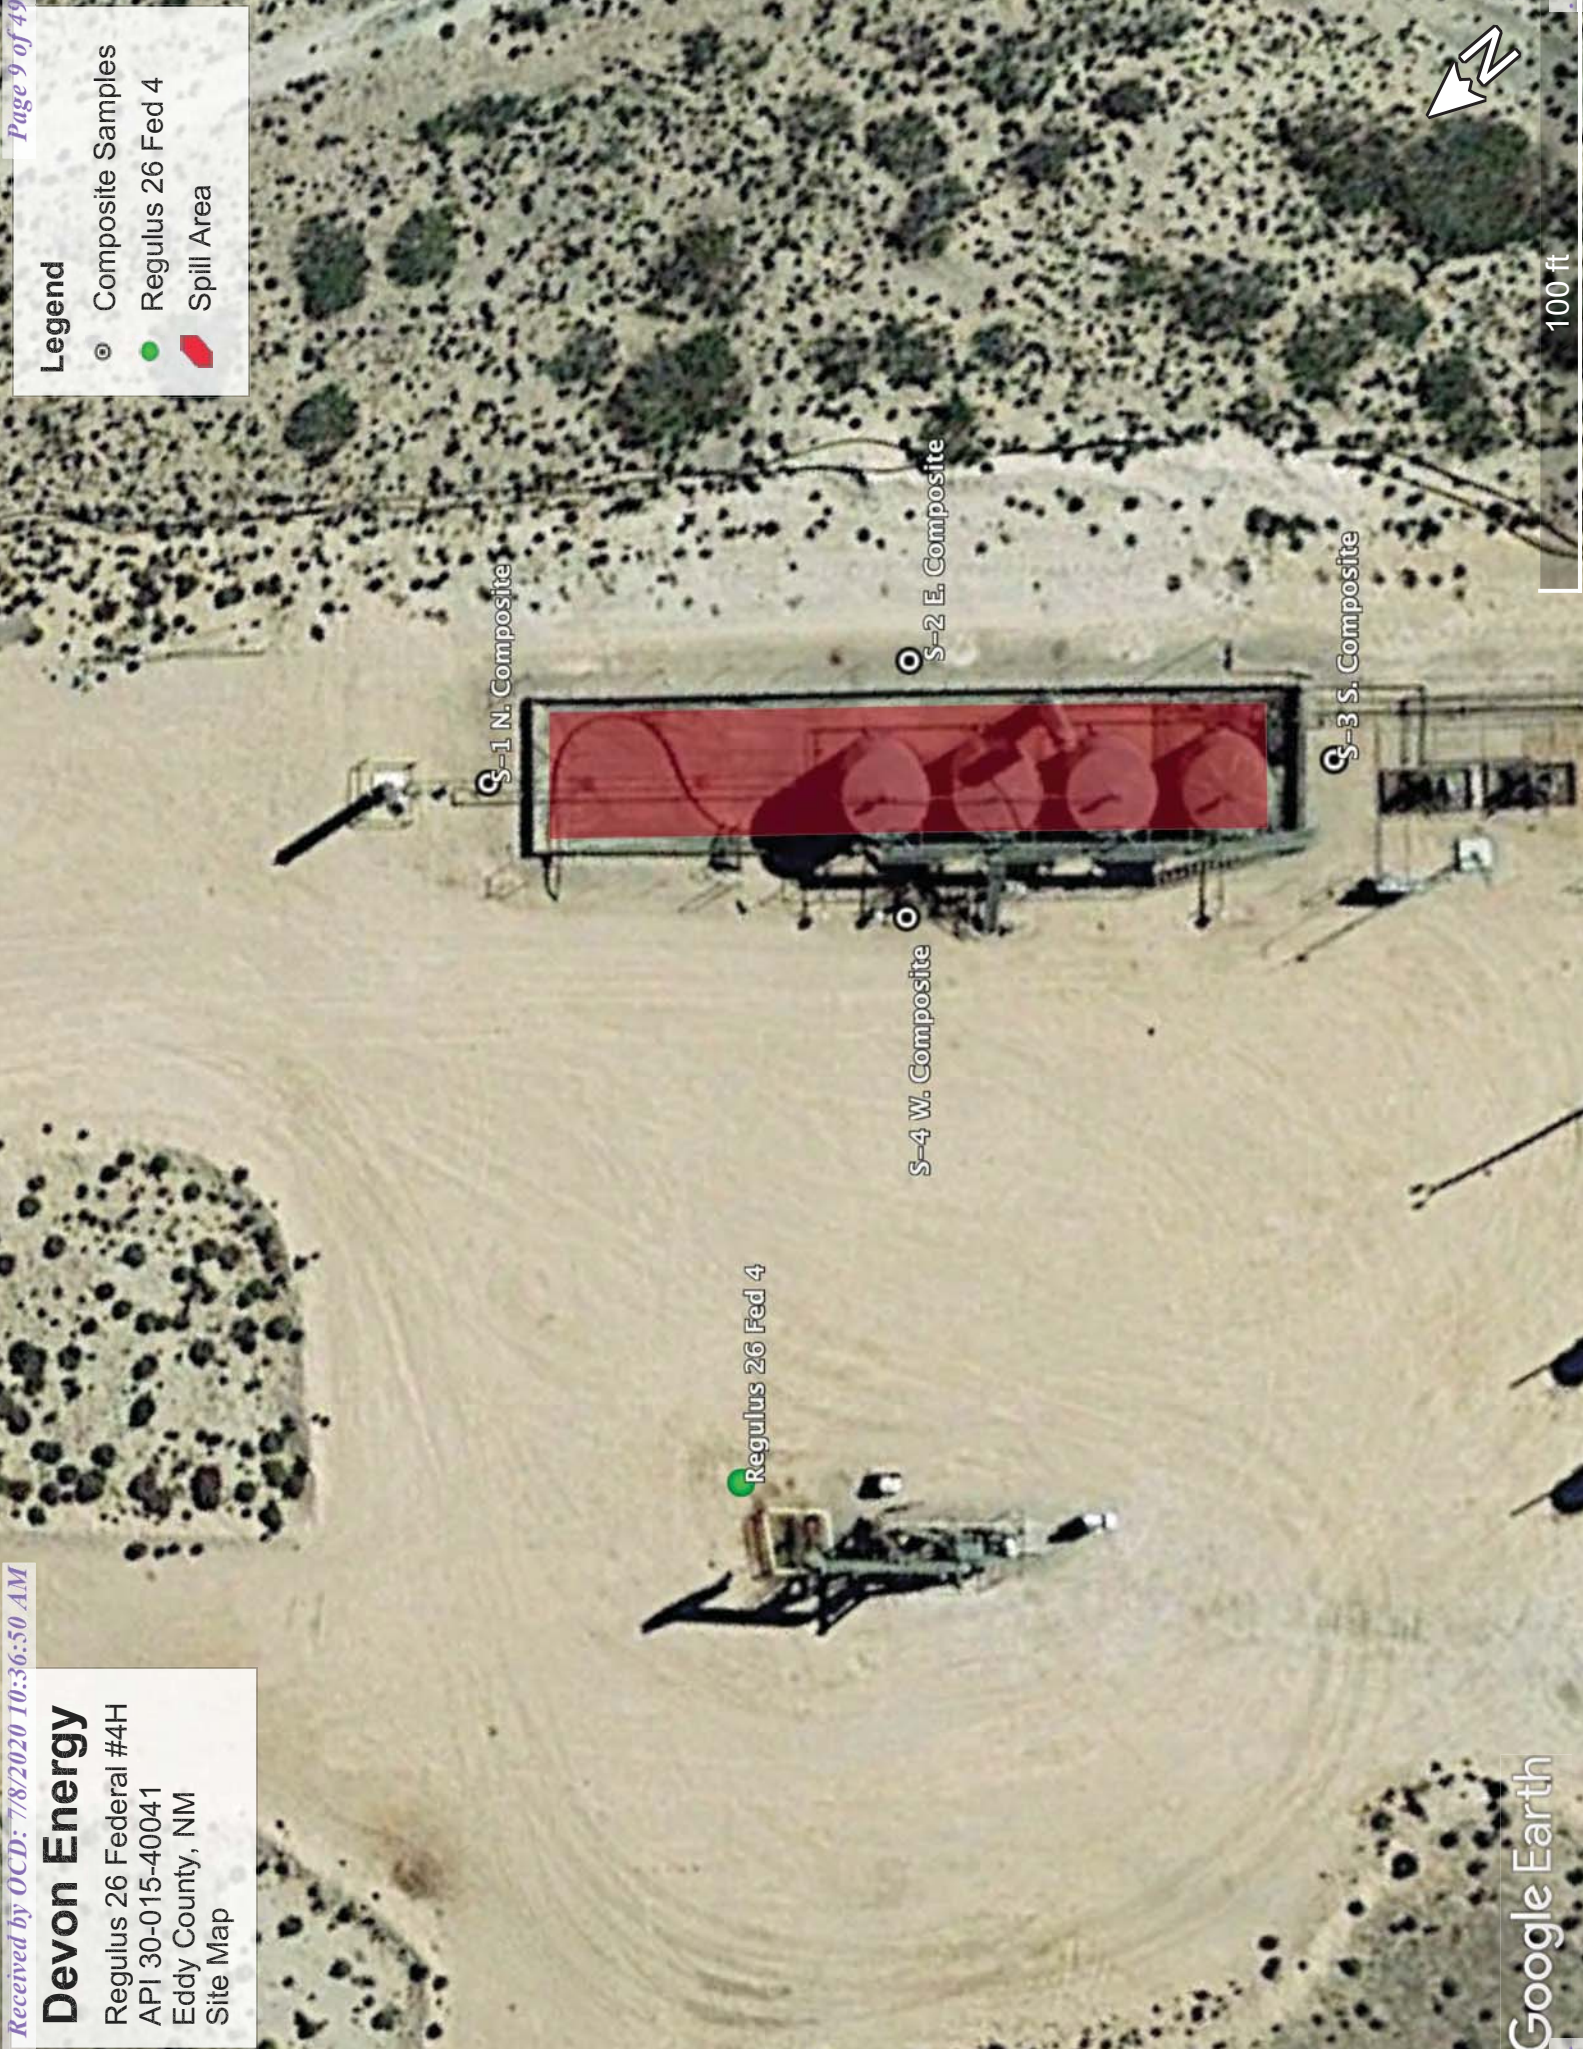
Regulus 26 Federal #4H
API 30-015-40041
Eddy County, NM
Site Map

NRM2015053388: On May 12, 2020, the fill line to the tank developed some holes releasing produced water into the engineered steel and poly-lined containment, resulting in the release of approximately 222 bbls of produced water. The initial response activities were conducted by the operator and included source elimination and site containment and the recovery of approximately 222 bbls of produced water. Figure 4 references a site map illustrating spill area and sample points.

On June 8, 2020, composite samples were collected outside the containment walls to verify that the liner had not been breached, and the integrity was still intact. The laboratory results of this sampling event can be found in the following data table.

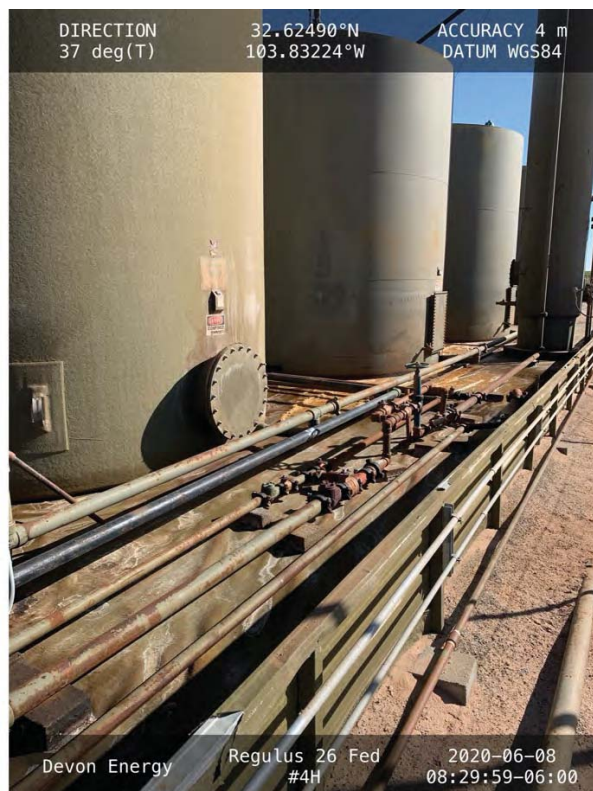
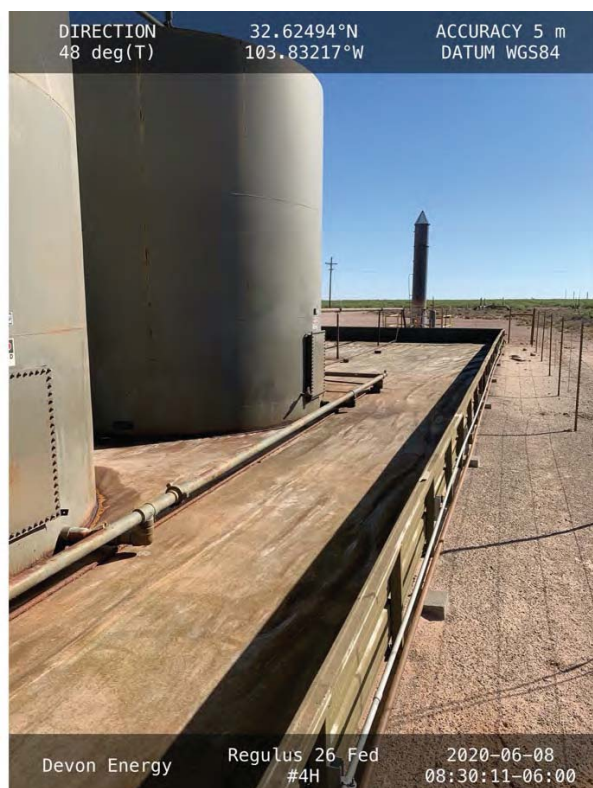
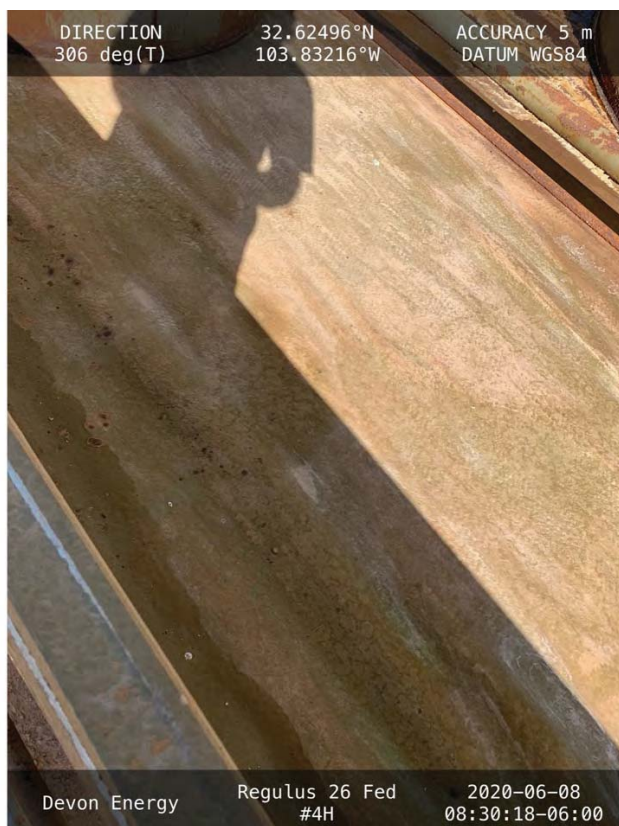
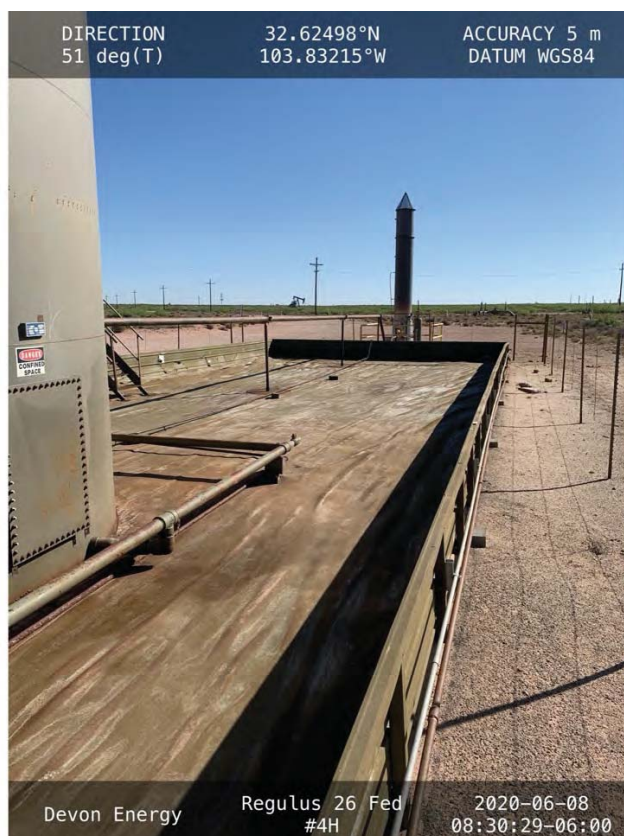
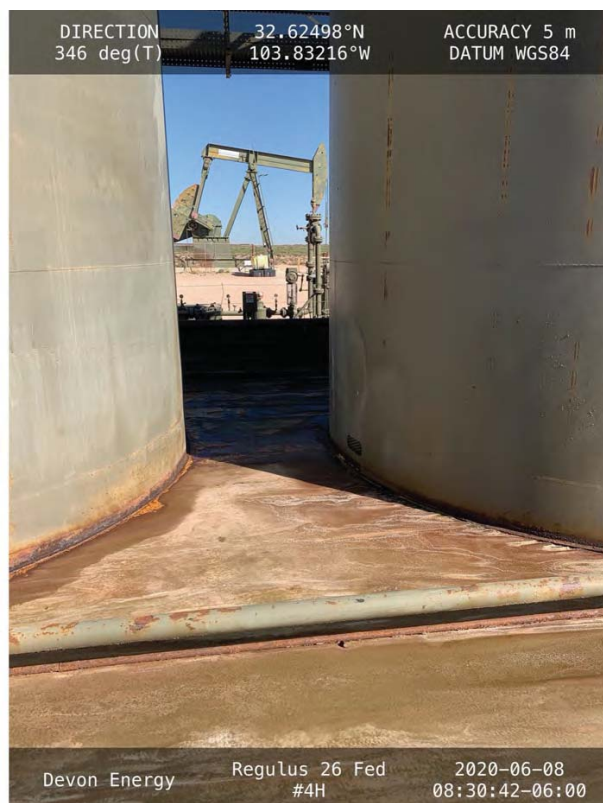
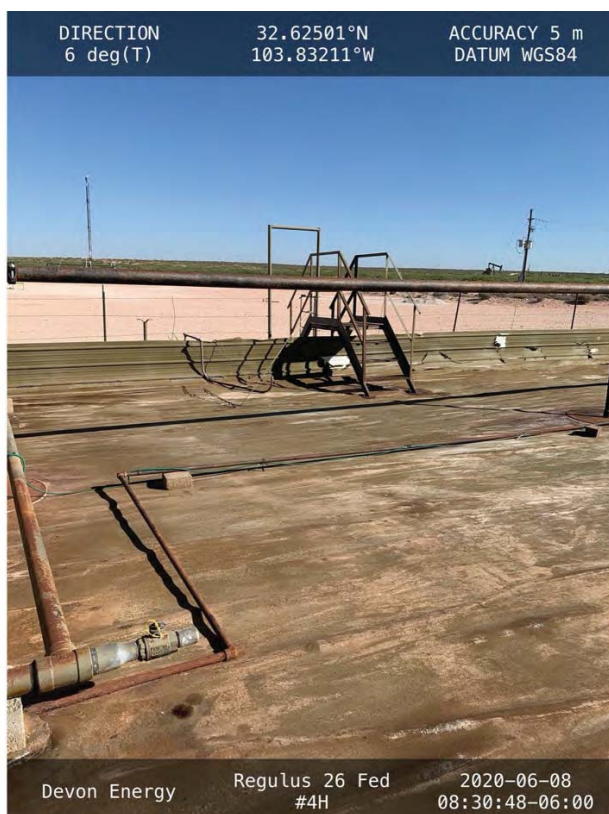
The sample results were below NMOCD Closure Criteria 19.15.29 NMAC; the visual liner inspection shows no evidence that the integrity was compromised. Based on these findings, no remediation activities were needed at this location.

After careful review, Pima, on behalf of Devon Energy, is requesting that no further action be required, and closure in regards to these incidents be granted.
