Release Notification

Site Name: Hayduke 34 Federal 1H	Site Type: Battery
Date Release Discovered: 3/26/2020	API# (if applicable) 30-015-36601

CIMAREX ENERGY
HAYDUKE 34 FEDERAL 1H
EDDY, NM

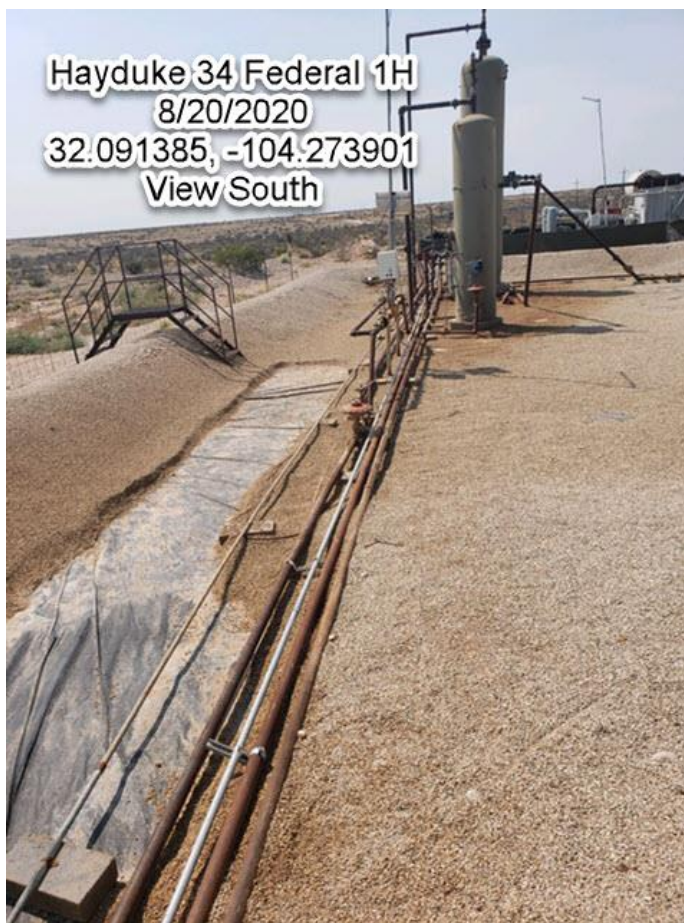
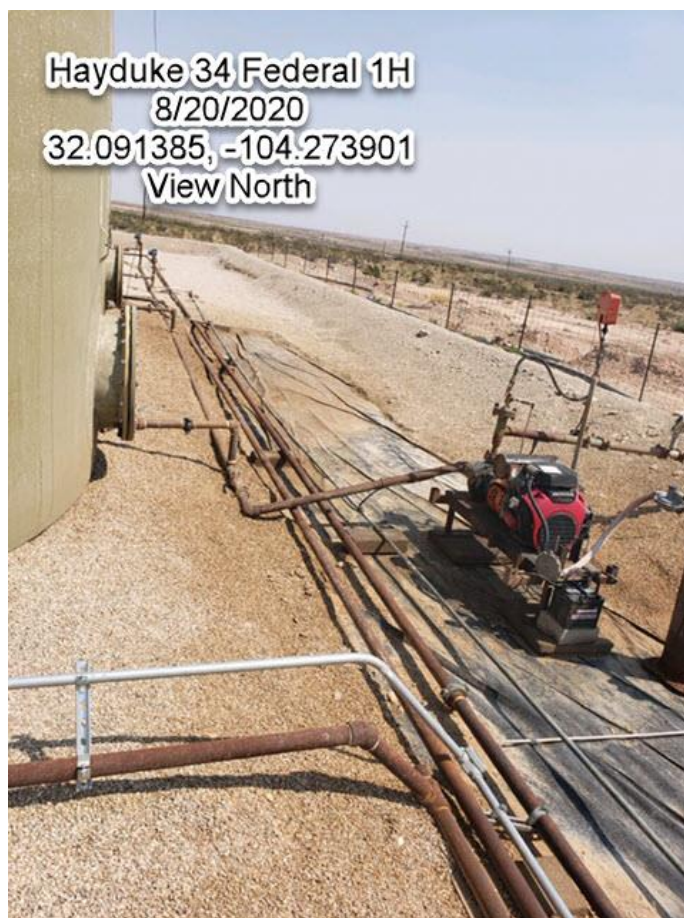
Cimarex removed contaminated gravel and visually inspected the liner in the affected area. Notification was given to the NMOCD and BLM for a liner inspection on 8/24/2020. The liner is intact and was able to contain the leak. Cimarex will backfill with clean gravel.
