**TAYLOR D 3 BATTERY
(CLOSEST WELL: TAYLOR D #003)
CLOSURE REPORT/DEFERRAL REQUEST**

**API NO. 30-025-39400
RELEASE DATE: 12/14/2019
INCIDENT ID: NCS2003151765
U/L G, SECTION 09, TOWNSHIP 17S, RANGE 32E
LEA COUNTY, NEW MEXICO**

RE: Taylor D3 Battery – Closure Report/Deferral Request
Date of Release: December 14, 2019
API No. 30-025-39400
U/L G, Section 09, Township 17S, Range 32A

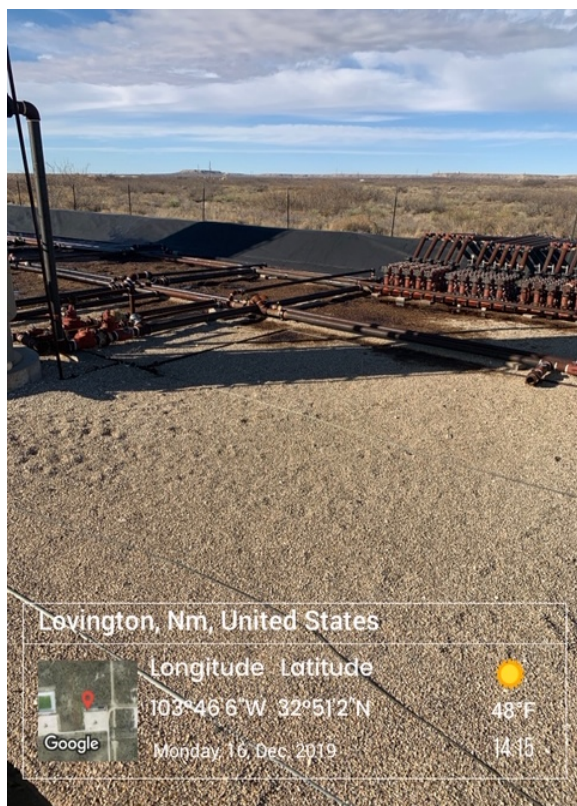
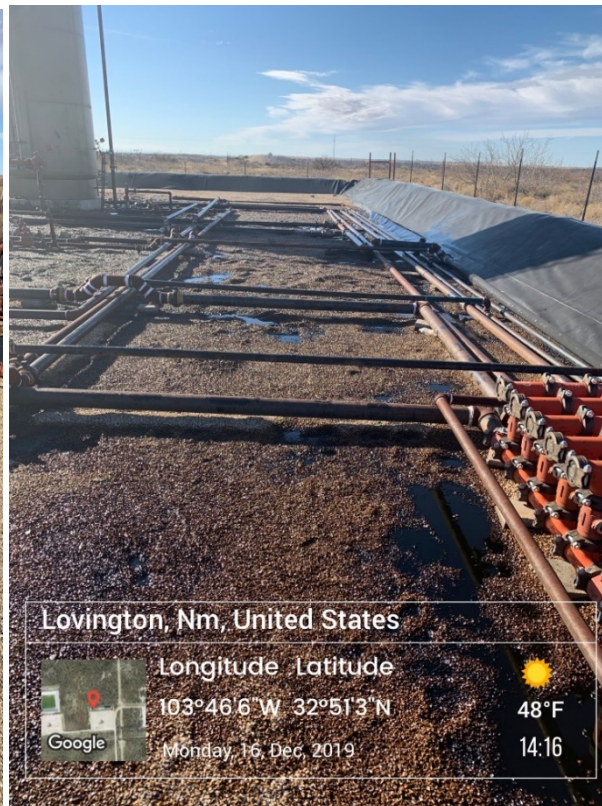
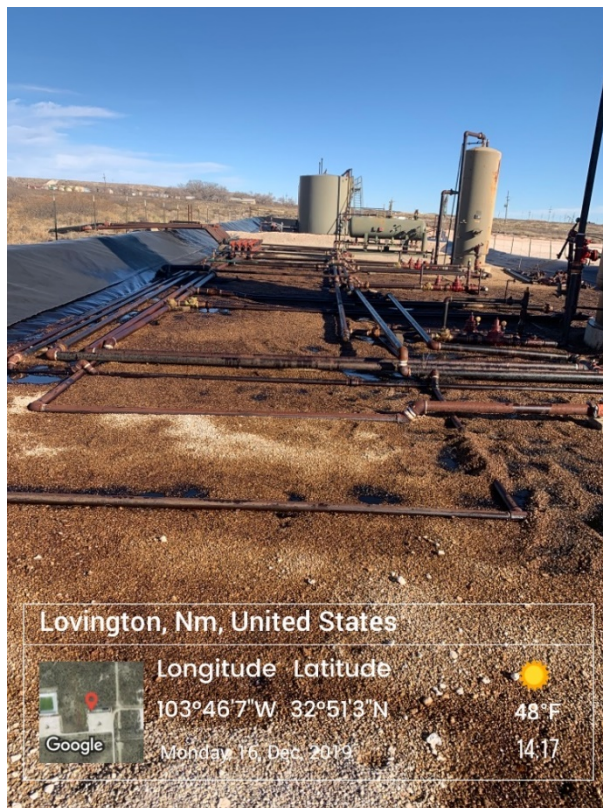
TAYLOR D3 BATTERY – SPILL DATE 12/14/19*****

On December 16th, 2019 of Hungry-Horse LLC was dispatched out to the Taylor D3 Battery to complete a site assessment. Initial photos were taken of the release which was contained inside the line facility. The soil on-top of the liner was hand excavated and hauled to Lea Landfill for disposal. Approximately 35.02 tons of contaminated soil from above the liner was hauled to disposal. Soil was not replaced to cover the liner waiting liner inspection and patching. Emails to the OCD are were not available by Hungry-Horse for liner inspection request. Several puncture holes were found during the liner inspection and noted in photographs.

As seen in the chart above, the integrity of the liner has been compromised and has caused there to be impacted soil beneath the liner.

The impacted soil found in the SP3 area will need to be remediated after the facility has been decommissioned and the wells are plugged.

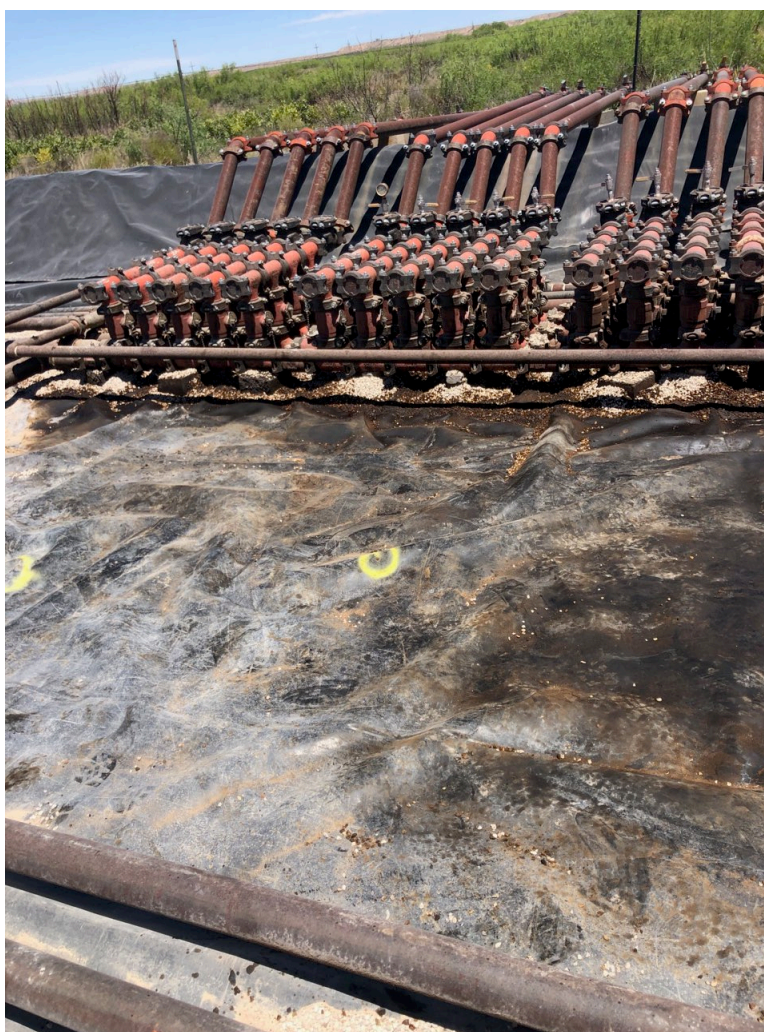
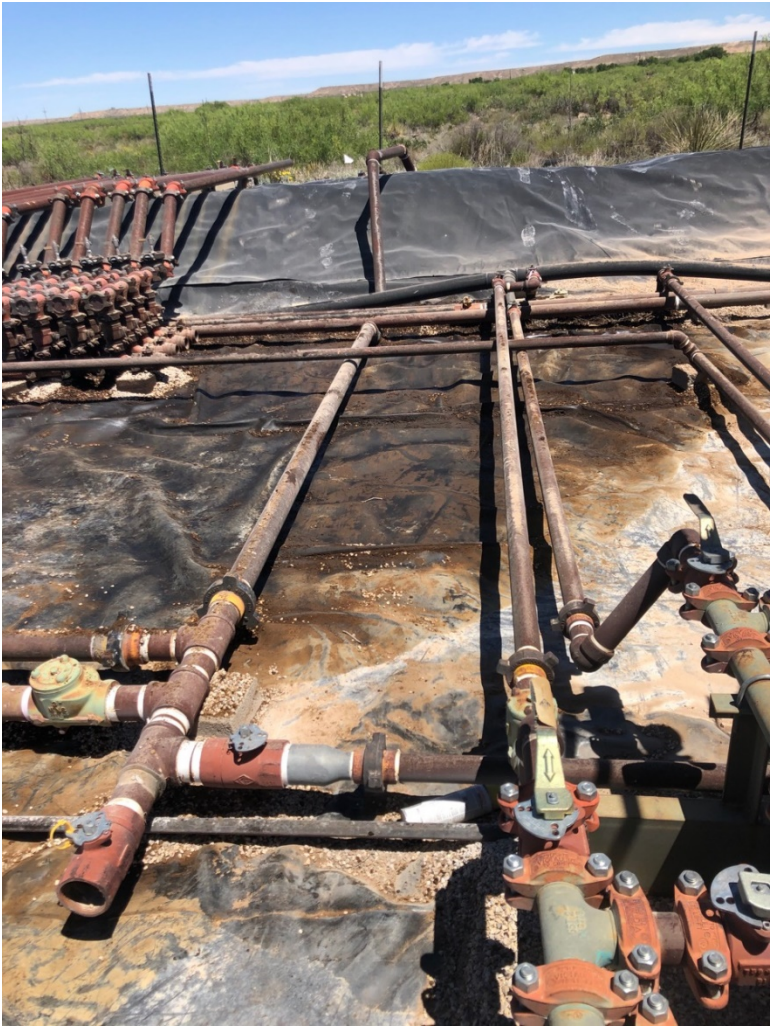
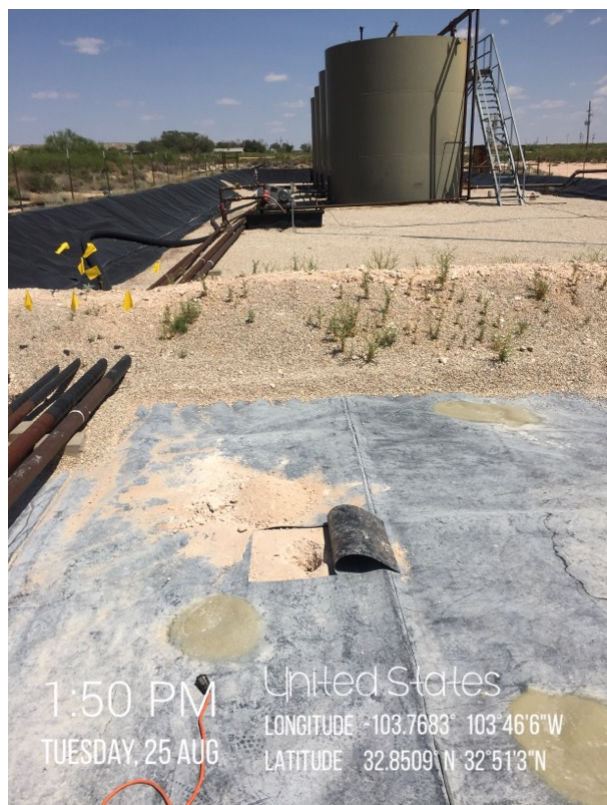
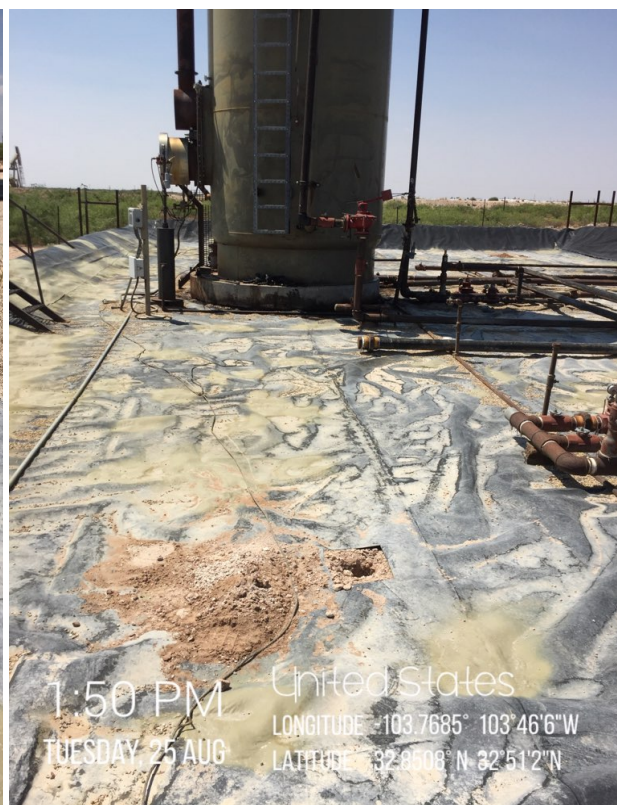
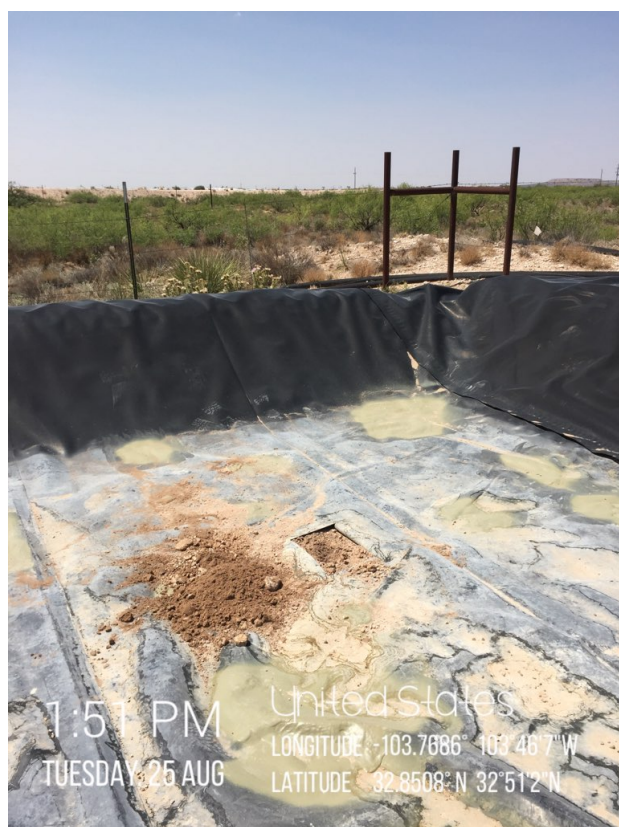
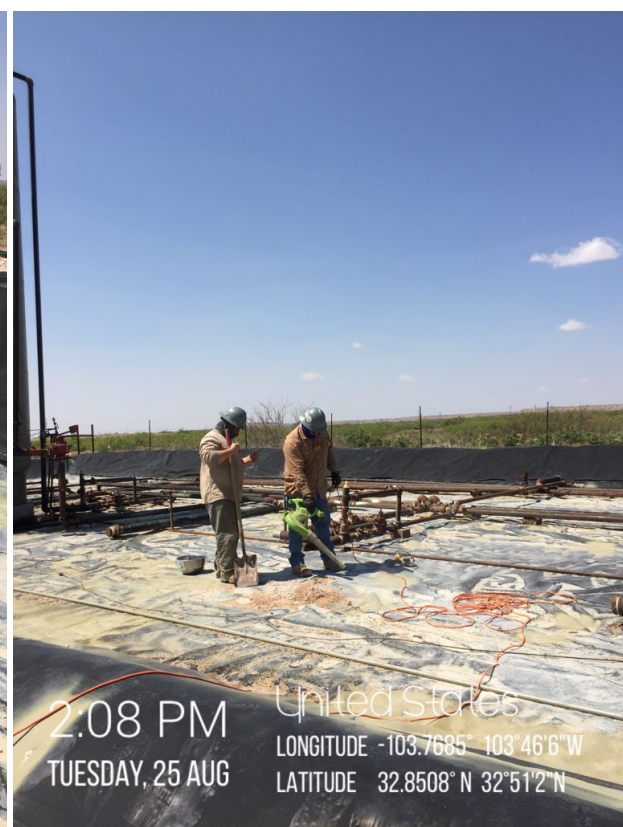
**TAYLOR D3 BATTERY
LINER AND FINAL PHOTOS**

On August 25th of 2020, ESS arrived on site to cut three 1' x 1' holes in the liner to delineate vertically to determine if the liner had been compromised. Three different areas were field tested under the patched liner. SP1 and SP2 were field tested to 3'bgs with no indication that the soil had been impacted. On SP3, crew's hand-augured to a depth of 6'bgs. At 4'bgs, chlorides dropped below 600 mg/kg chlorides with no indication of TPH. Therefore, a total of three consecutive field samples, depths 4', 5' and 6' ranged from 0 mg/kg to 240 mg/kg on chlorides with no detection of volatiles. Immediately following the delineation process, crews patched and sprayed the liner. The soil samples were sampled using 1' intervals by use of hand auger. ESS crews also obtained a background sample of the site which came back at 23.9 mg/kg

chlorides with no indication of BTEX or TPH. The field samples were tested in the field using the Titration Method for chlorides and volatiles in the soil by use of a PID Meter. All the other compromised areas were also patched and sprayed by ESS.
