Closure Report

Site Description		
Site Name:	Cedar Canyon 22-1H Well Battery	Incident ID: NRM2012537816
Company:	Oxy, Permian	
Legal Description:	U/L K, Section 22, T24S, R29E	
County:	Eddy County, NM	
GPS Coordinates:	N 32.2014 W -103.9744

Release Data	
Date of Release:	3/30/2020
Type of Release:	Crude Oil
Source of Release:	Over Pressure
Volume of Release:	80 bbls
Volume Recovered:	76 bbls

Cedar Canyon 22-1H Well Battery (3-30-20)

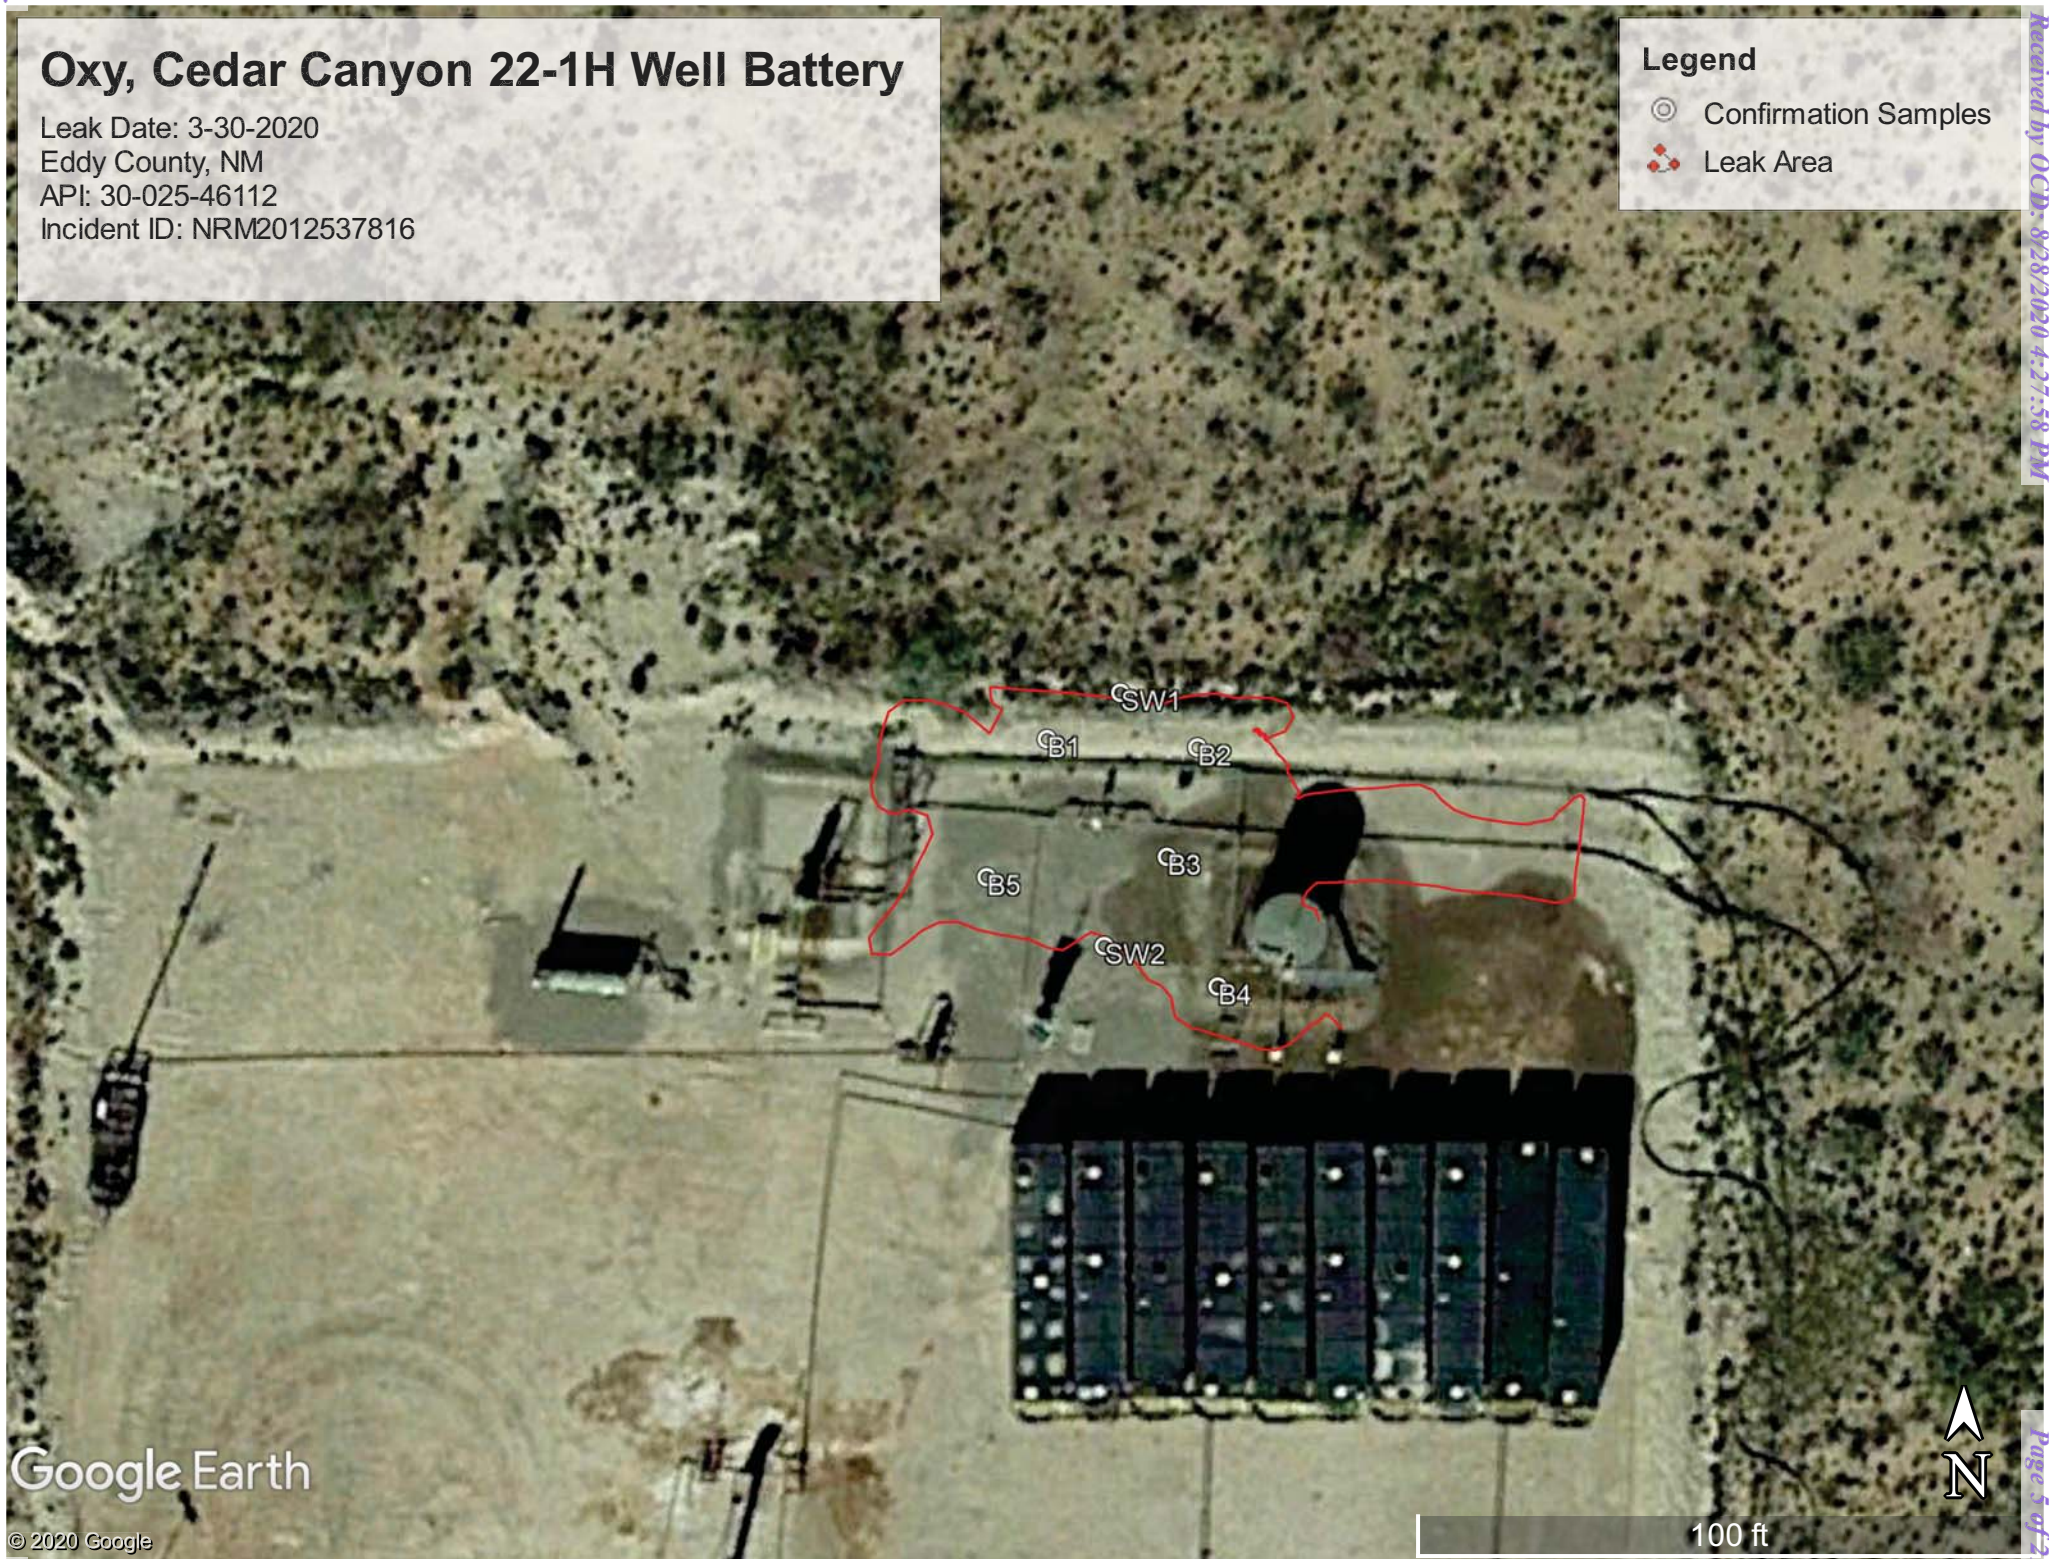
Oxy, Cedar Canyon 22-1H Well Battery

Remediation Specifications	
Remediation Parameters:	The release occurred inside and outside of a lined containment. The liner was cleaned and inspected for integrity. The soil outside was excavated and confirmation samples were collected per the at risk requirements of the spill rule.
Remediation Activities:	July 22, 2020 through August 6, 2020

Leak Date: 3-30-2020
Eddy County, NM
API: 30-025-46112
Incident ID: NRM2012537816

- Confirmation Samples
- Leak Area
