Re: Site Remediation and Closure Report
Rigel 20 Fed Com #3H
API No. 30-015-39725
GPS: Latitude 32.6431353 Longitude -103.898920
UL "L", Sec. 20, T19S, R31E
Eddy County, NM
NMOCD Ref. No. 2RP-2960; 2RP-4452; 2RP-5429

Rigel 20 Fed Com #3H
API 30-015-39725
Eddy County, NM
Location Map

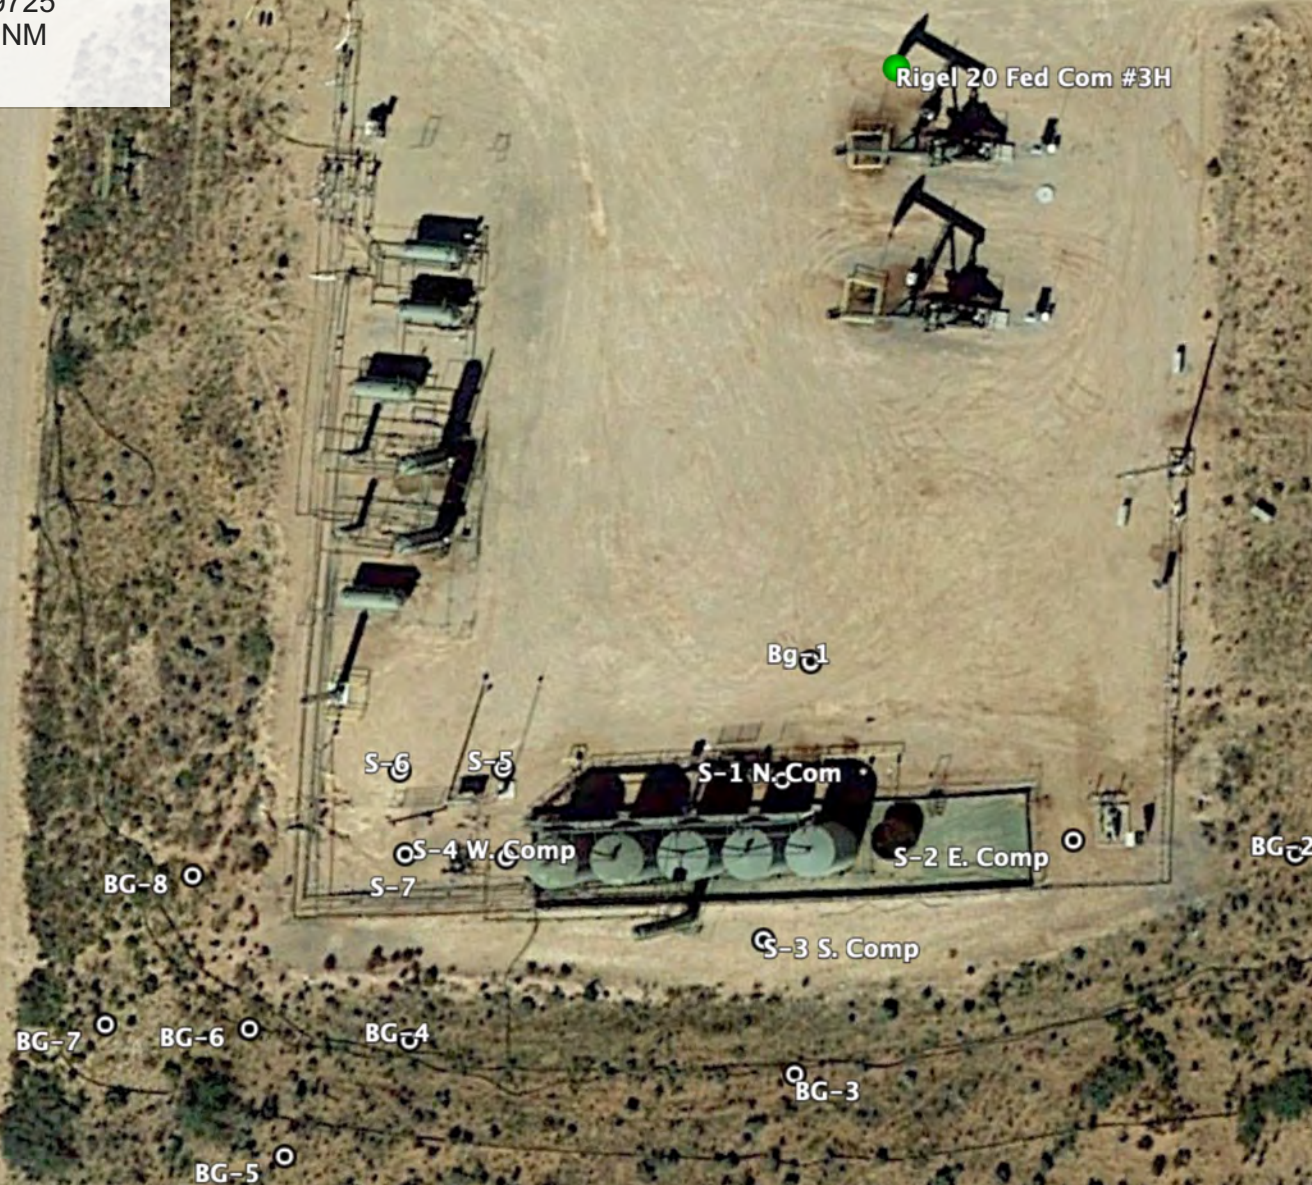
On July 27, 2020, Pima Environmental conducted a site assessment and obtained composite soil samples to verify that the liner had not been breached, and the integrity was still intact. Location and background samples were also obtained in the pasture to ensure that the fluids expelled into the pasture had not contaminated the soil. The laboratory results of this sampling event can be found in the following data table.
