Remediation and Closure Report

Hackberry 26 Fed Com 1H
Eddy County, New Mexico
API # 30-015-43856
Incident # **Nvv2002839011**

Subject: **Remediation and Closure Report**
Hackberry 26 Fed Com 1H
Eddy County, NM
API # 30-015-43856

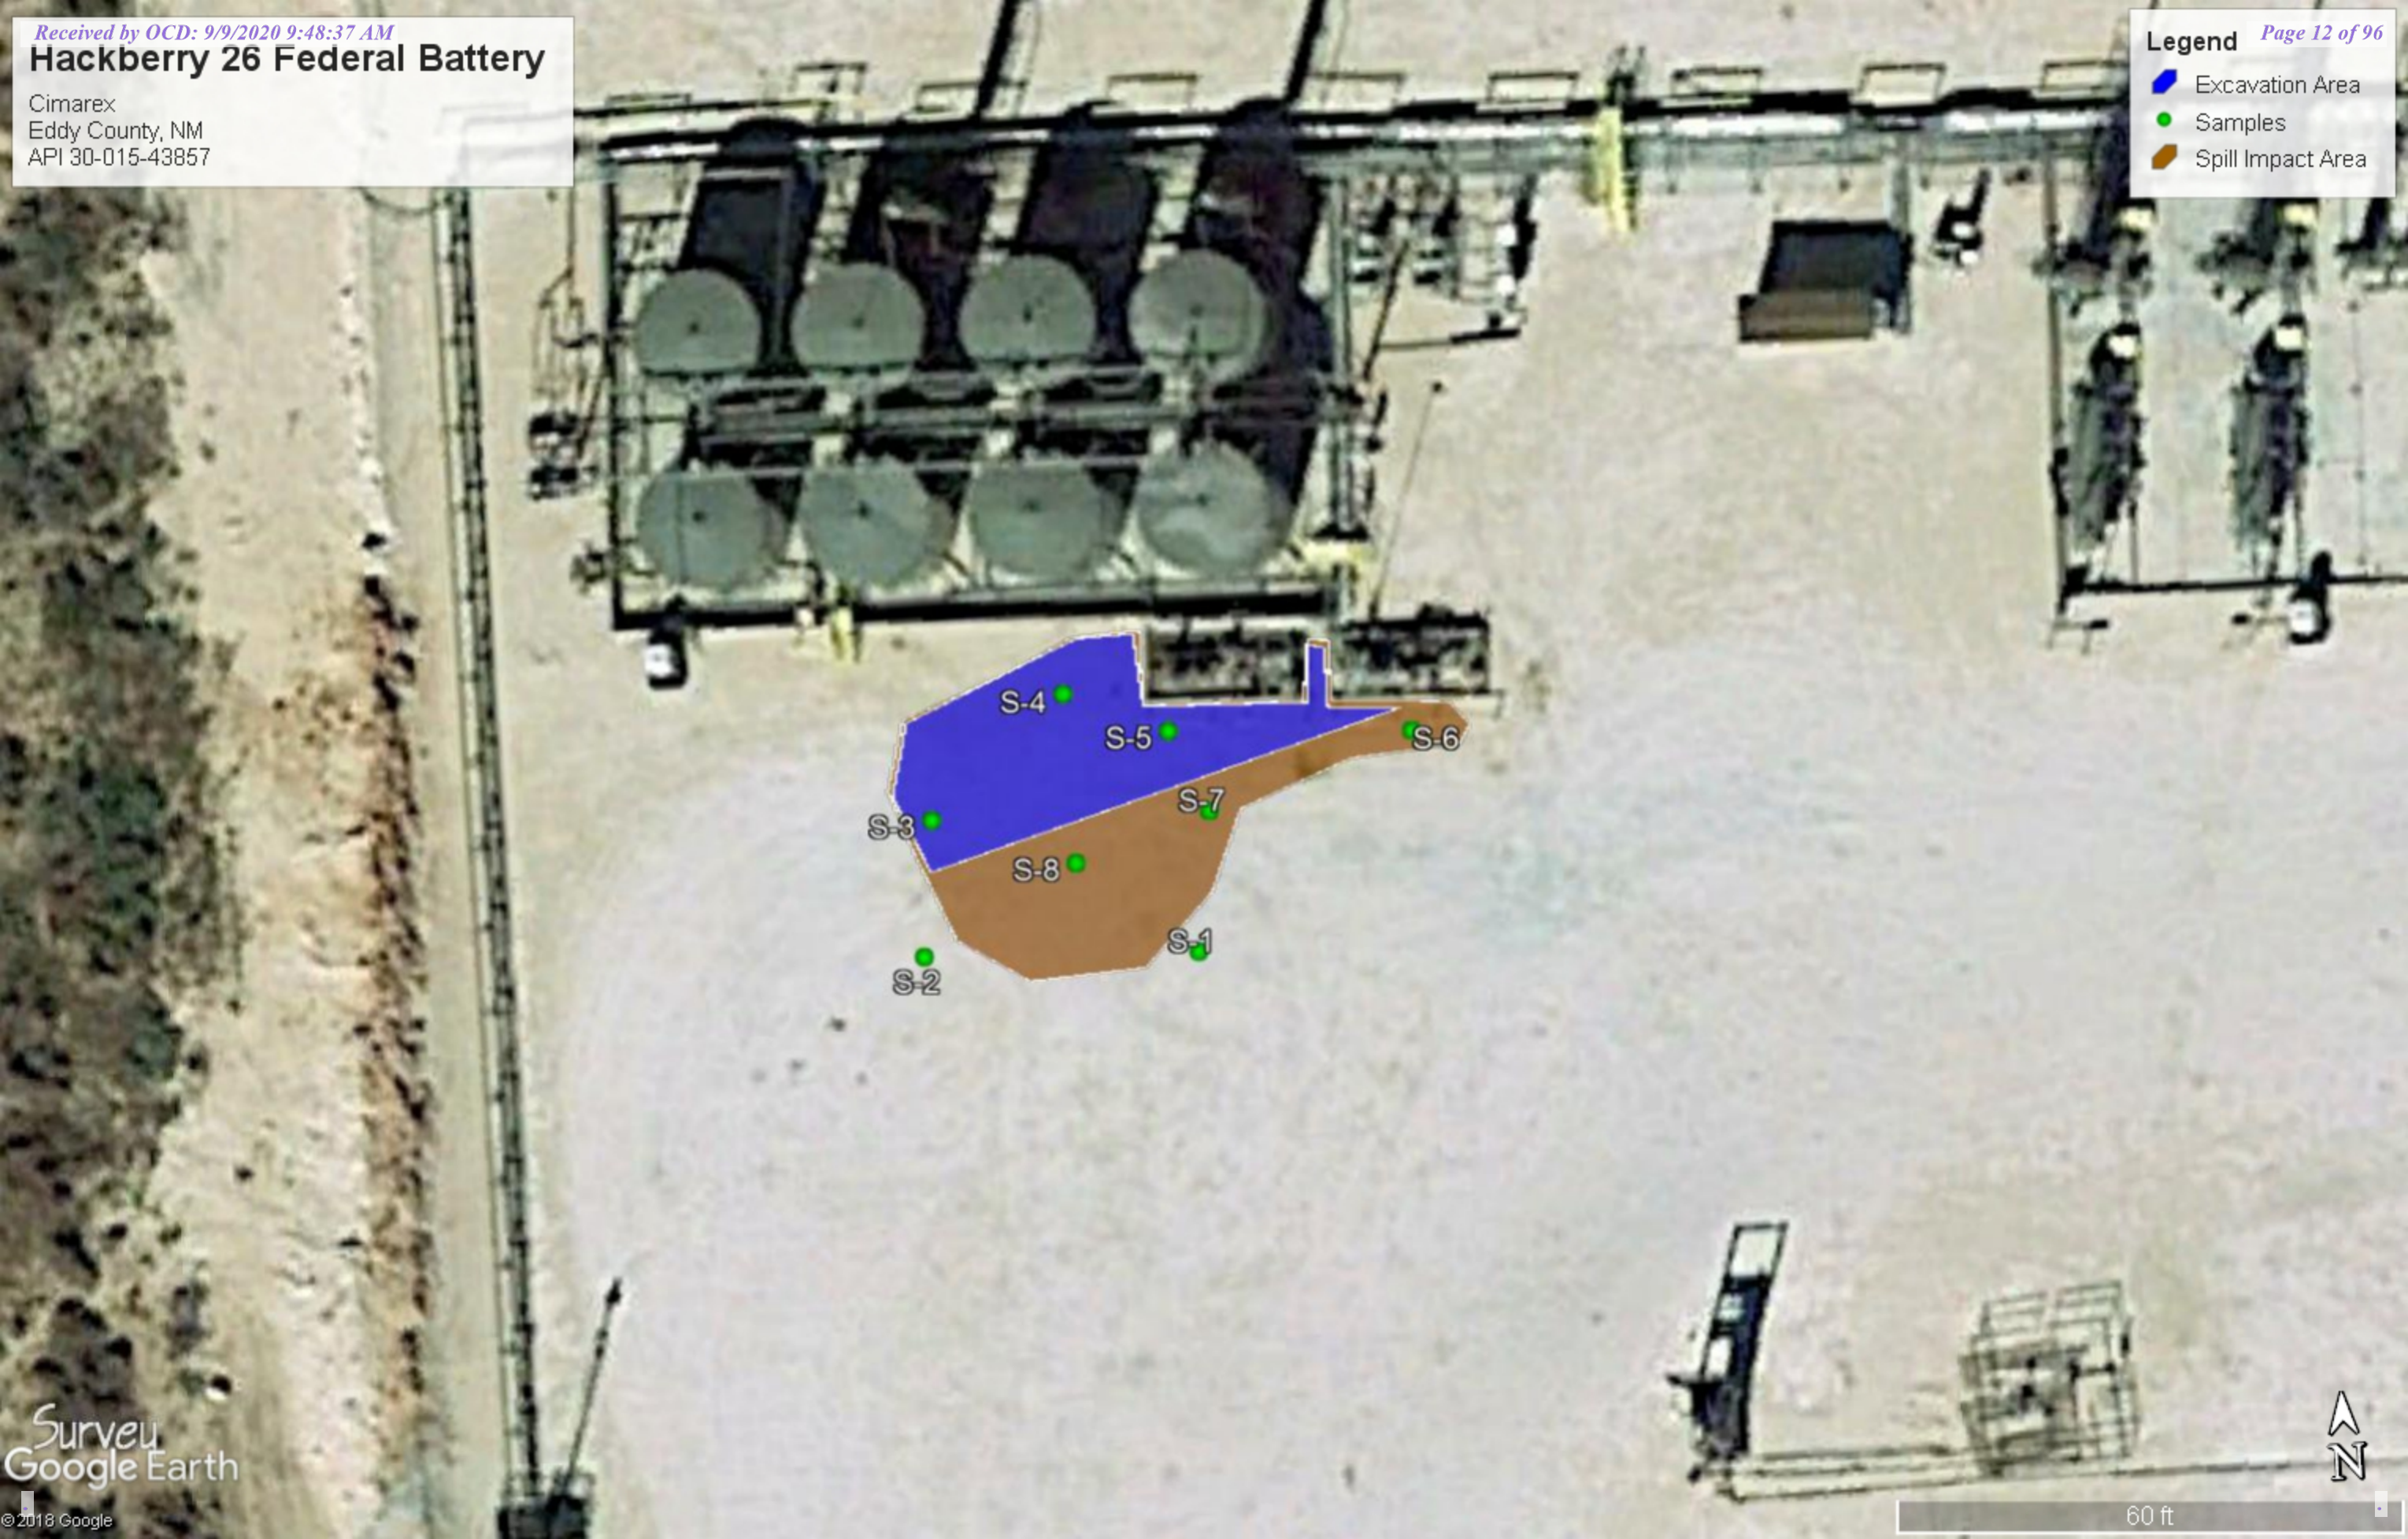
Eddy County, NM
API 30-015-43857
Excavation Site Plan

Based on the results of our site assessment and upon client authorization, excavation activities commenced on April 20, 2020. Approximately .5' bgs. was excavated throughout the impacted area. Confirmation samples were collected at the base of sidewalls which also serve as bottom confirmation of soil analytes and that NMOCD closure criteria had been met, for the analytes of concern. The results of which can be found in the following data table. Confirmation sample locations and excavation dimensions can be found in [Appendix I](#). Complete laboratory reports are attached in [Appendix V](#).

Spill Impact Area
