Site Name	Corral Canyon 10 East Battery	Site Type	Battery
Date Release Discovered	12/22/2019	API# (if applicable)	30-015-45432 (Corral Canyon 3 34 Fed 907H)

**RE: Deferral Request
 Corral Canyon 10 East Battery
 Incident Number NCS2002354093
 Eddy County, New Mexico**

LT Environmental, Inc. (LTE), on behalf of XTO Energy, Inc. (XTO), presents the following Deferral Request detailing site assessment, soil sampling, and excavation activities at the Corral Canyon 10 East Battery (Site) in Unit B, Section 10, Township 25 South, Range 29 East, in Eddy County, New Mexico (Figure 1). The purpose of the site assessment, soil sampling, and excavation activities was to address impacts to soil resulting from a release of crude oil at the Site. Based on field observations, field screening, and laboratory analytical results from soil sampling activities, XTO is submitting this Deferral Request, describing remediation that has occurred and requesting deferral of final remediation for this release event.

FIGURE 2
 PRELIMINARY SOIL SAMPLE LOCATIONS
 CORRAL CANYON 10 EAST BATTERY
 UNIT B SEC 10 T25S R29E
 EDDY COUNTY, NEW MEXICO
XTO ENERGY, INC.

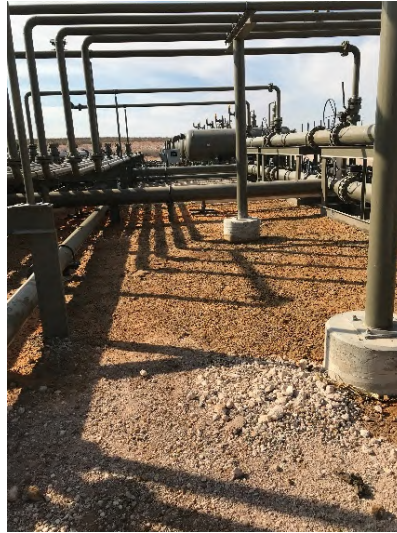
Photograph 1: View west of impacted soil.

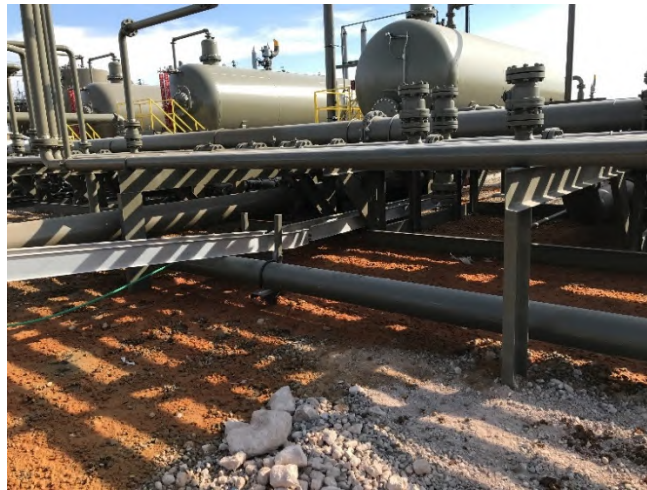
A total of approximately 50 cubic yards of impacted soil were excavated from the Site; however, residual impacted soil was left in place for compliance with the XTO safety policy regarding earth-moving activities within two feet of active production equipment and pipelines and the inability to access the impacted soil due to overhanging infrastructure. Impacted soil between the risers, pipelines, and separators could not be accessed due to the space limitations and safety considerations.

Photograph 2: View of inaccessible impacted soil.

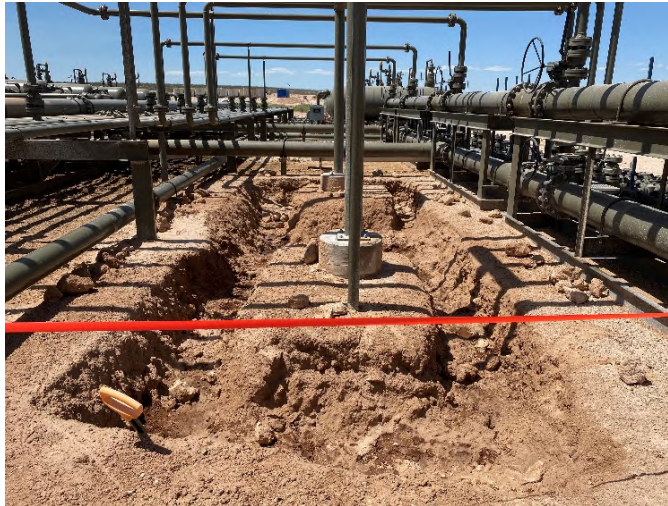
Photograph 3: View west of hydro vacuum excavation, red line in forefront is reflective tape.

Impacted soil was excavated to the extent possible, including hand shoveling and hydro-excavation in accessible areas. Laboratory analytical results for excavation sidewall samples SW01A and SW02A indicated that soil with TPH and/or GRO/DRO concentrations exceeding the Closure Criteria was left in place within 2 feet of active production equipment and pipelines. Additional impacted soil was visibly identified beneath and around active production equipment and could not be excavated without major facility deconstruction. The impacted soil remaining in place is delineated laterally and vertically by excavation soil samples FS01A, FS02A, FS03, SW03, and SW04 and delineation soil samples collected at depths ranging from 2 feet to 4 feet bgs from boreholes BH01 through BH11.

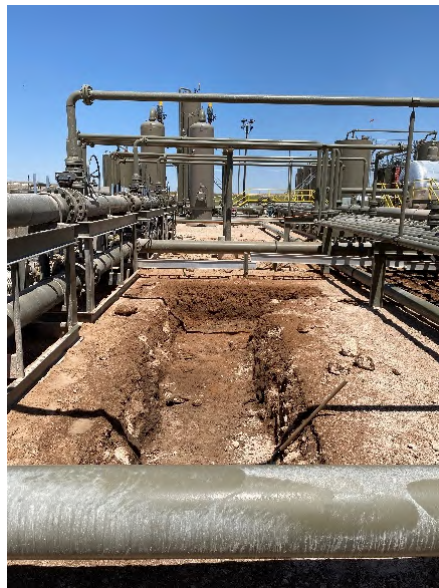
Photograph 4: View east of hydro vacuum excavation
