Closure Report

Prepared for
Mewbourne Oil Company

Pecos River 20 #1
API # 30-015-34230
Eddy County, NM

Re: Drilling Pit Closure of Mewbourne Oil – Pecos River 20 #1

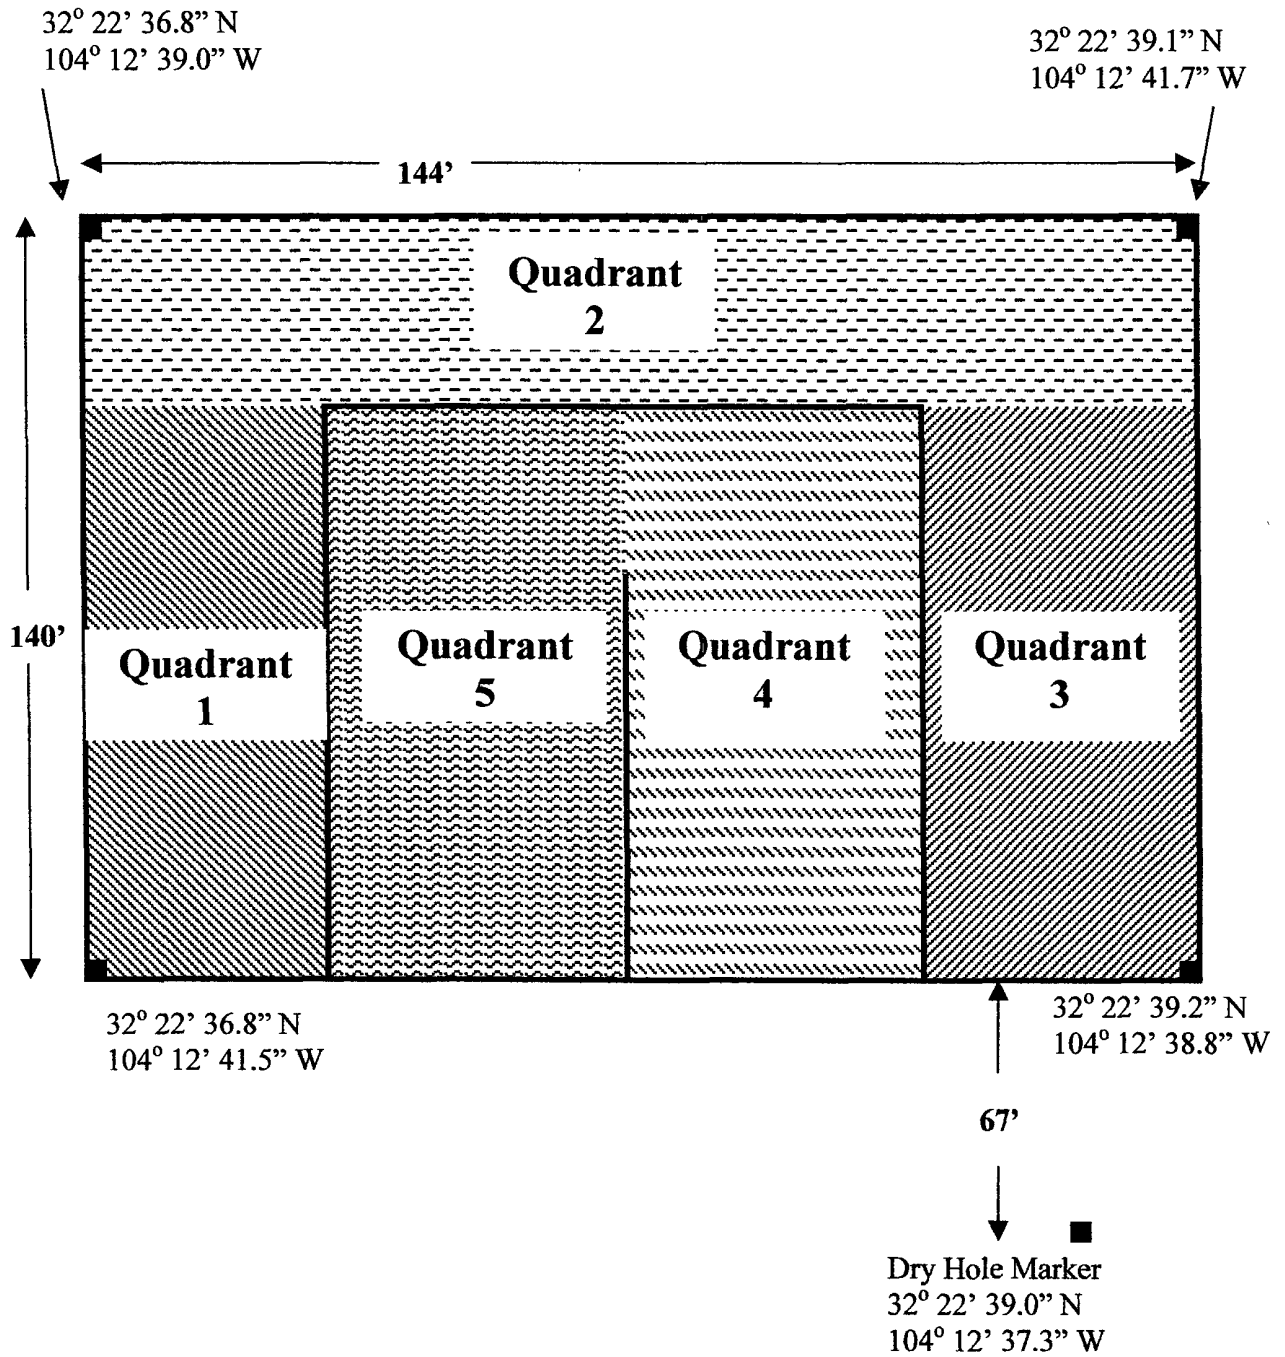
Plat Map

Mewbourne Oil
Pecos River 20 #1
UL 'P' Sec. 20 T22S R27E

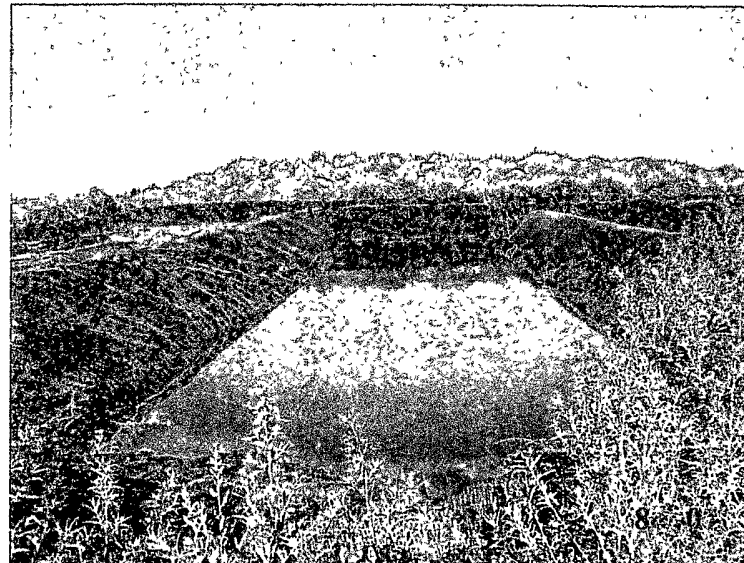
Drilling pit before closure starts.

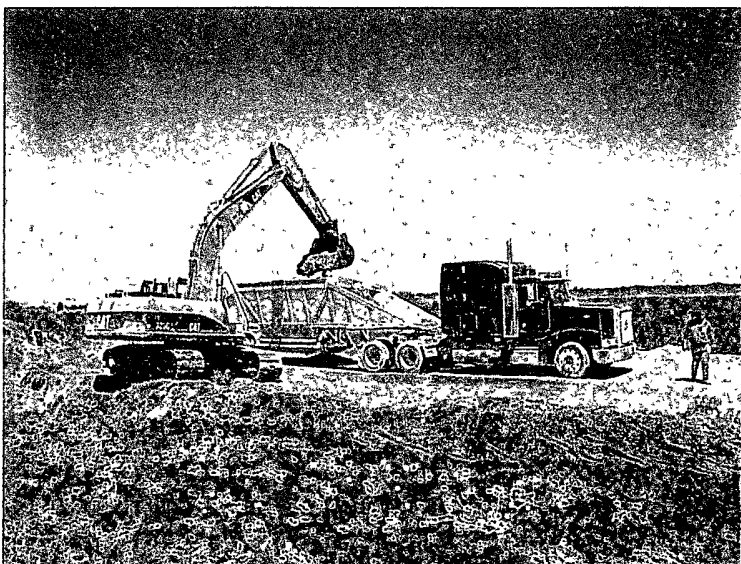
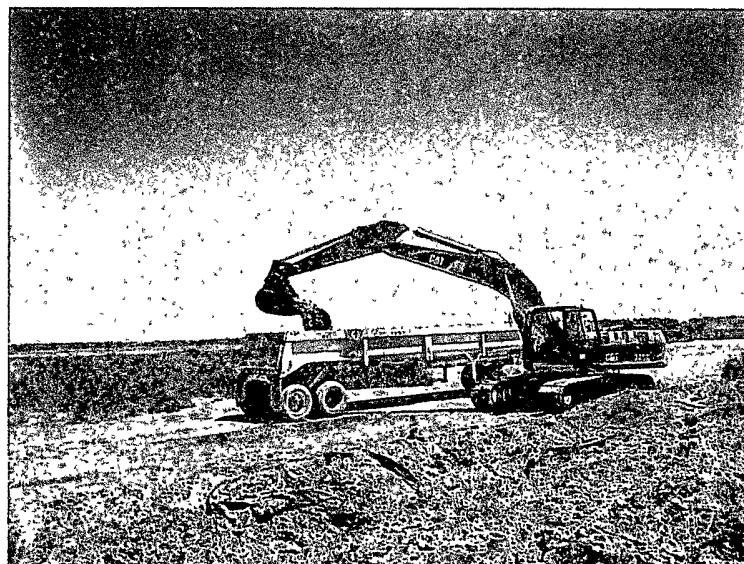
Loading mud on trucks to be hauled to Lea Landfill.

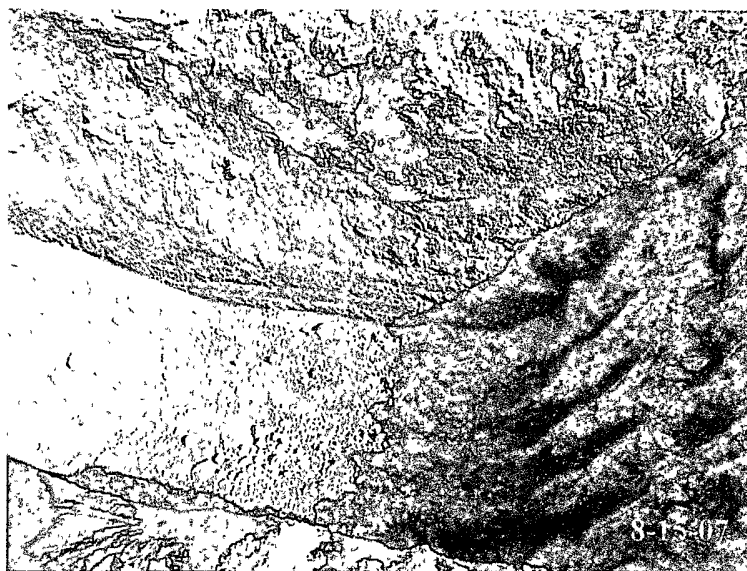
Delineation trench of Quadrant 4.

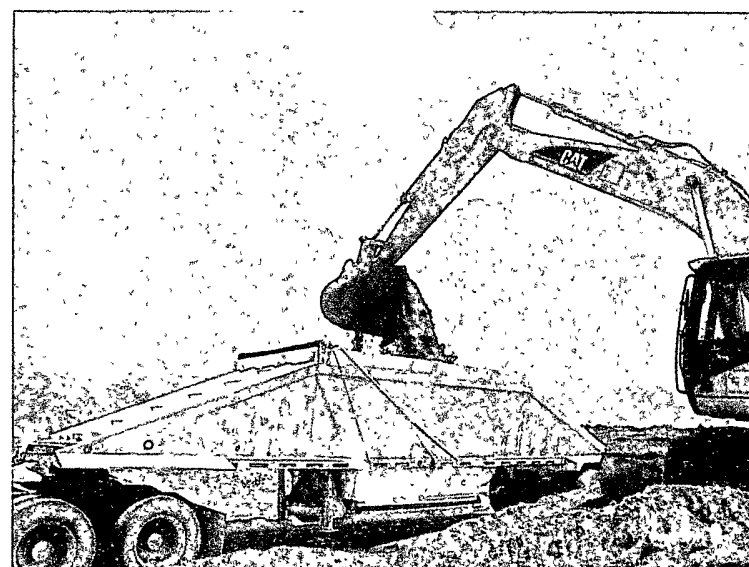
Contamination being loaded to be hauled to Lea Landfill.

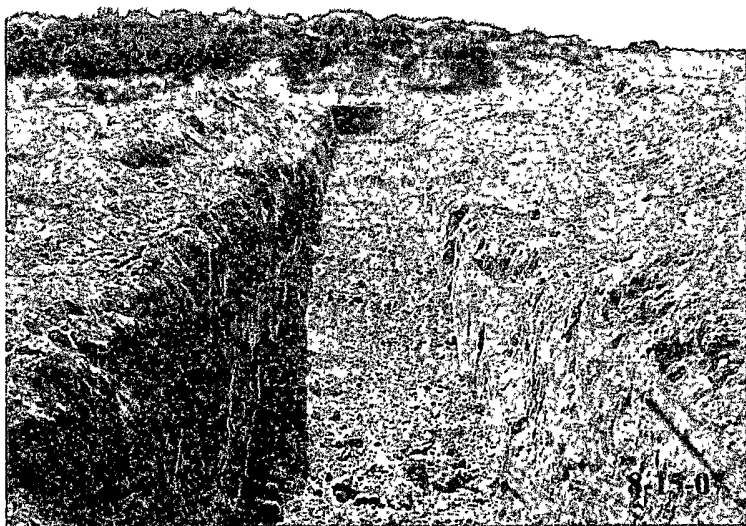
Quadrant 4 after excavation of contamination.

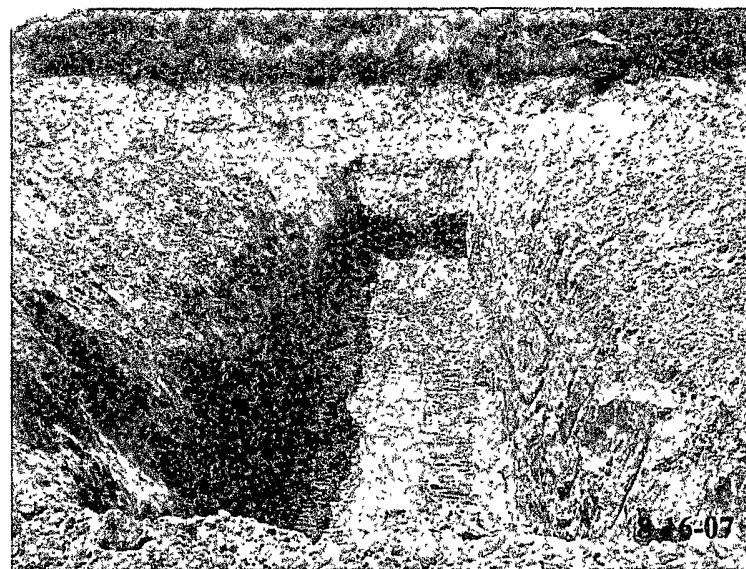
Quadrant 5 after excavation of contamination.
