**Pit or Below-Grade Tank Registration or Closure**

Re: Drilling Pit Closure of EOG Resources – Brazos A 11 Fee #1H  
UL 'A' Sec. 11 T16S R24E Eddy County  
API # 30-015-34481

# **Closure Report**

**Brazos A 11 Fee #1H**  
**API # 30-015-34481**  
**Eddy County, NM**

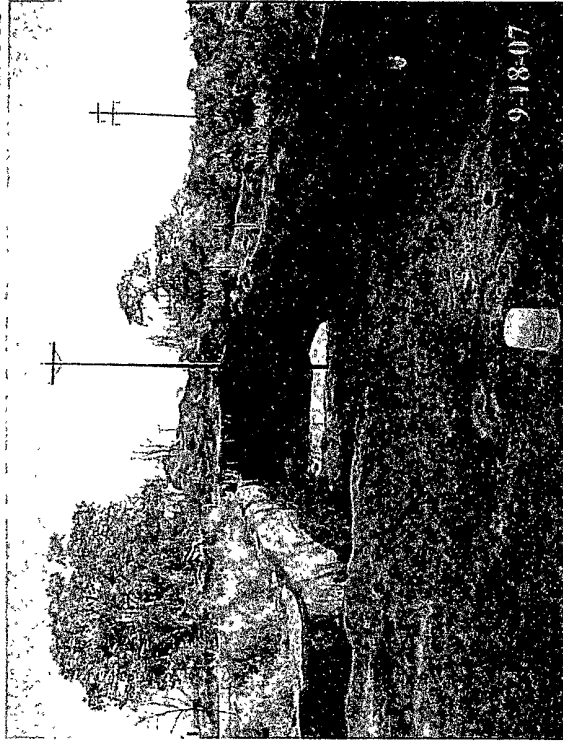
Drilling pit before closure.

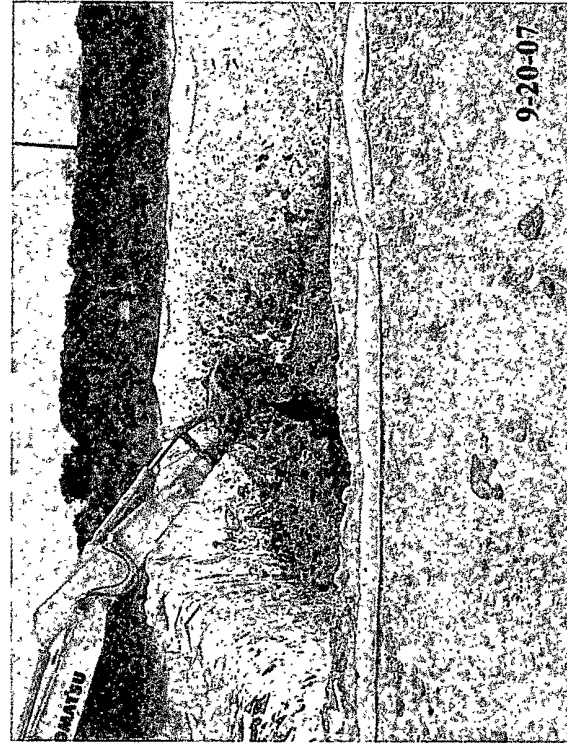
Solidified mud being placed in the burial pit.

Additional Comments: A burial pit was constructed and lined with a 12mil impervious liner. The drilling pit contents were mixed with Elke Environmental Solidification Product at a 20 (mud) to 1 (product) ratio to solidify the contents then placed in the burial pit. The burial pit was capped with a 20 mil impervious liner and backfilled with clean native soil. After all mud was removed 5 bottom samples were tested per NMOCD Guidelines and all points met NMOCD standards. The drilling pit was backfilled with clean native soil and contoured to the surrounding area.
