# ***Final Closure Report***

*Bear Bryant 31 Federal #1 Reserve Drilling Pit, API: 30-015-34906  
Sec. 31 16S 29E – Eddy County, New Mexico  
(LOV NO 02-08-033)*

***Phoenix Environmental, LLC.***

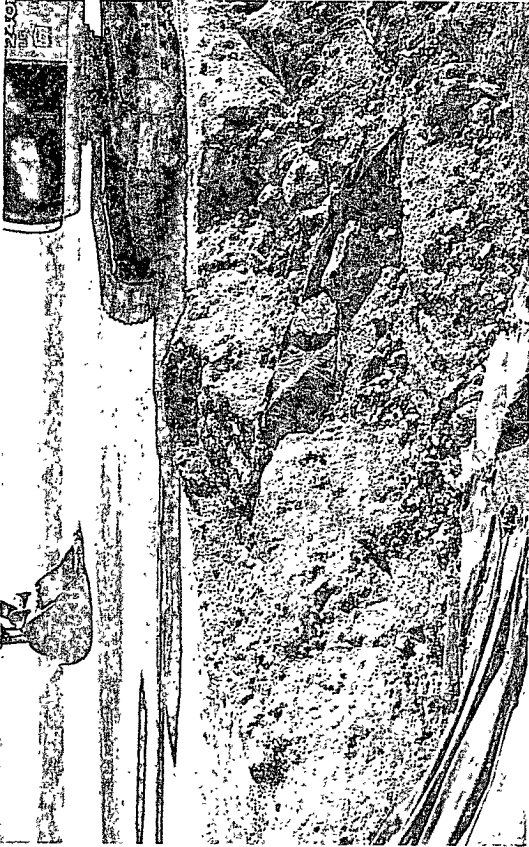
*Photo #1 Starting to Excavate Work Over Pit*

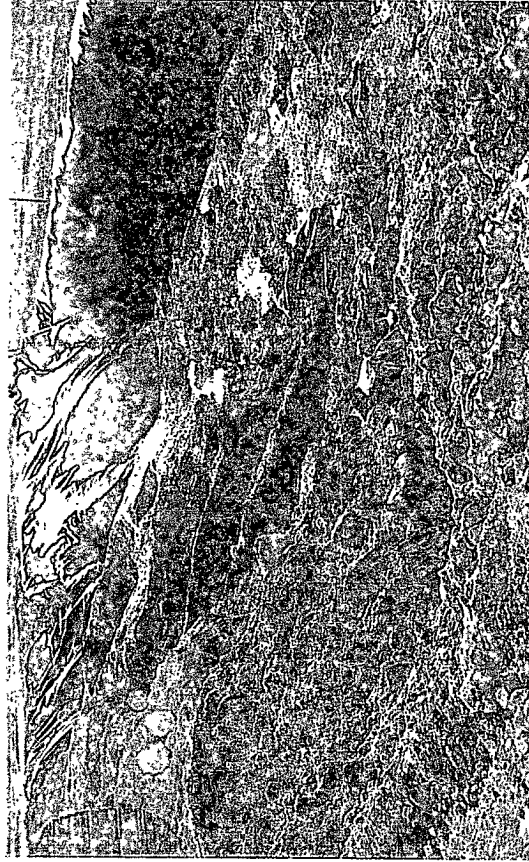
*Photo #2 Excavating Work Over Pit*

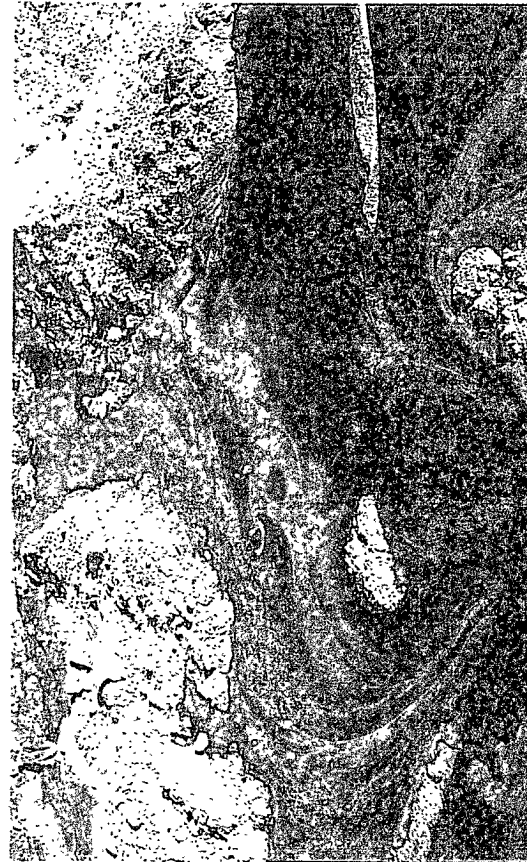
**Comments on Inspection:** Violation of OCD rule 50. Unauthorized, unregistered pit on location. The north side of pit has caved in. Looks like fluid level was above where liner is down. Some fluids are inside the pit.

*Photo #4 Fluid Found Underneath Liner*

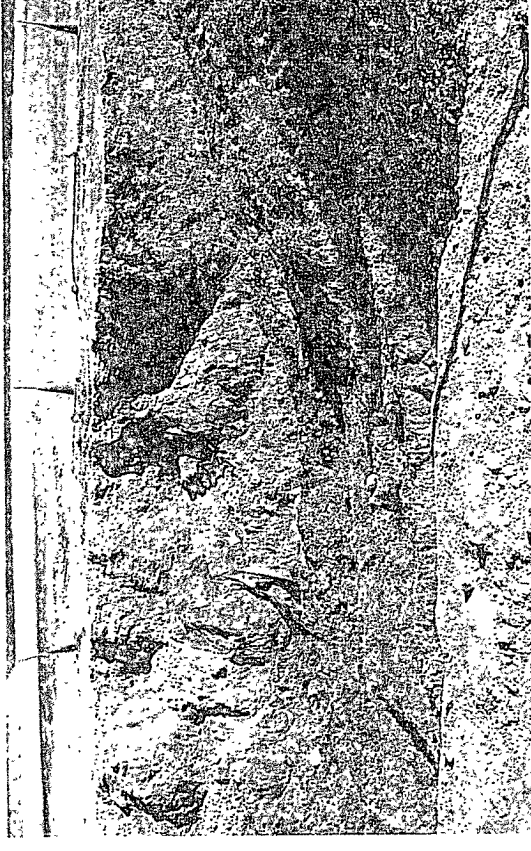
*Photo #8 Excavation of Work Over Pit*

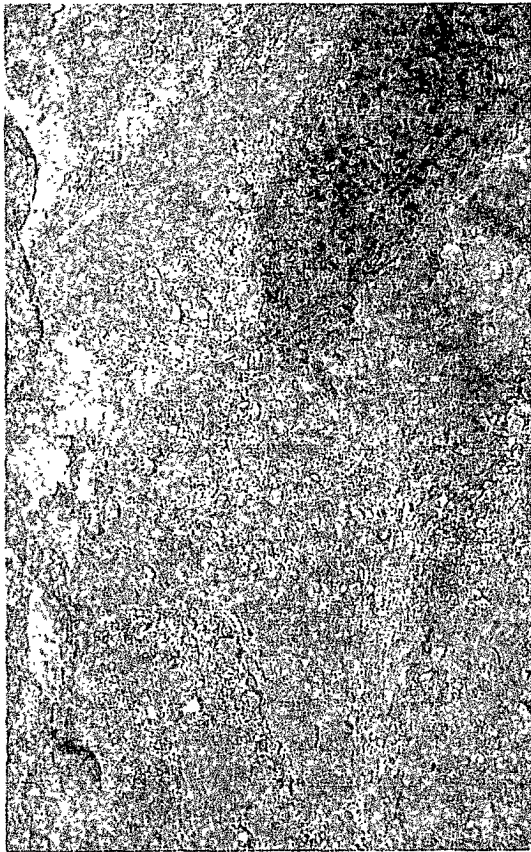
*Photo #9 Cleaning Bottoms of Work Over Pit*

*The bottom of the excavation (approximately 10 feet) was tested for TPH, BTEX & Chlorides to make certain that the target limits had been met prior to backfilling and compaction for closure. The site cleaned up well with vertical depth of impact, listed above at 12 feet and not impacting groundwater. All of the final lab analyses were below the NMOCD guidelines for unlined surface impoundments (refer to attached laboratory reports for actual levels.)*

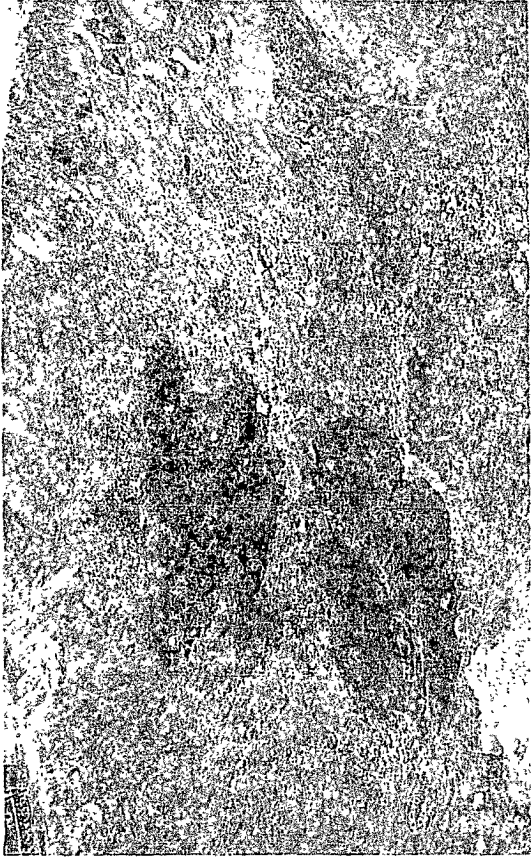
*Photo #10 Cleaning Bottoms of Work Over Pit*
