Closure Report

Ballard Grayburg San Andres #265 API # 30-015-35929 **Eddy County, NM**

Elke Environmental, Inc.

Re: Drilling Pit Closure of Tandem Energy – Ballard Grayburg #265

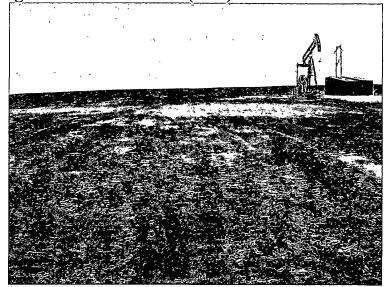
Drilling pit area after closure.
