**Pit, Closed-Loop System, Below-Grade Tank, or
Proposed Alternative Method Permit or Closure Plan Application**

1.
Operator: OXY USA OGRID #: 192463
Address: P O Box 1988 Carlsbad, NM 88221-1988
Facility or well name: Pure Gold A Federal #14
API Number: 30-015-35307 OCD Permit Number: _____
U/L or Qtr/Qtr B Section 21 Township 23S Range 31E County: Eddy
Center of Proposed Design: Latitude 32.295778° N Longitude 103.780139° W NAD: ☒ 1927 ☐ 1983
Surface Owner: ☒ Federal ☐ State ☐ Private ☐ Tribal Trust or Indian Allotment

OXY USA – Pure Gold A Federal #14

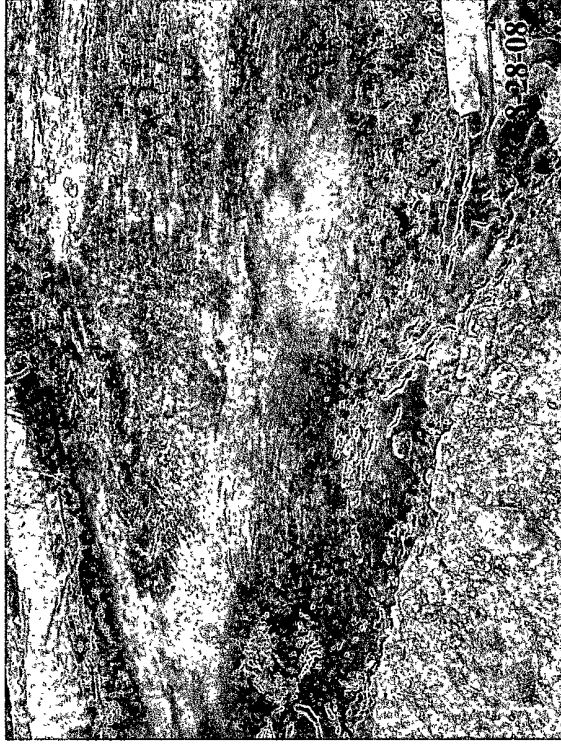
Drilling pit before closure.

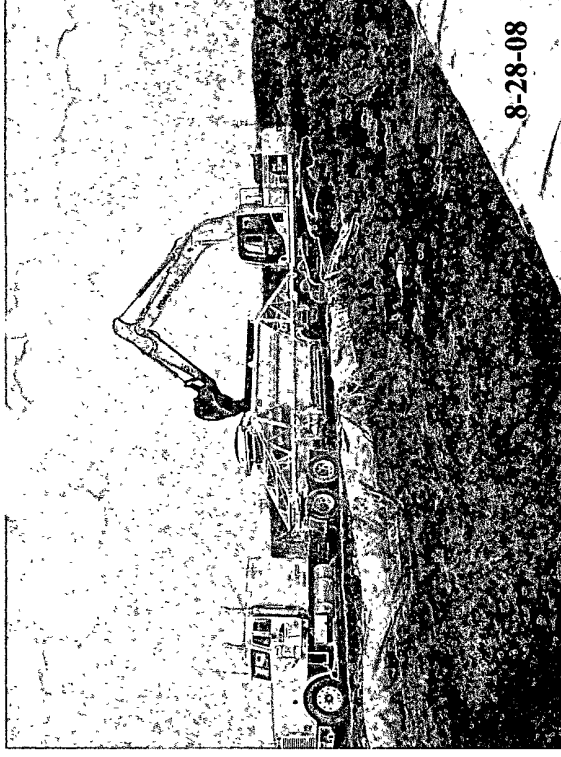
Loading drilling mud onto trucks for disposal.

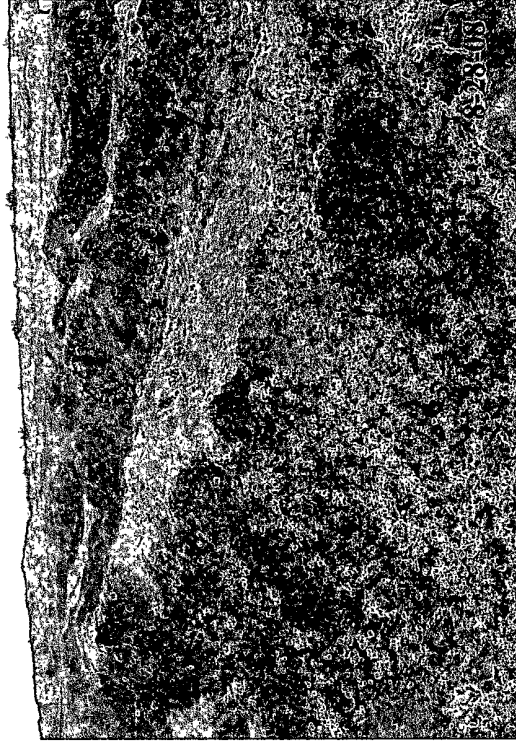
Drilling pit after excavation and disposal of mud.

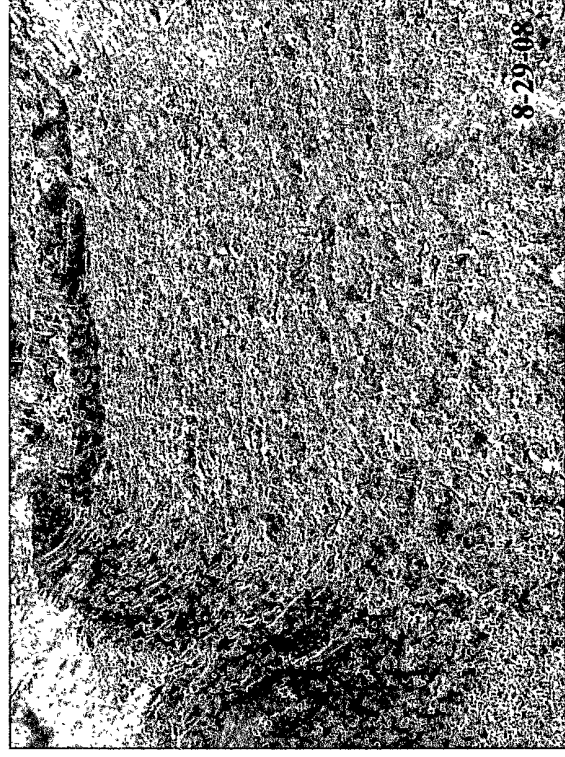
Describe Cause of Problem and Remedial Action Taken.* Drilling pit leaked into underlying soil 2' deep below pit.

TP3 after excavation and of 2' of impacted soil.

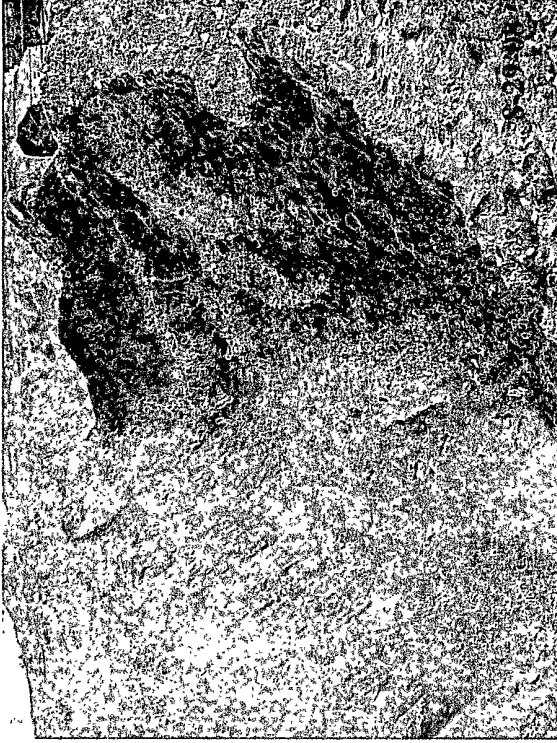
TP1 after excavation of 2' of impacted soil.

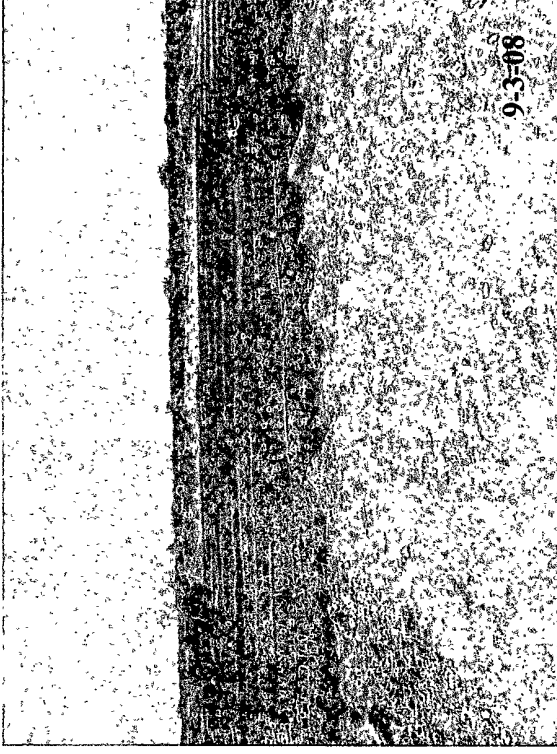
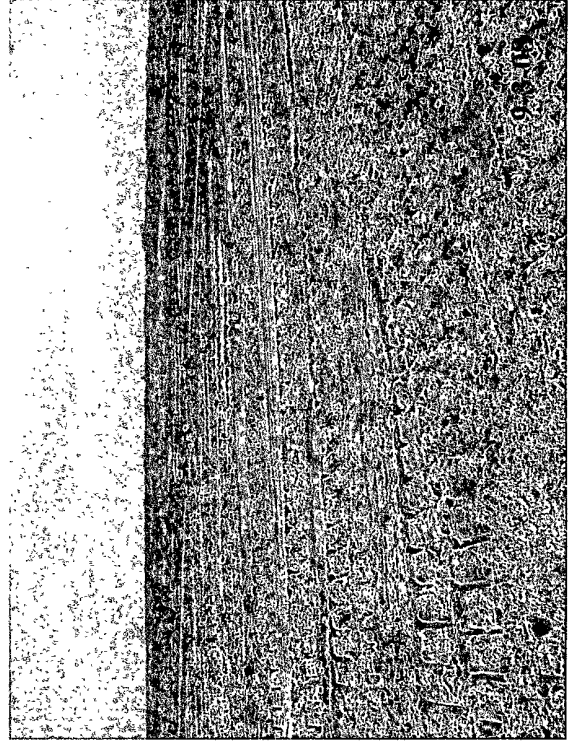
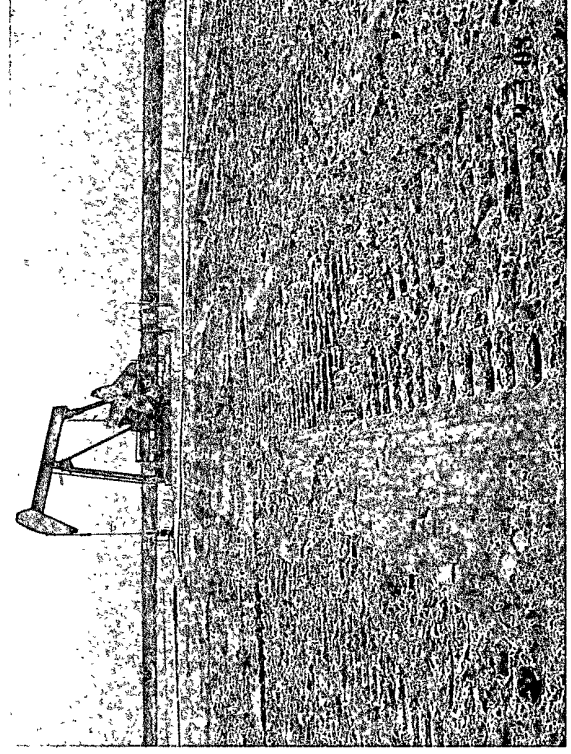
Drilling pit after backfill of clean soil and 1' of topsoil.
