Details of bop test

Kewanee Oil Company

Feathers #1

10/15/74

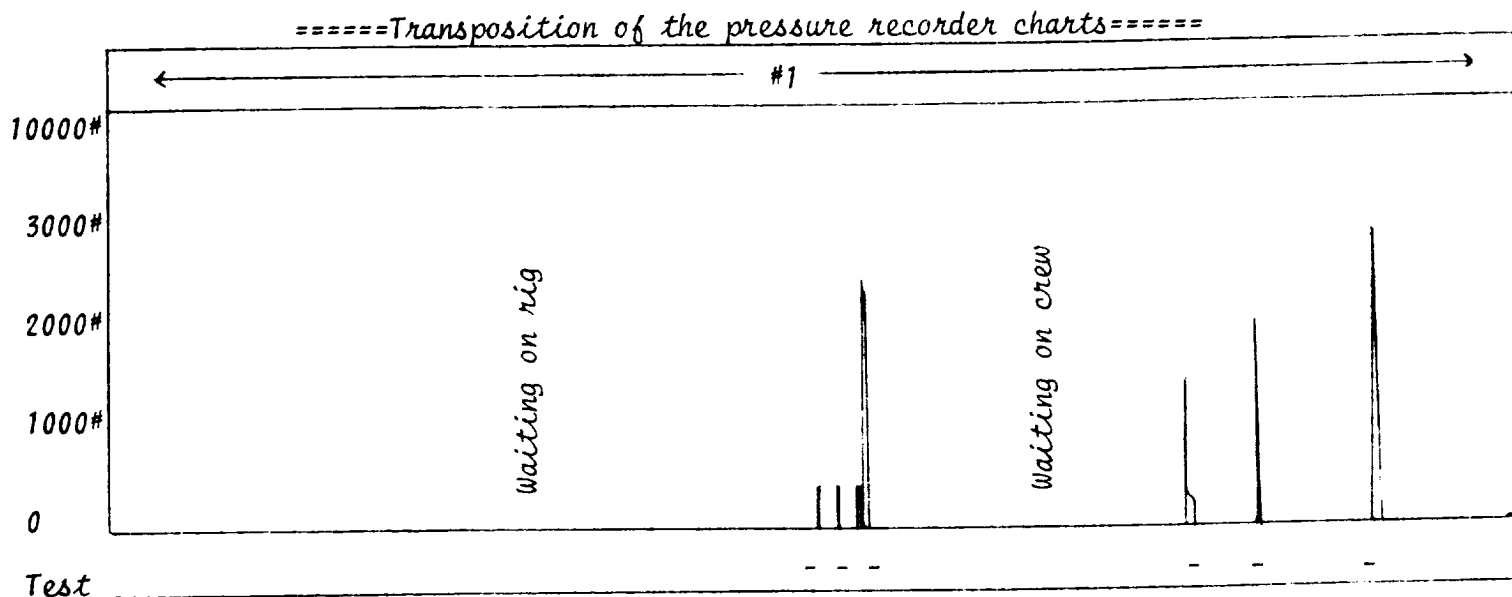
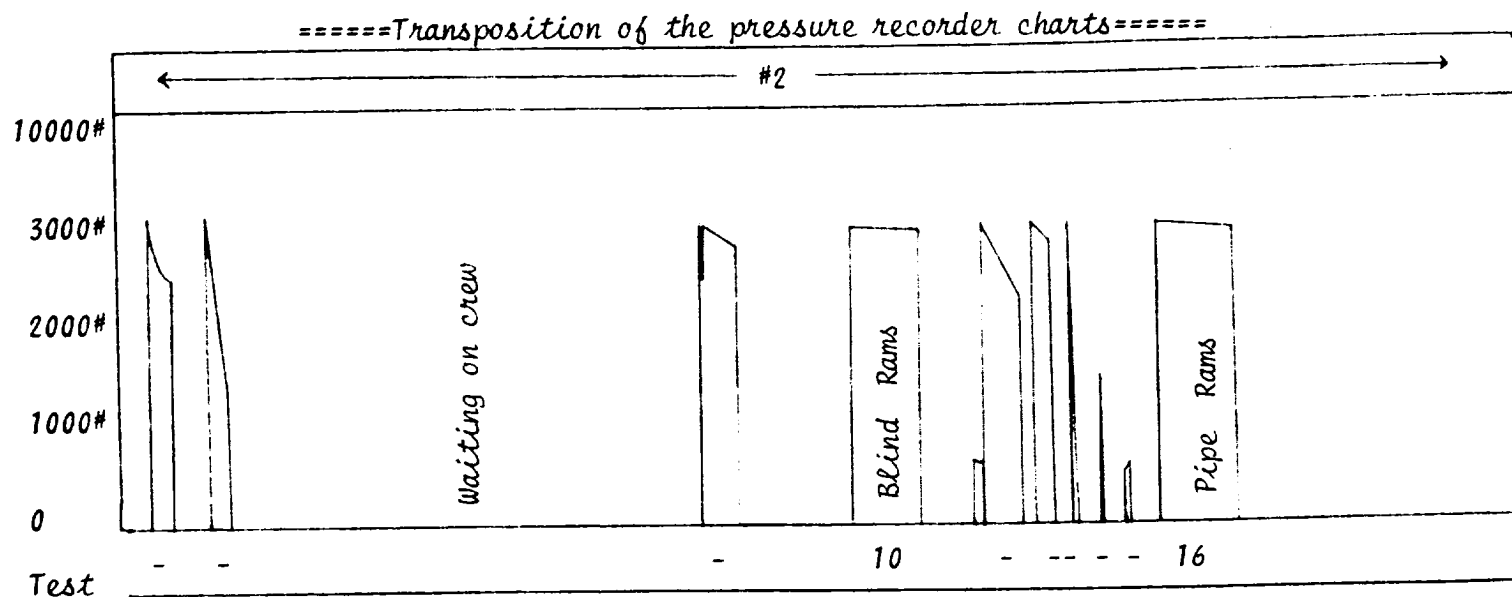
The above is a transposition of the pressure recorder charts covering test to the blowout control equipment in service on your well drilling in the Artesia Area, Artesia District, New Mexico. Test was made with test plug landed in casing head with the following test results:
