**Interim Corrective Action
Report and Supplemental
Site Investigation Work
Plan – Dec 2014**

**Chaco Gas Plant
Bisti Receiver Tanks**

**SUPPLEMENTAL SITE
INVESTIGATION WORK PLAN (2014)**

**Former Bisti Receiver Tanks
Chaco Gas Plant
GW Discharge Permit No. (GW-071)
Section 21, Township 26N, Range 12W
Navajo Nation, San Juan County, New Mexico**

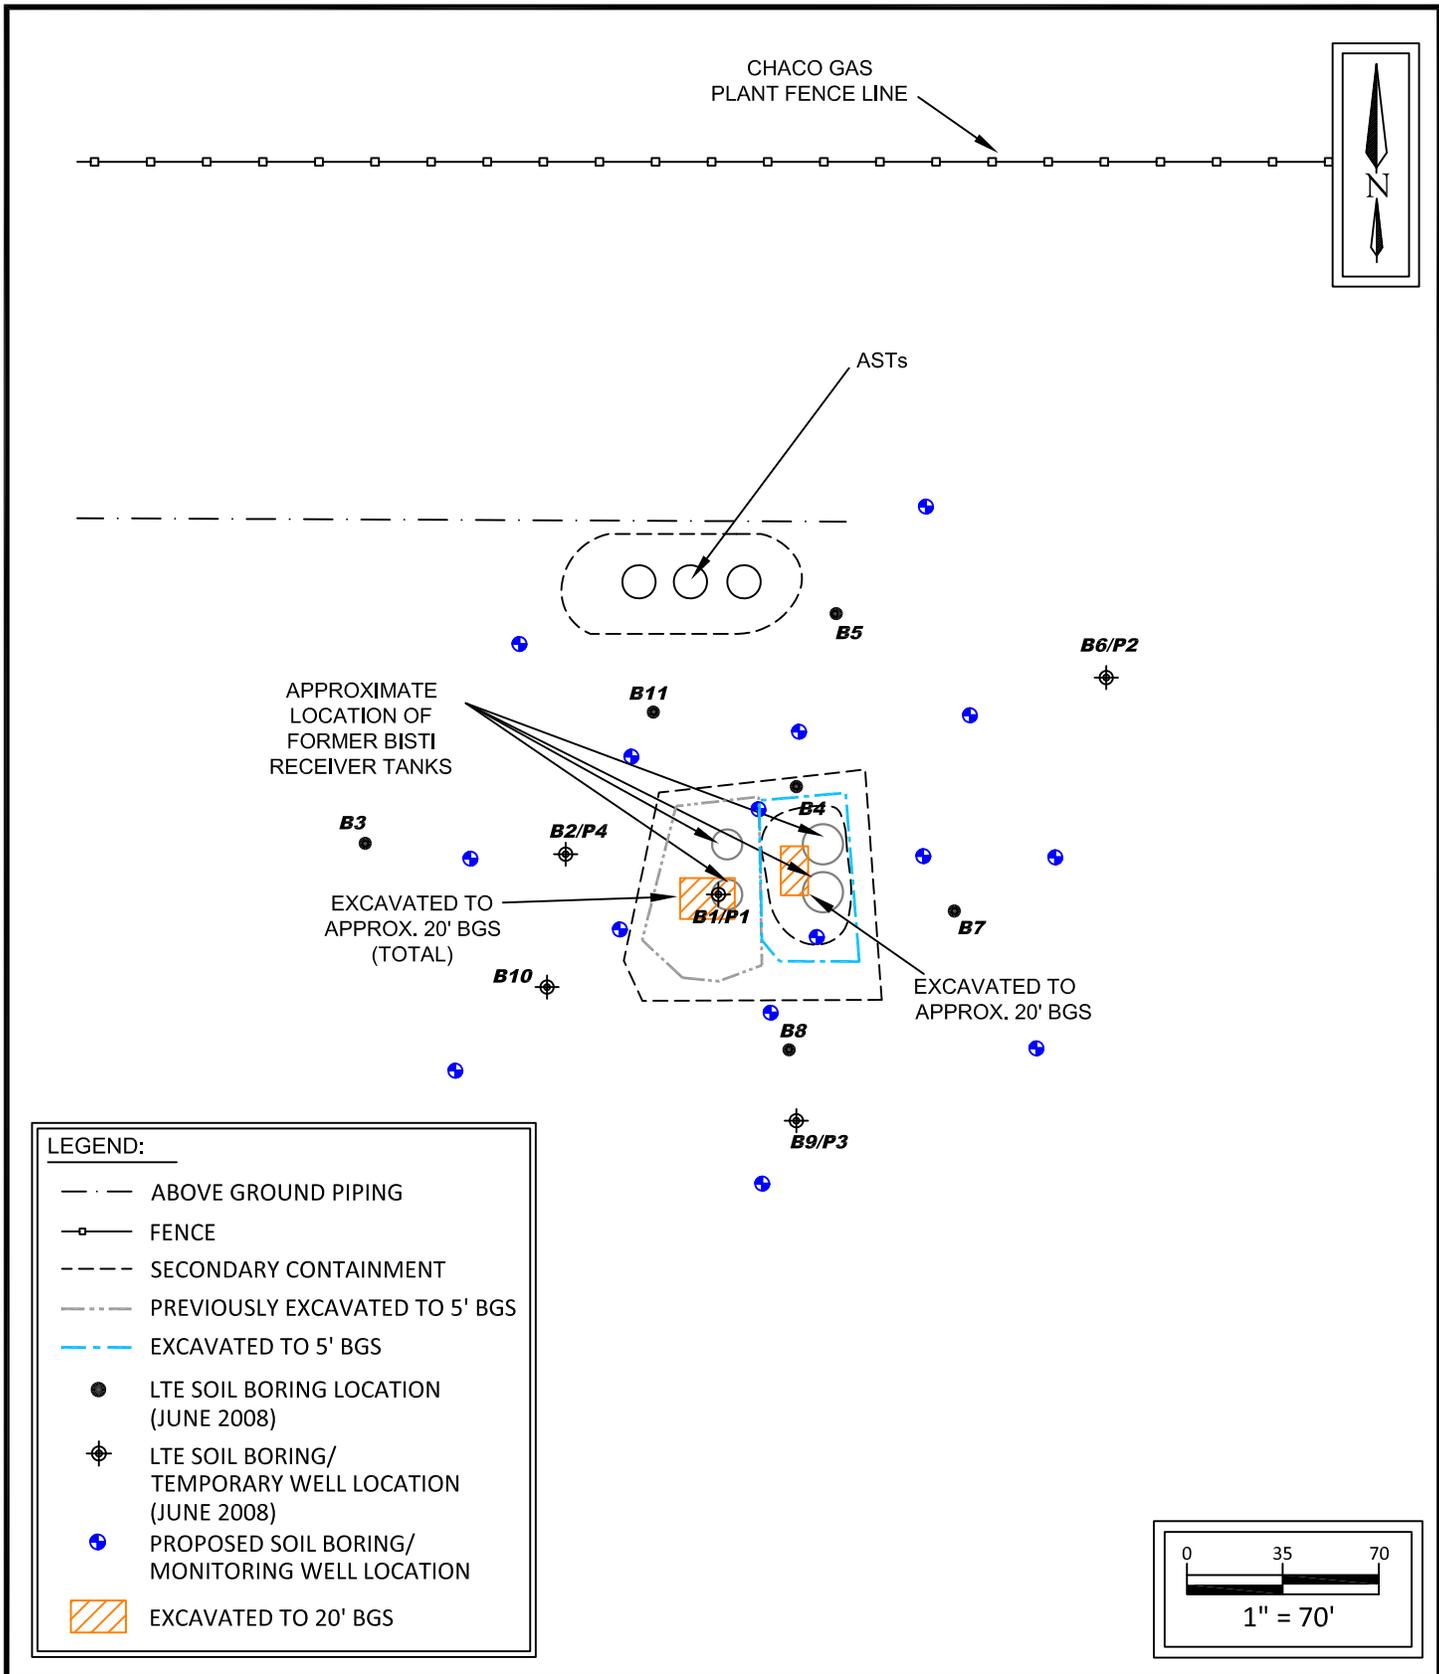
FIGURE 3
Site Map

Figure 3 indicates the approximate locations of the borings/piezometers and excavations completed to date at the Site in relation to pertinent Site features and general Site boundaries.

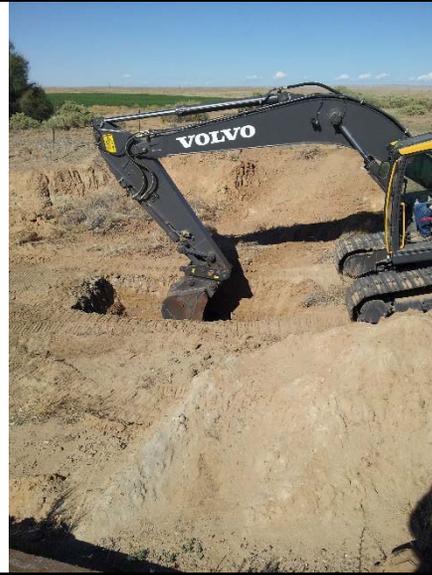
Photograph 1

Early stages of western excavation, facing west.

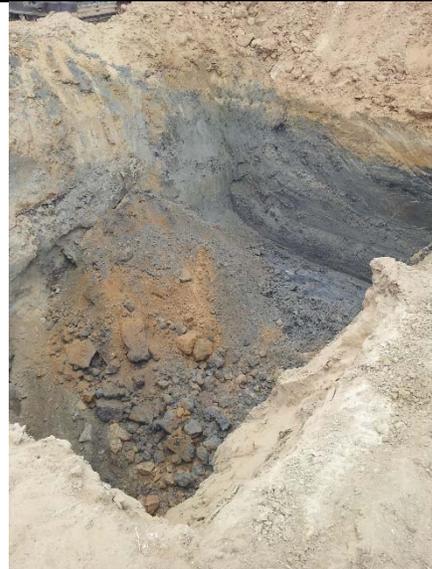
**Photograph 2**

View of western excavation prior to encountering groundwater, facing northeast.

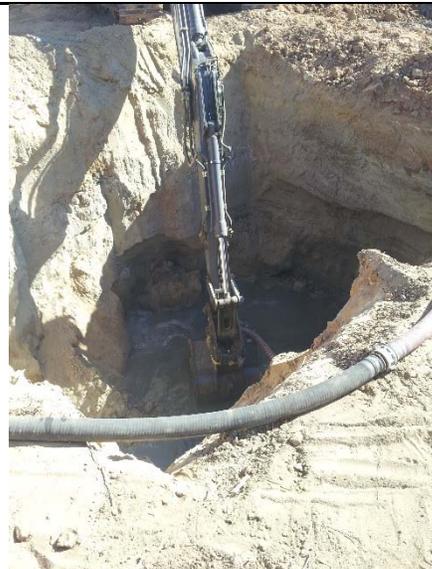
**Photograph 3**

Attempting to withdraw water from the western excavation.

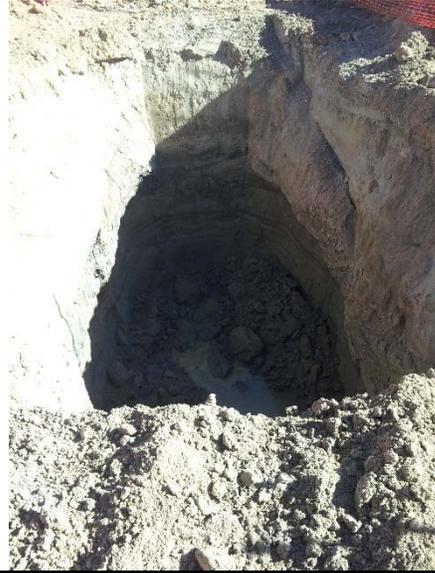
Photograph 4

View of eastern excavation, facing north. Groundwater is visible at the base of the excavation.

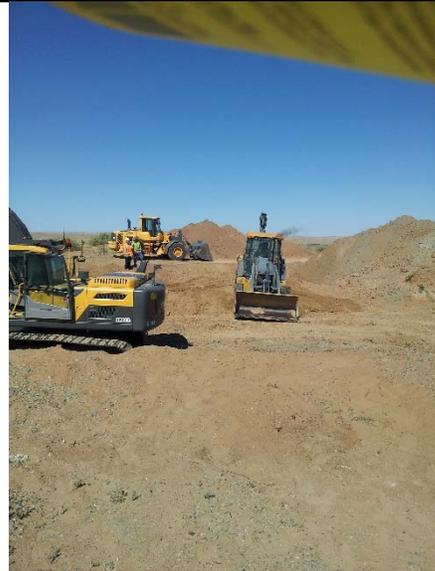
**Photograph 5**

View of backfilling activities, facing west.
