Release Notification

Site Name Schwerdtfeger A 3M	Site Type Well Site
Date Release Discovered BGT Closure 5/31/2019	API# (if applicable) 30-045-11605

Cause of Release Closure of two BGTs on site – the 95 bbl BGT did not meet closure standards.

Executive Summary

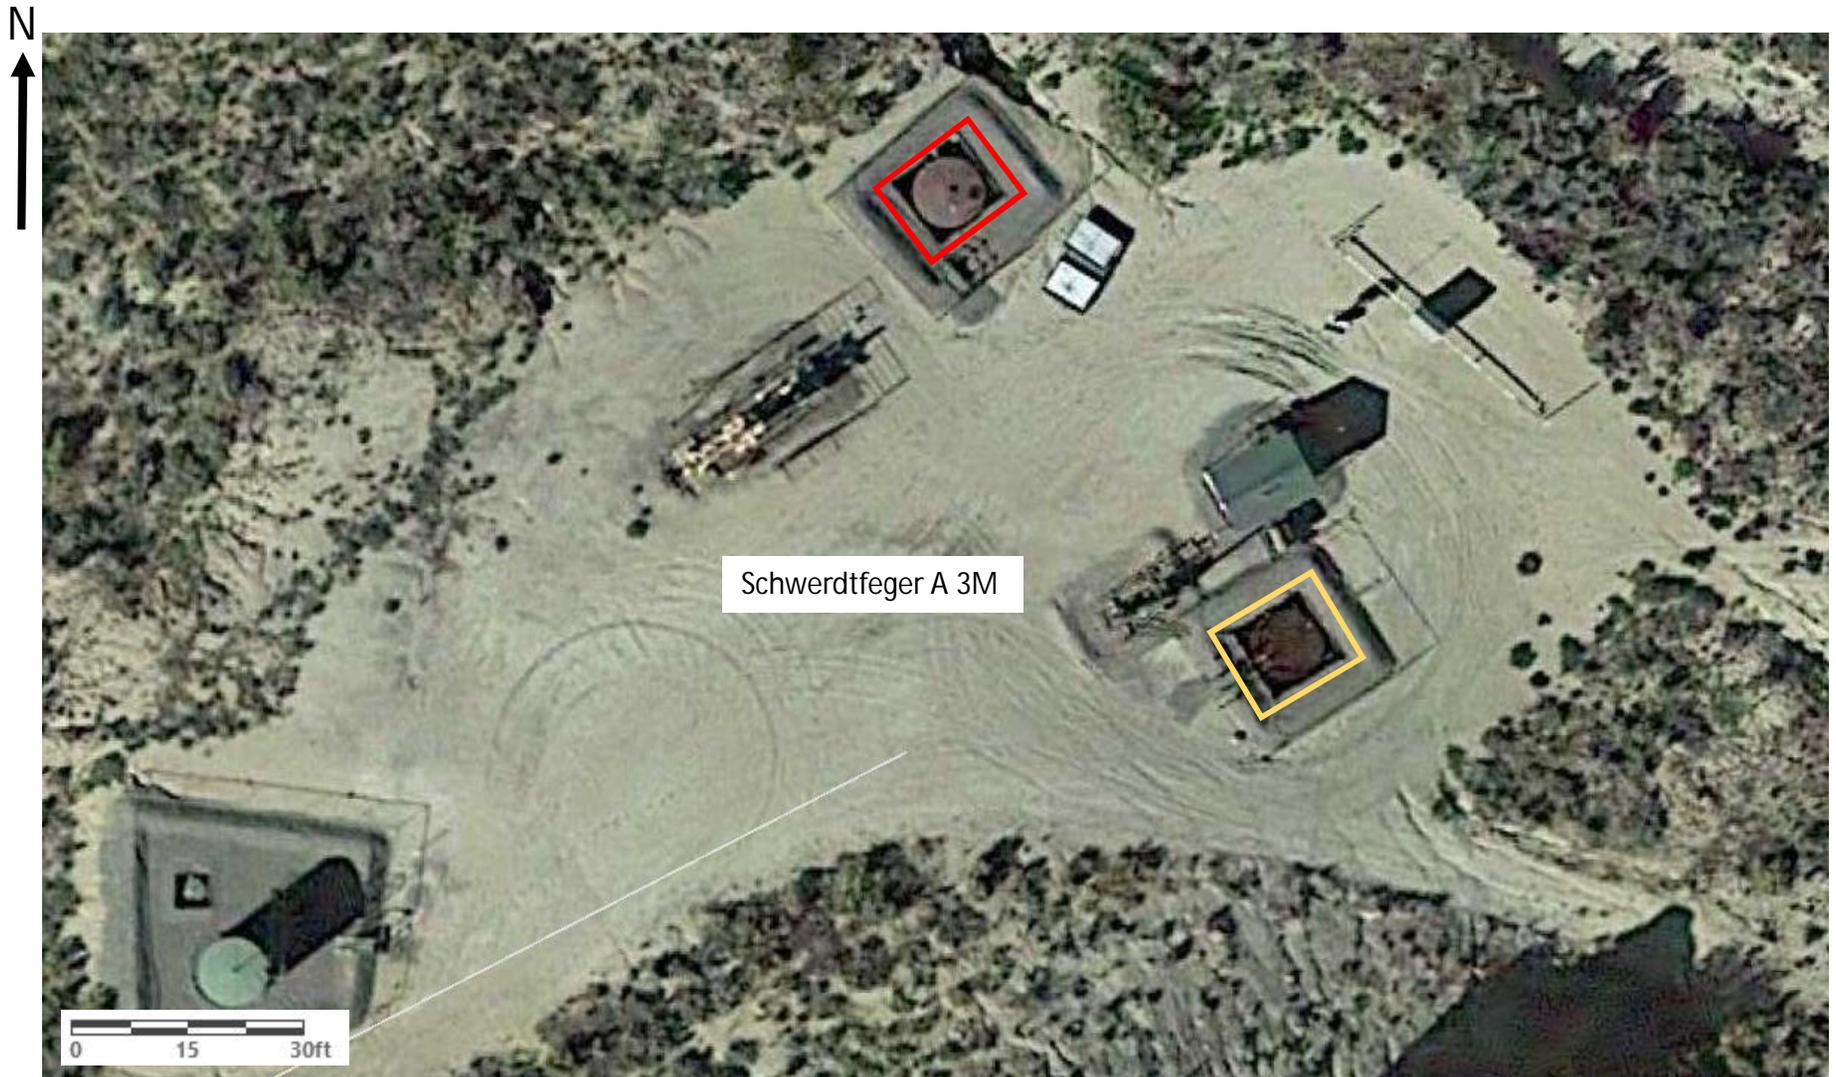
Schwerdtfeger A 3M

- 95 bbl BGT
- 21 bbl BGT

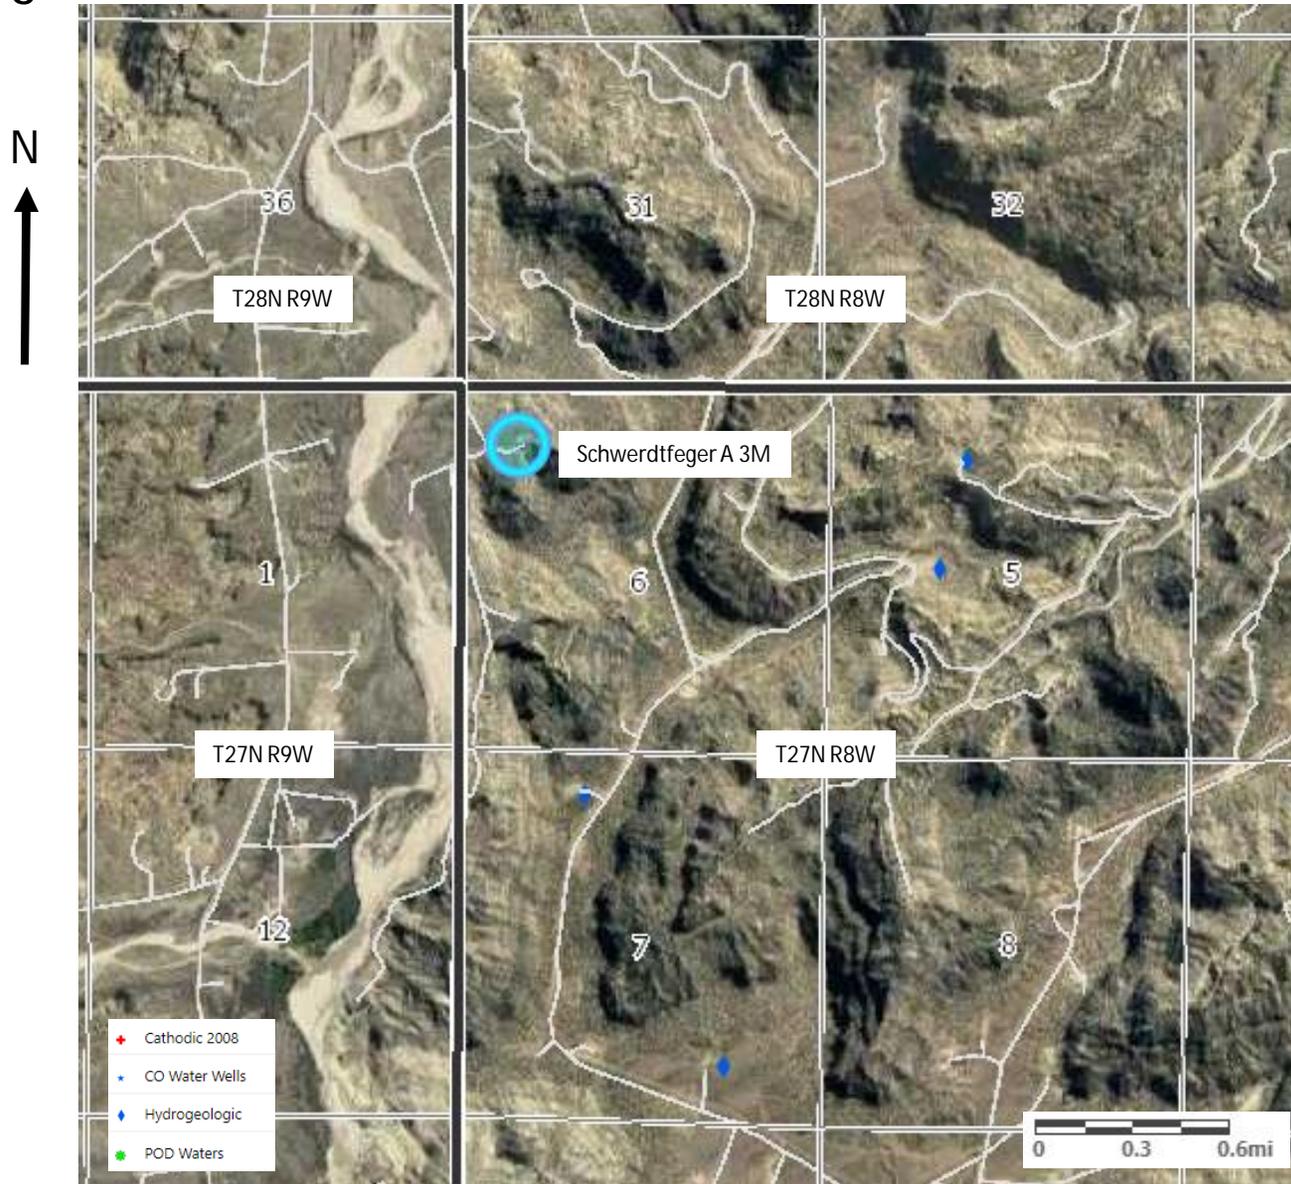
Depth to groundwater

No data available on the NM Office State Engineers. Default to the closure clean-up standards from BGT permit of < 50 ft for groundwater depth. For any future reporting and/or closures this will be revisited as necessary.

No groundwater depth data available on the NM Office of the State Engineer website or cathodic data from HEC

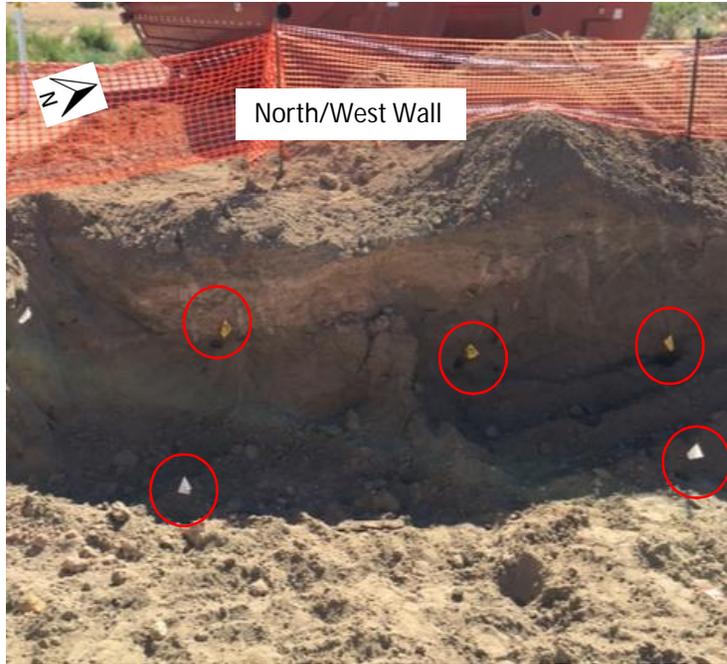
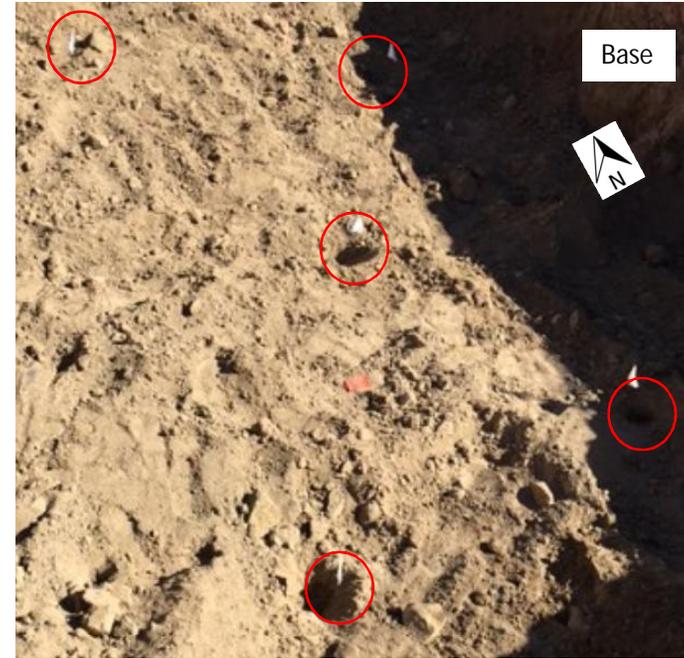
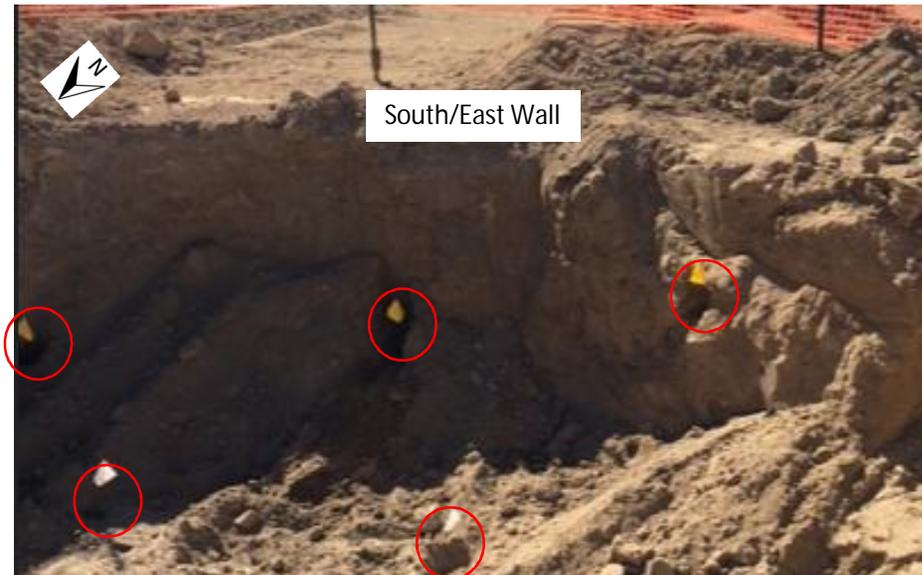
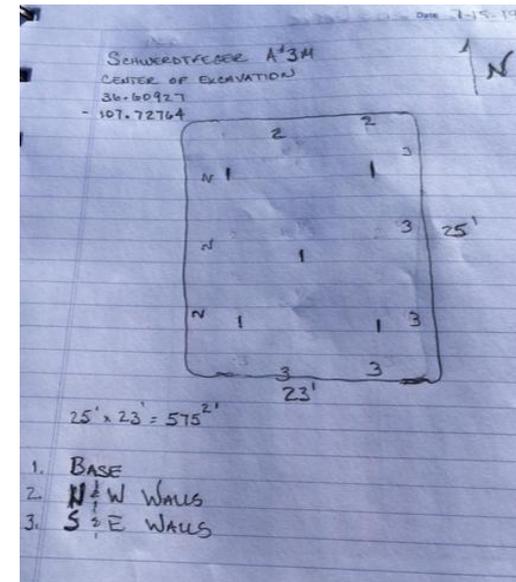
Sample locations from excavation of 95 bbl BGT

Confirmation samples taken on 5/31/2019 in accordance with NMAC 19.15.29.12.D. The 95 bbl BGT failed on Total TPH. The area of the BGT was excavated and samples were taken again on 7/11/2019 in accordance with NMAC 19.15.29.12.D. NMOCD was present during the sampling event. Because there was no groundwater data for this site the closure standards from the BGT permit was utilized. For any future reporting and/or closures this will be revisited as necessary.

Hello Cory, per our conversation on location today I took three confirmation samples; one composite of the base, one composite of the north and west walls, and one composite of the south and east walls.
