Release Notification

Project #17035-0107

RE: Release Closure Report for the Buena Suerte Pipeline Located in Section 32, Township 25N, Range 11W, San Juan County, New Mexico

**SITE PHOTOGRAPHY
DJR OPERATING, LLC.
BUENA SUERTE PIPELINE RELEASE CLOSURE REPORT
SECTION 32, TOWNSHIP 25N, RANGE 11W
SAN JUAN COUNTY, NEW MEXICO
PROJECT #17035-0107
NOVEMBER 2019**

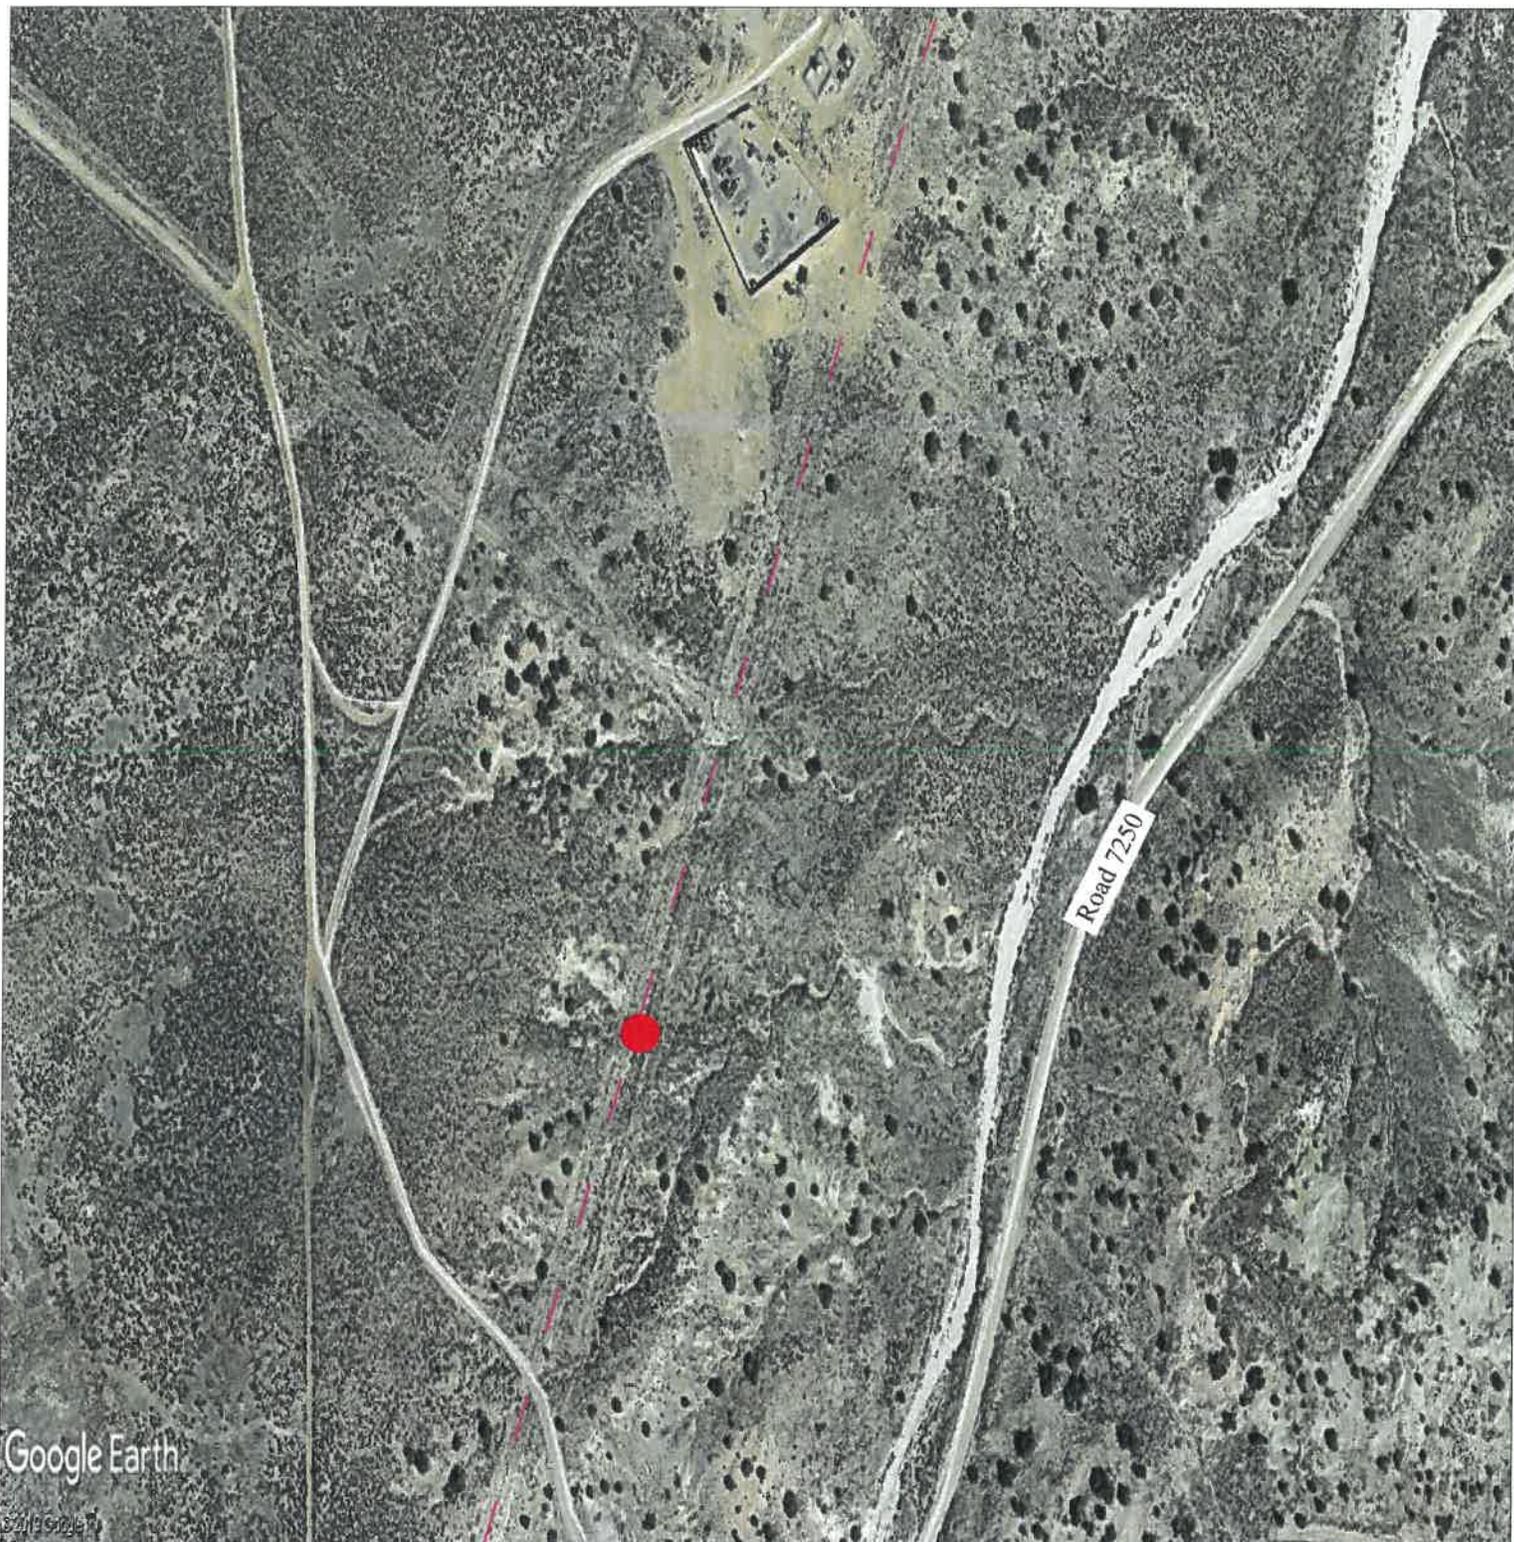
Figure 2, Site Map

Soil sample locations are illustrated in **Figure 2, Site Map** and in the attached **Site Photography**.

- - Release location
- Pipeline

ULSTR/Lat/Long do not match report location, ariel images.
- Figure 2 does not meeting the requirements of a detail site map, no excavation size, no sampling location, etc.
- Please include the sampling notice to show compliance with 19.15.29 NMAC
- Review and resubmit no later than June 30, 2020

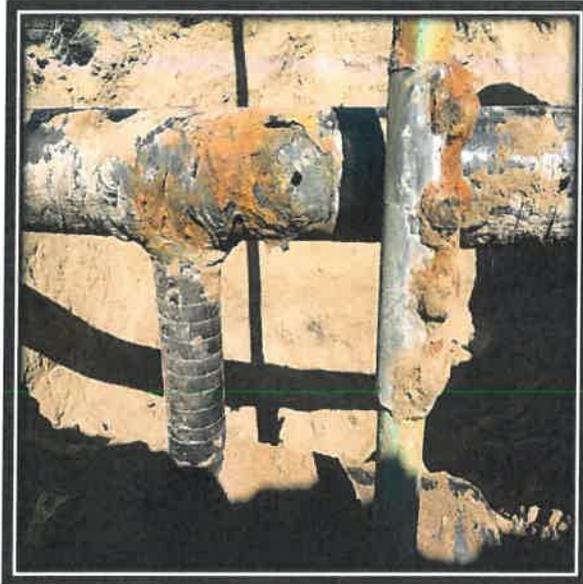
Cause of Release: External corrosion. This was a dry gas leak comprised of coalbed methane production. No produced water or liquid hydrocarbon were released.

Picture 1: View of Damaged Pipeline (View 1)

Prior to Envirotech's arrival, DJR contractor had excavated the area around the damaged to complete repair activities. The pipeline was repaired, and the surrounding soil was inspected for evidence of any liquids. Upon inspection, no evidence of released liquid was found, and the excavation was backfilled. On November 27, 2019 Envirotech personnel collected two (2) five-point composite confirmation soil samples from the east and west side of the release utilizing a hand auger. The auger was advanced into the subsurface until a total depth of five (5) feet below ground surface (bgs). A sample aliquot was collected at one-foot intervals.

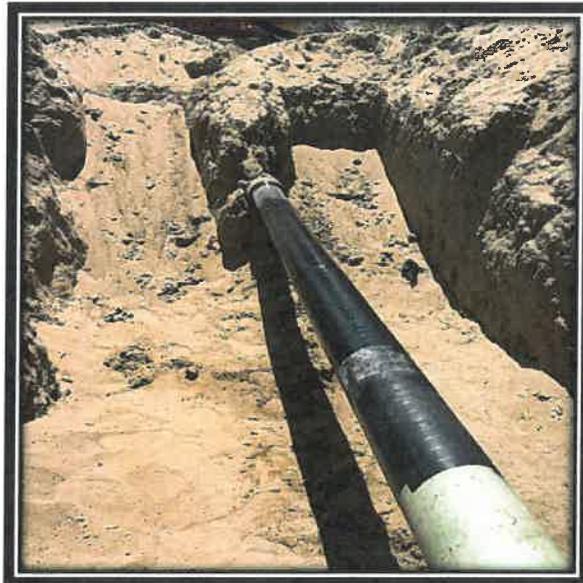
Picture 2: View of Excavation (View 1)

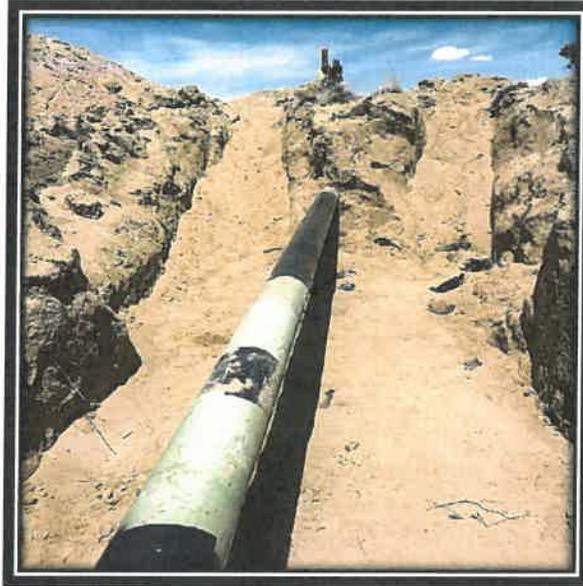
Picture 3: View of Excavation (View 2)

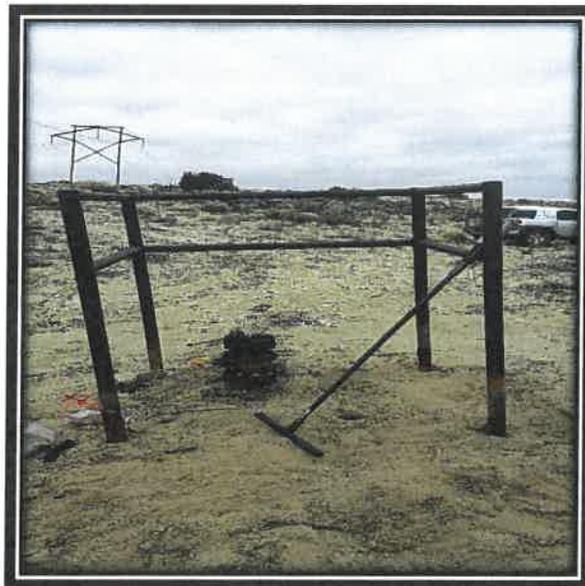
Picture 4: View of Backfill of Pipeline Repair Excavation
