Incident ID	NCS2002455215
District RP	
Facility ID	
Application ID

### **Release Notification**

# Scaled Map – blue line depicts release area

### Summary of events

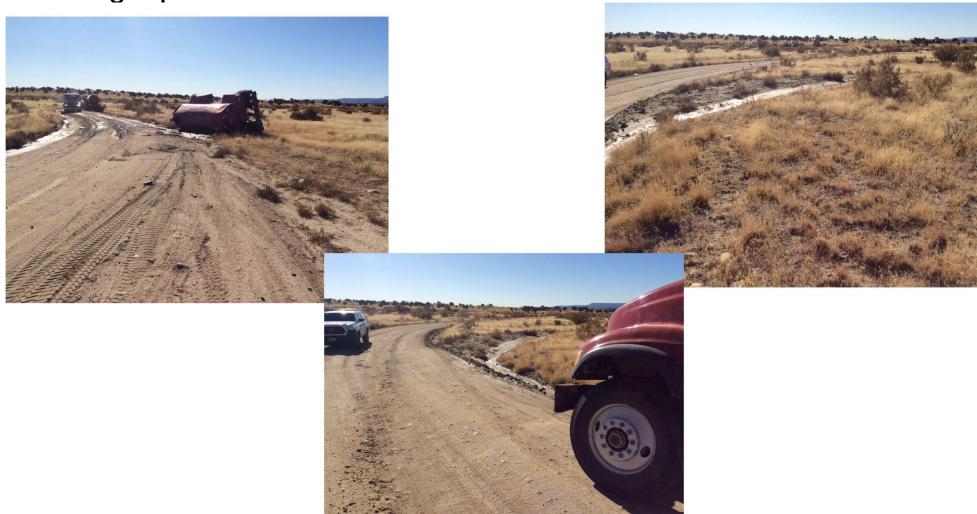
# Photographs – 10/31/2019 Initial Release

Natural C	Gas	Volume Releas	ed (Mcf)			Volume Recovered (Mcf)			
Other (describe) Volume/Weight Released (provide units		ide units)		Volume/Weight Recovered (provide units)					
Cause of Rel									
						o 80 barrel pup	o truck rollover on county road 1354.		
		release of 40 bbls ides of dirt road				o 80 barrel pup	o truck rollover on county road 1354.

- 11/3/2019 Crew from Aztec Well Service (Construction Division) began performing excavation of release. They used a mini excavator and skid steer for this process. The mini excavator scrapped soils to a depth of 6"-12" or; in some instances, to visibly dry soil. Stock piles of the impacted soils where made along the road and the skid steer then loaded the impacted soils into a dump truck. Billy T Trucking was utilized to haul the impacted soils to Envirotech Landfarm. Crew hauled off (2) loads of impacted soil.

- 11/4/2019 Crew from Aztec Well Service (Construction Division) continued with excavation efforts
  of release. The same process was taken today as previous day. Crew; again, hauled off (2) loads of
  impacted soil. Monica Kelling (OCD) met us at the location about 8:30am. I informed her that we
  would be ready to do the post excavation samples in the morning at about 8:30am.

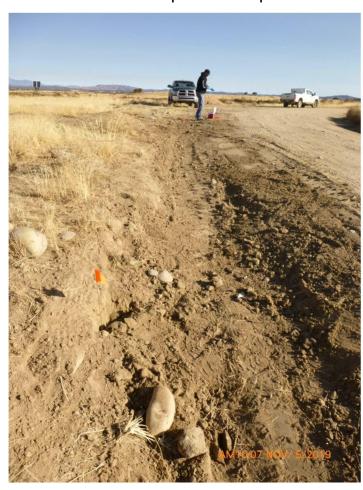
TP02 #1 Composite Sample

- TP02 #1 Time: 9:07 Five point composite sample on north side of road.
    - TP02 #2 Time: 9:15 Five point composite sample on north side of road.
    - TP02 #3 Time: 9:34 Five point composite sample on south side of road.

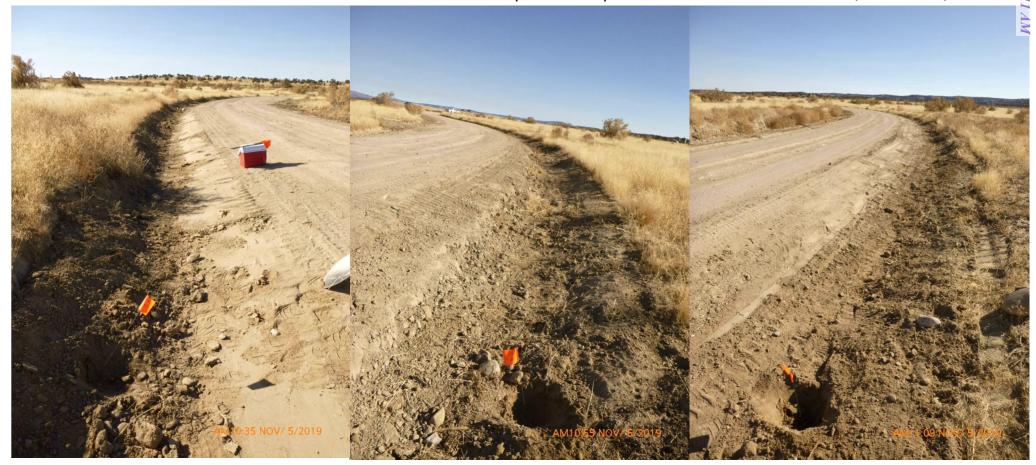
# Photographs – 11/5/2019 Sampling Event

TP02 #3 Composite Sample

TP02 #4 Composite Sample

TP02 #5 Composite Sample

- TP02 #4 Time: 9:55 Five point composite sample on south side of road.
    - TP02 #5 Time: 10:08 Five point composite sample on south side of road.

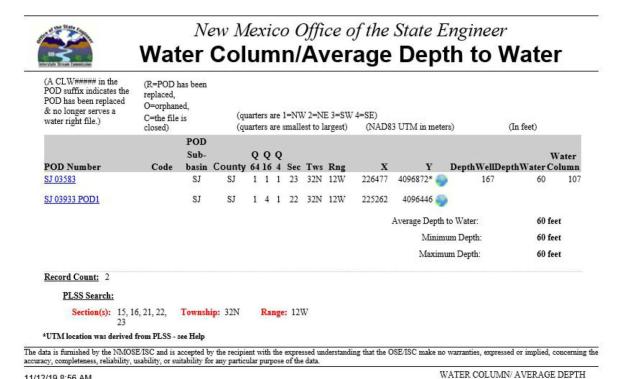
### Depth to water determination

Elevation of spill location = 6076ft making GW <50ft

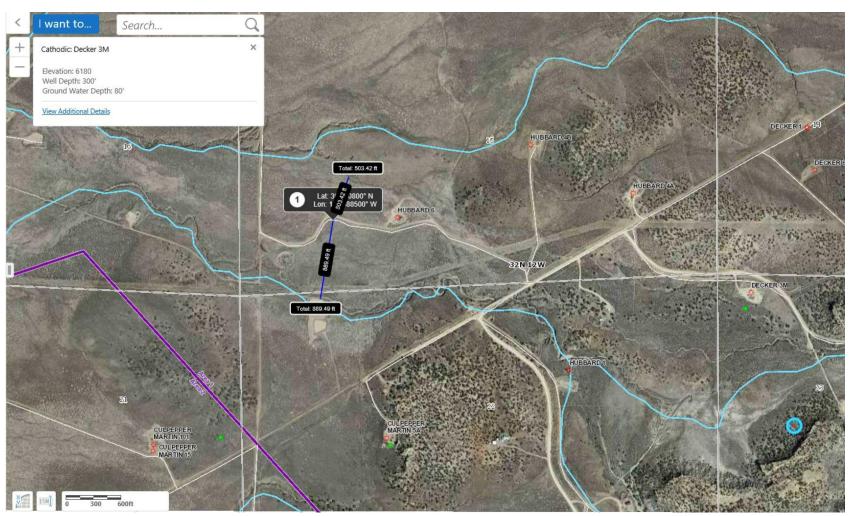
Determination of water sources and significant watercourses within ½ mile of the lateral extent of the release
