State of New Mexico
Oil Conservation Division

Incident ID	NCS 1927549428
District RP	
Facility ID	
Application ID

TOPOGRAPHIC SITE LOCATION MAP

Rosa 89
NMOCD Incident No. NCS 1929556371
Pipeline Excavation Clearance

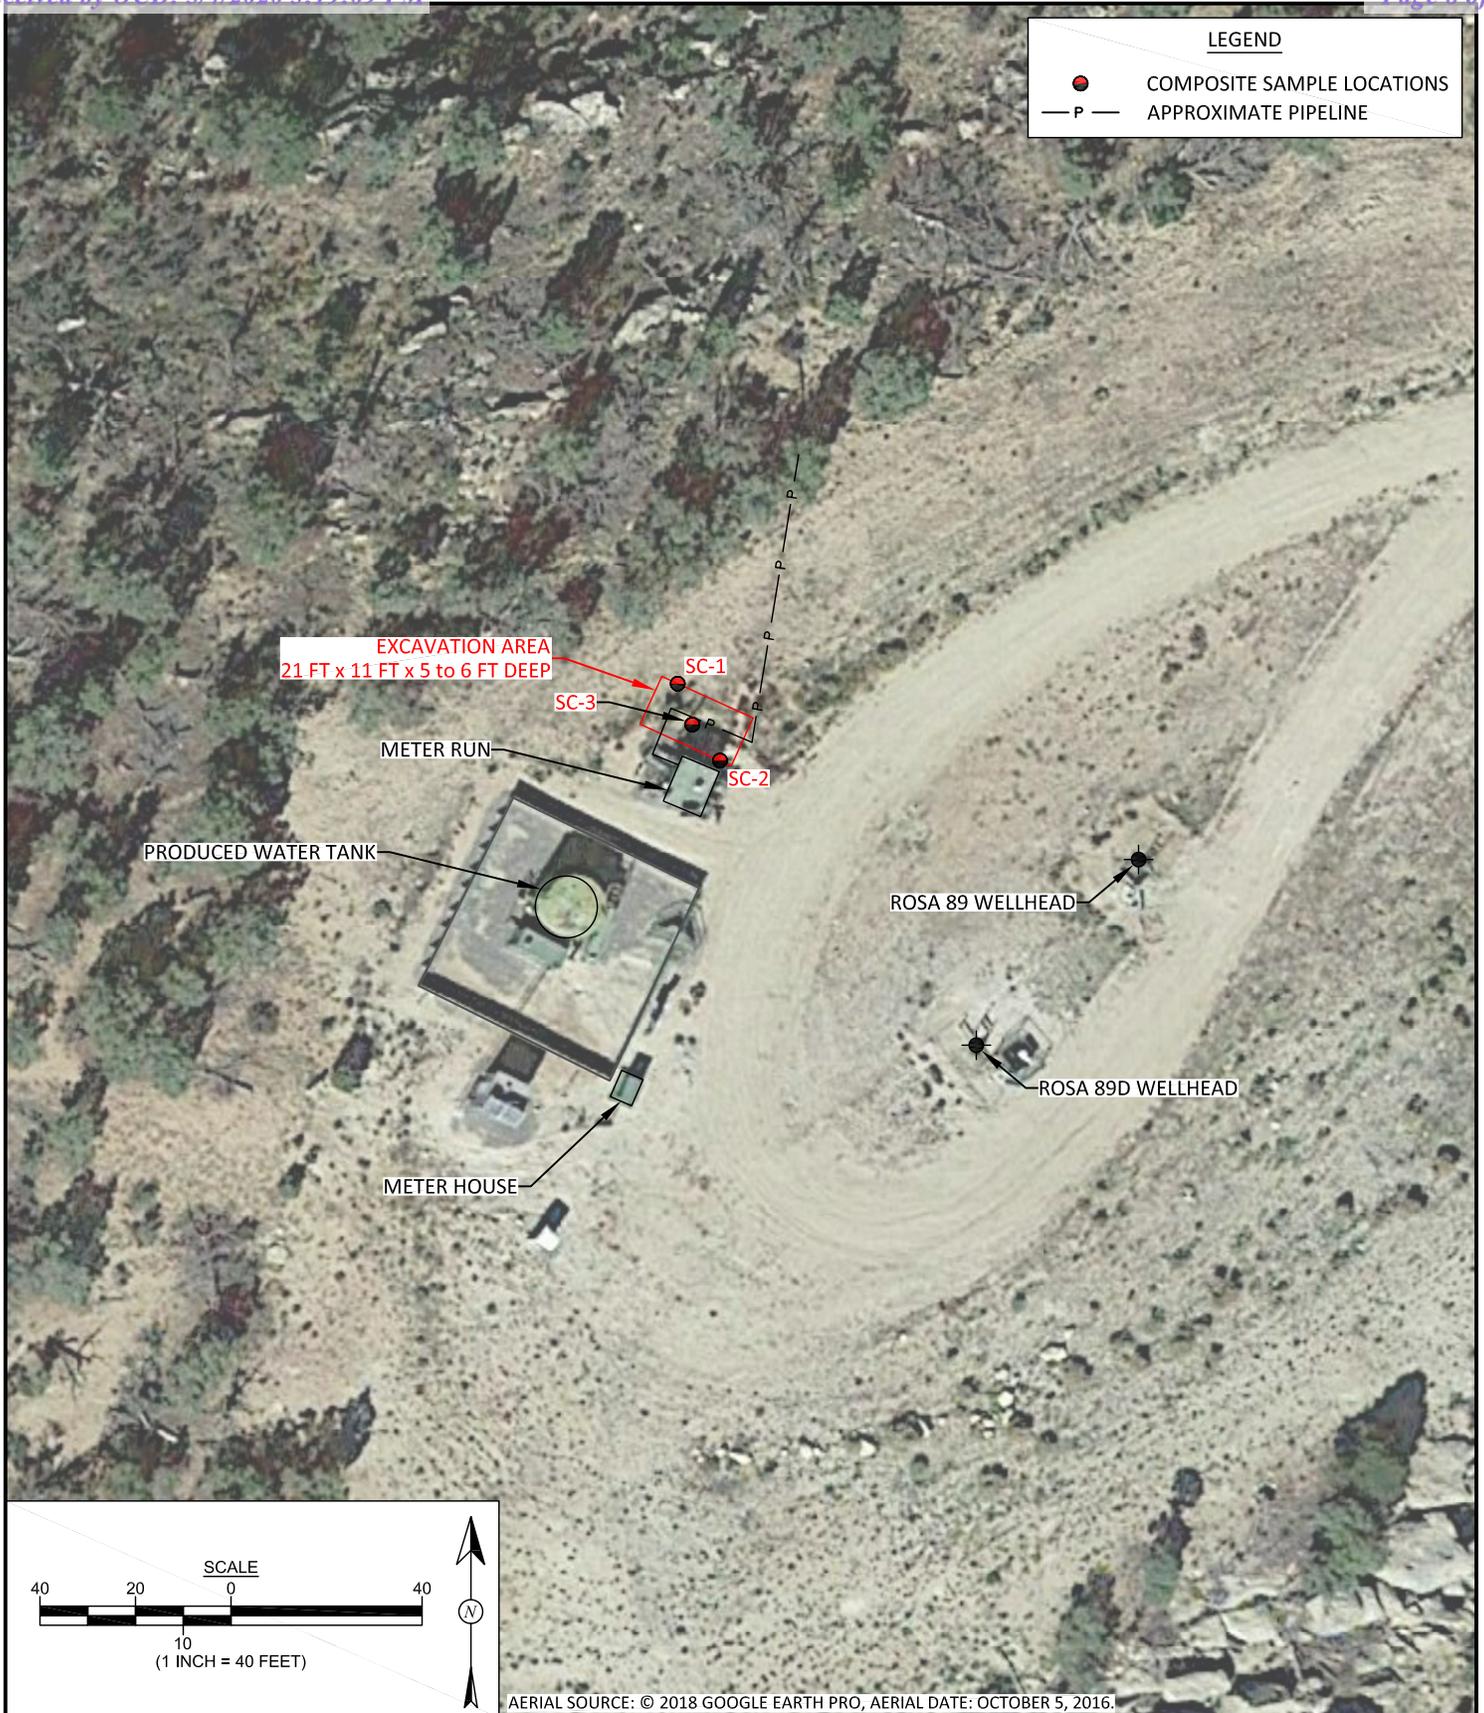
<p>animas environmental services Farmington, NM • Durango, CO animasenvironmental.com</p>	<p>DRAWN BY: C. Lameman</p>	<p>DATE DRAWN: February 11, 2020</p>	<p>FIGURE 3</p> <p>EXCAVATION AREA MAP AND SOIL SAMPLE LOCATIONS HARVEST MIDSTREAM ROSA 089 NE¼ NE¼, SECTION 34, T32N, R6W RIO ARRIBA COUNTY, NEW MEXICO N36.9427, W107.4384</p>
	<p>REVISIONS BY: C. Lameman</p>	<p>DATE REVISED: February 11, 2020</p>	
	<p>CHECKED BY: E. McNally</p>	<p>DATE CHECKED: February 11, 2020</p>	
	<p>APPROVED BY: E. McNally</p>	<p>DATE APPROVED: February 11, 2020</p>

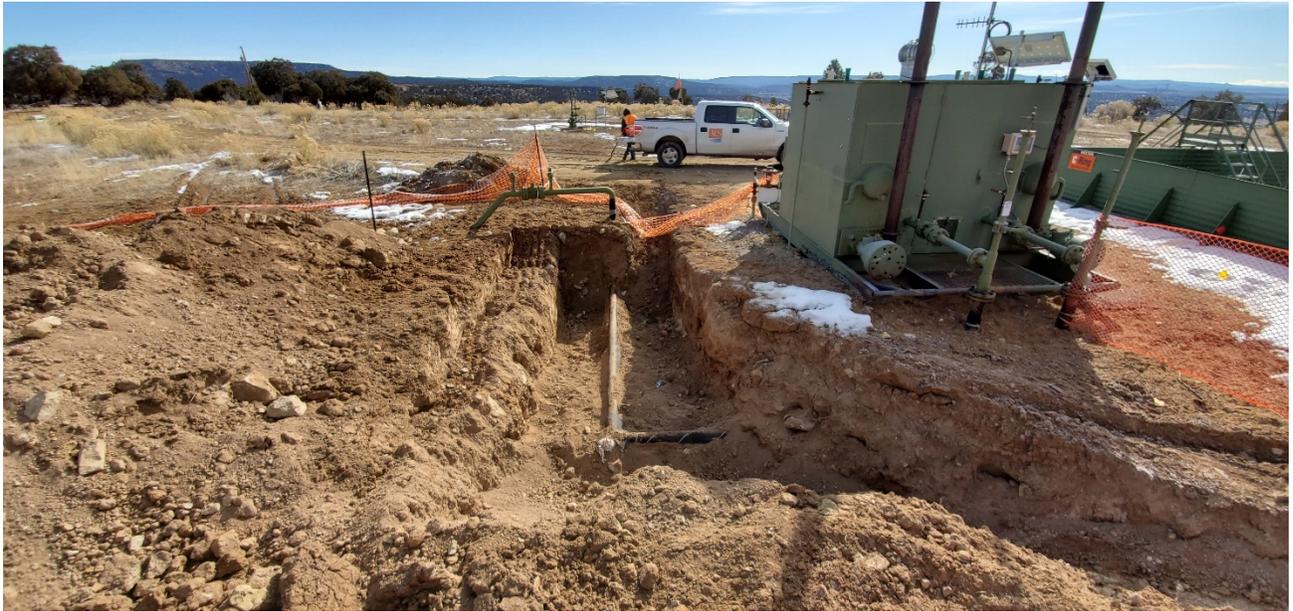
Photo 1: Excavation Area (21' x 11' x 5' to 6' deep).

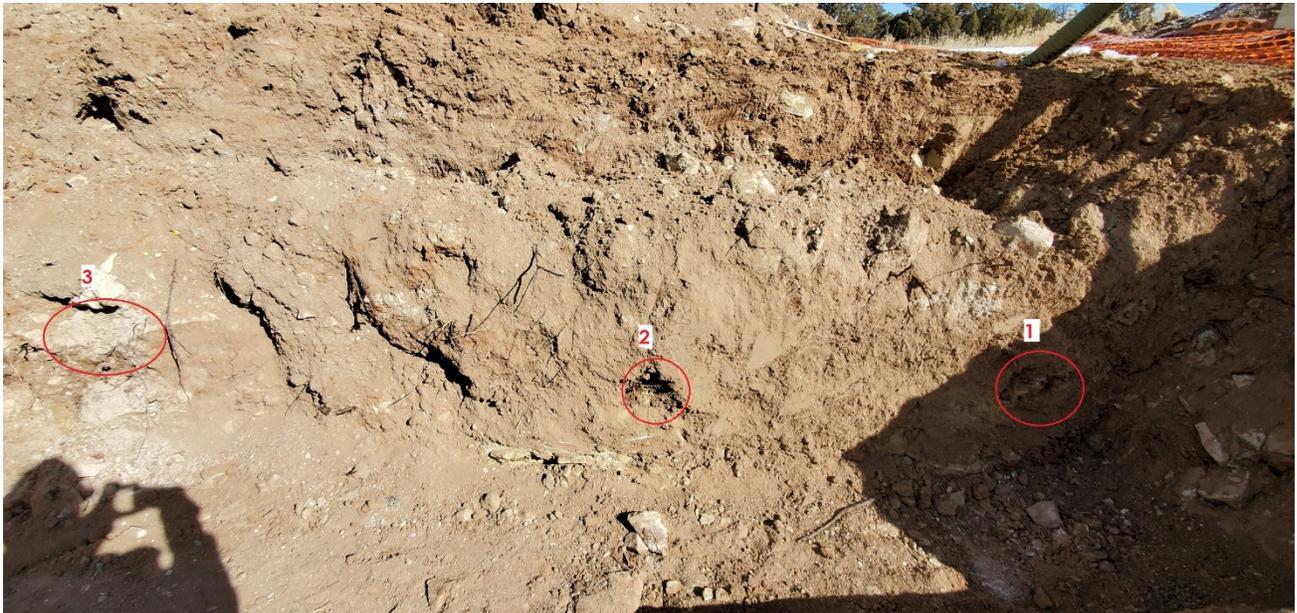
Photo 2: Composite Sample SC-1. North Wall. Sample points 1 through 3.

Client Sample ID: SC-1

Analyses	Result	RL	Qual	Units	DF	Date Analyzed	Batch
EPA METHOD 300.0: ANIONS							Analyst: CAS
Chloride	65	60		mg/Kg	20	2/7/2020 1:31:10 PM	50328
EPA METHOD 8015M/D: DIESEL RANGE ORGANICS							Analyst: CLP
Diesel Range Organics (DRO)	ND	10		mg/Kg	1	2/7/2020 12:53:13 PM	50322
Motor Oil Range Organics (MRO)	ND	50		mg/Kg	1	2/7/2020 12:53:13 PM	50322
Surr: DNOP	97.5	55.1-146		%Rec	1	2/7/2020 12:53:13 PM	50322
EPA METHOD 8015D: GASOLINE RANGE							Analyst: RAA
Gasoline Range Organics (GRO)	ND	4.2		mg/Kg	1	2/7/2020 11:49:12 AM	50313
Surr: BFB	80.7	66.6-105		%Rec	1	2/7/2020 11:49:12 AM	50313
EPA METHOD 8021B: VOLATILES							Analyst: RAA
Benzene	ND	0.021		mg/Kg	1	2/7/2020 11:49:12 AM	50313
Toluene	ND	0.042		mg/Kg	1	2/7/2020 11:49:12 AM	50313
Ethylbenzene	ND	0.042		mg/Kg	1	2/7/2020 11:49:12 AM	50313
Xylenes, Total	ND	0.085		mg/Kg	1	2/7/2020 11:49:12 AM	50313
Surr: 4-Bromofluorobenzene	89.3	80-120		%Rec	1	2/7/2020 11:49:12 AM	50313

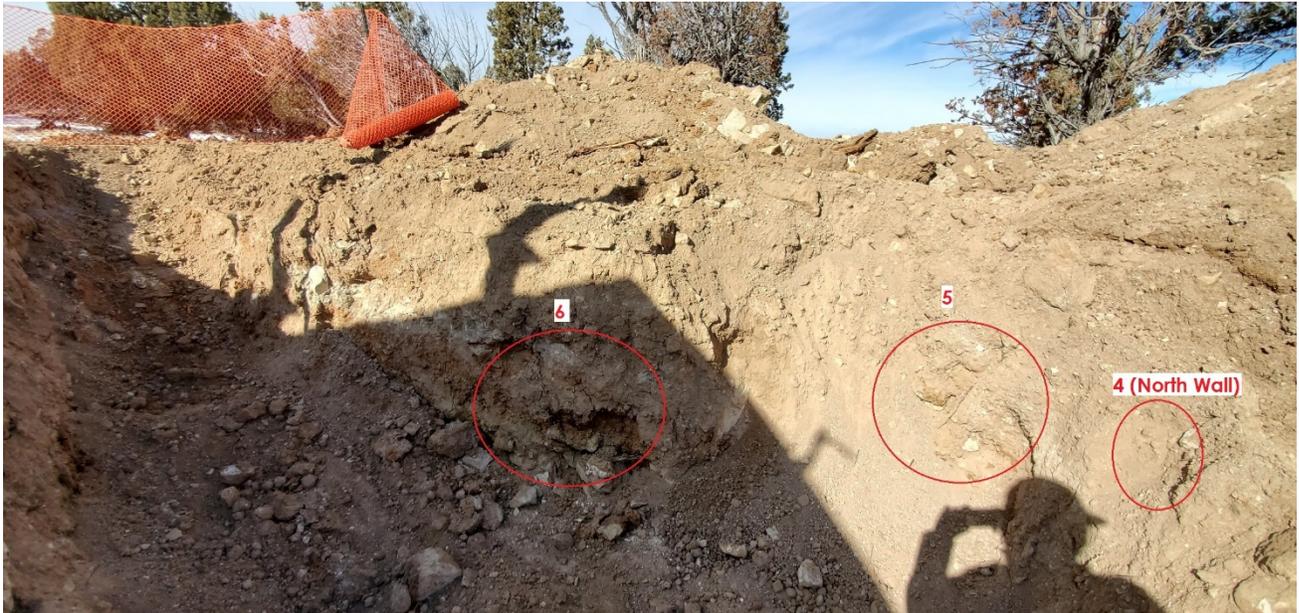
Photo 3: Composite Sample SC-1. North and West Wall. Sample points 4 through 6.

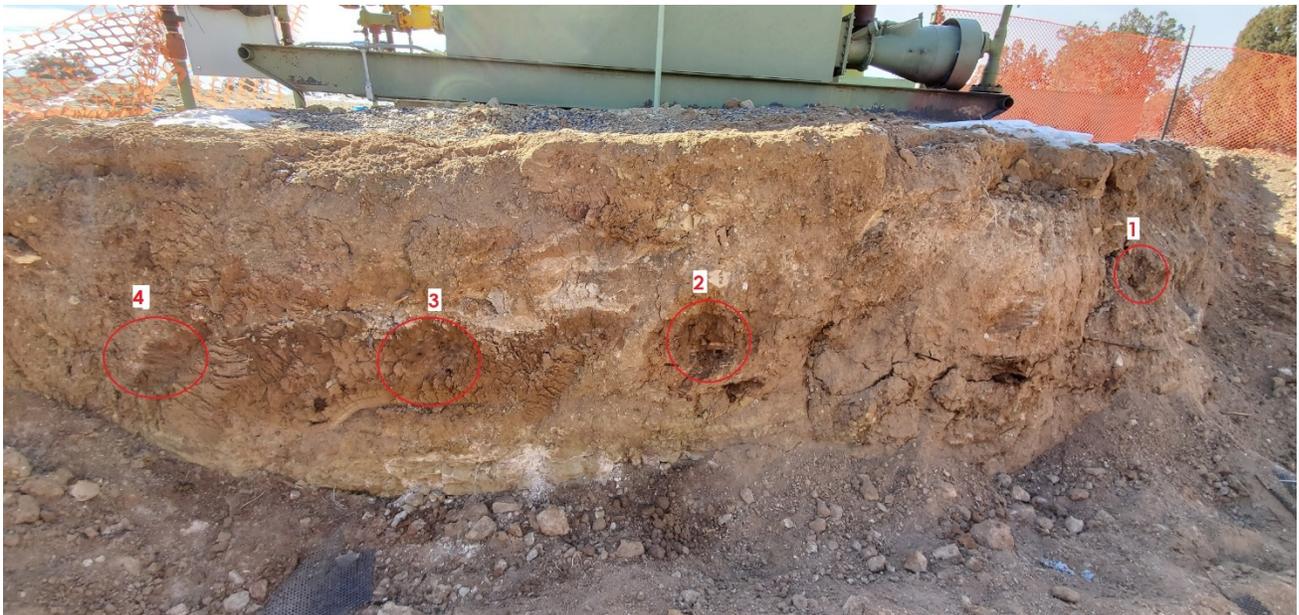
Photo 4: Composite Sample SC-2. South Wall. Sample points 1 through 4.

Client Sample ID: SC-2

Analyses	Result	RL	Qual	Units	DF	Date Analyzed	Batch
EPA METHOD 300.0: ANIONS							Analyst: CAS
Chloride	ND	60		mg/Kg	20	2/7/2020 1:43:30 PM	50328
EPA METHOD 8015M/D: DIESEL RANGE ORGANICS							Analyst: CLP
Diesel Range Organics (DRO)	ND	9.6		mg/Kg	1	2/7/2020 1:02:27 PM	50322
Motor Oil Range Organics (MRO)	ND	48		mg/Kg	1	2/7/2020 1:02:27 PM	50322
Surr: DNOP	95.7	55.1-146		%Rec	1	2/7/2020 1:02:27 PM	50322
EPA METHOD 8015D: GASOLINE RANGE							Analyst: RAA
Gasoline Range Organics (GRO)	ND	4.7		mg/Kg	1	2/7/2020 12:12:40 PM	50313
Surr: BFB	85.0	66.6-105		%Rec	1	2/7/2020 12:12:40 PM	50313
EPA METHOD 8021B: VOLATILES							Analyst: RAA
Benzene	ND	0.023		mg/Kg	1	2/7/2020 12:12:40 PM	50313
Toluene	ND	0.047		mg/Kg	1	2/7/2020 12:12:40 PM	50313
Ethylbenzene	ND	0.047		mg/Kg	1	2/7/2020 12:12:40 PM	50313
Xylenes, Total	ND	0.093		mg/Kg	1	2/7/2020 12:12:40 PM	50313
Surr: 4-Bromofluorobenzene	95.2	80-120		%Rec	1	2/7/2020 12:12:40 PM	50313

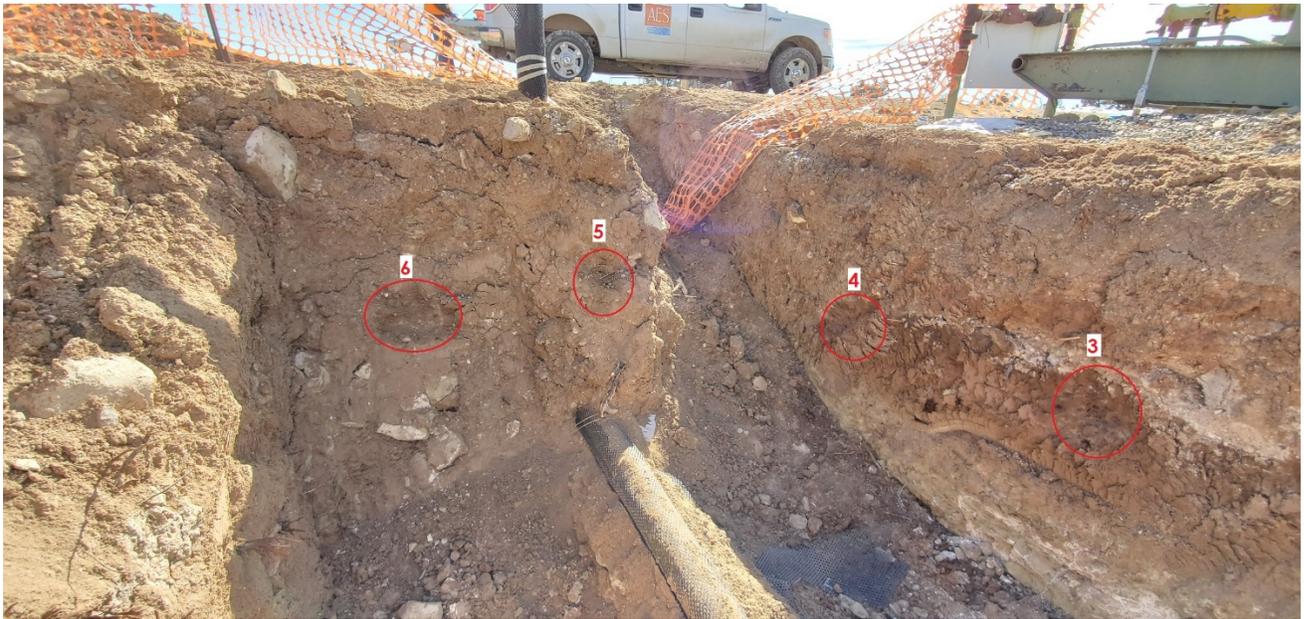
Photo 5: Composite Sample SC-2. East and South Wall. Sample points 3 through 6.

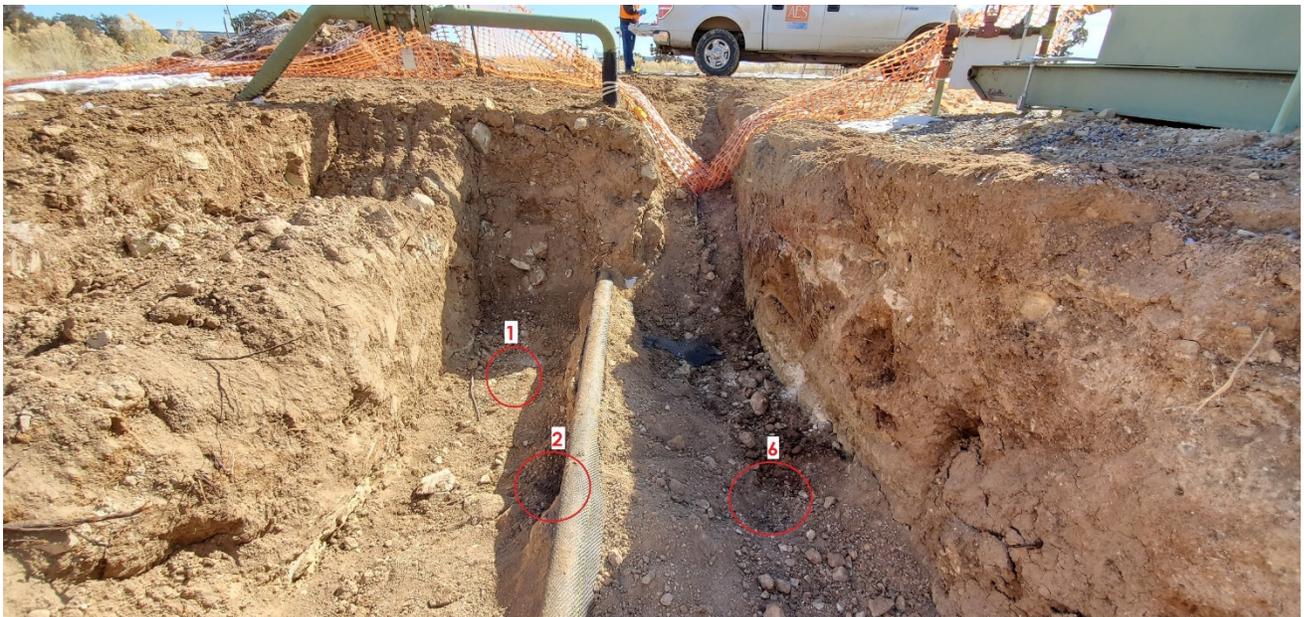
Photo 6: Composite Sample SC-3. Base. Sample points 1, 2, and 6.

Client Sample ID: SC-3

Analyses	Result	RL	Qual	Units	DF	Date Analyzed	Batch
EPA METHOD 300.0: ANIONS							Analyst: CAS
Chloride	110	60		mg/Kg	20	2/7/2020 1:55:51 PM	50328
EPA METHOD 8015M/D: DIESEL RANGE ORGANICS							Analyst: CLP
Diesel Range Organics (DRO)	11	9.9		mg/Kg	1	2/7/2020 1:11:41 PM	50322
Motor Oil Range Organics (MRO)	ND	50		mg/Kg	1	2/7/2020 1:11:41 PM	50322
Surr: DNOP	103	55.1-146		%Rec	1	2/7/2020 1:11:41 PM	50322
EPA METHOD 8015D: GASOLINE RANGE							Analyst: RAA
Gasoline Range Organics (GRO)	ND	4.9		mg/Kg	1	2/7/2020 12:36:14 PM	50313
Surr: BFB	81.8	66.6-105		%Rec	1	2/7/2020 12:36:14 PM	50313
EPA METHOD 8021B: VOLATILES							Analyst: RAA
Benzene	ND	0.025		mg/Kg	1	2/7/2020 12:36:14 PM	50313
Toluene	ND	0.049		mg/Kg	1	2/7/2020 12:36:14 PM	50313
Ethylbenzene	ND	0.049		mg/Kg	1	2/7/2020 12:36:14 PM	50313
Xylenes, Total	ND	0.099		mg/Kg	1	2/7/2020 12:36:14 PM	50313
Surr: 4-Bromofluorobenzene	91.2	80-120		%Rec	1	2/7/2020 12:36:14 PM	50313

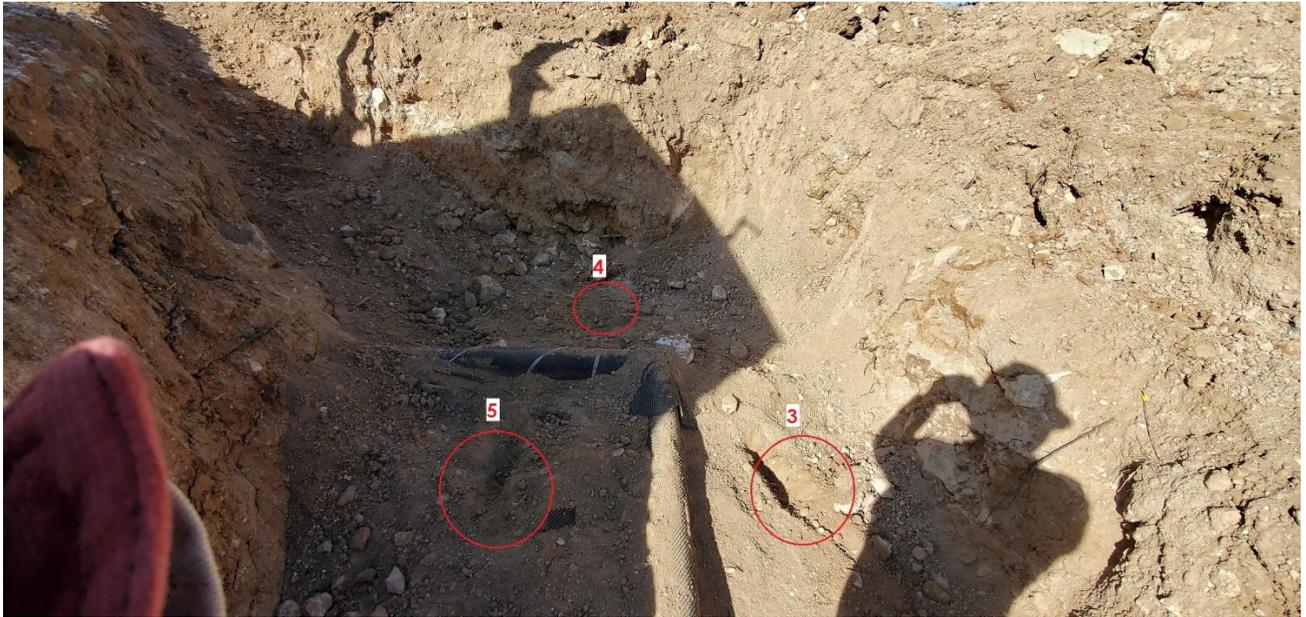
Photo 7: Composite Sample SC-3. Base. Sample points 3 through 5.
