Release Notification

Site Name: JACQUEZ #002S	Site Type: Natural Gas Production Well Pad
Date Release Discovered: March 3, 2020	API#: 30-045-31905

Jaquez 002S
March 4, 2020

SITING AND HYDRO-GEOLOGICAL REPORT FOR JACQUEZ 001A

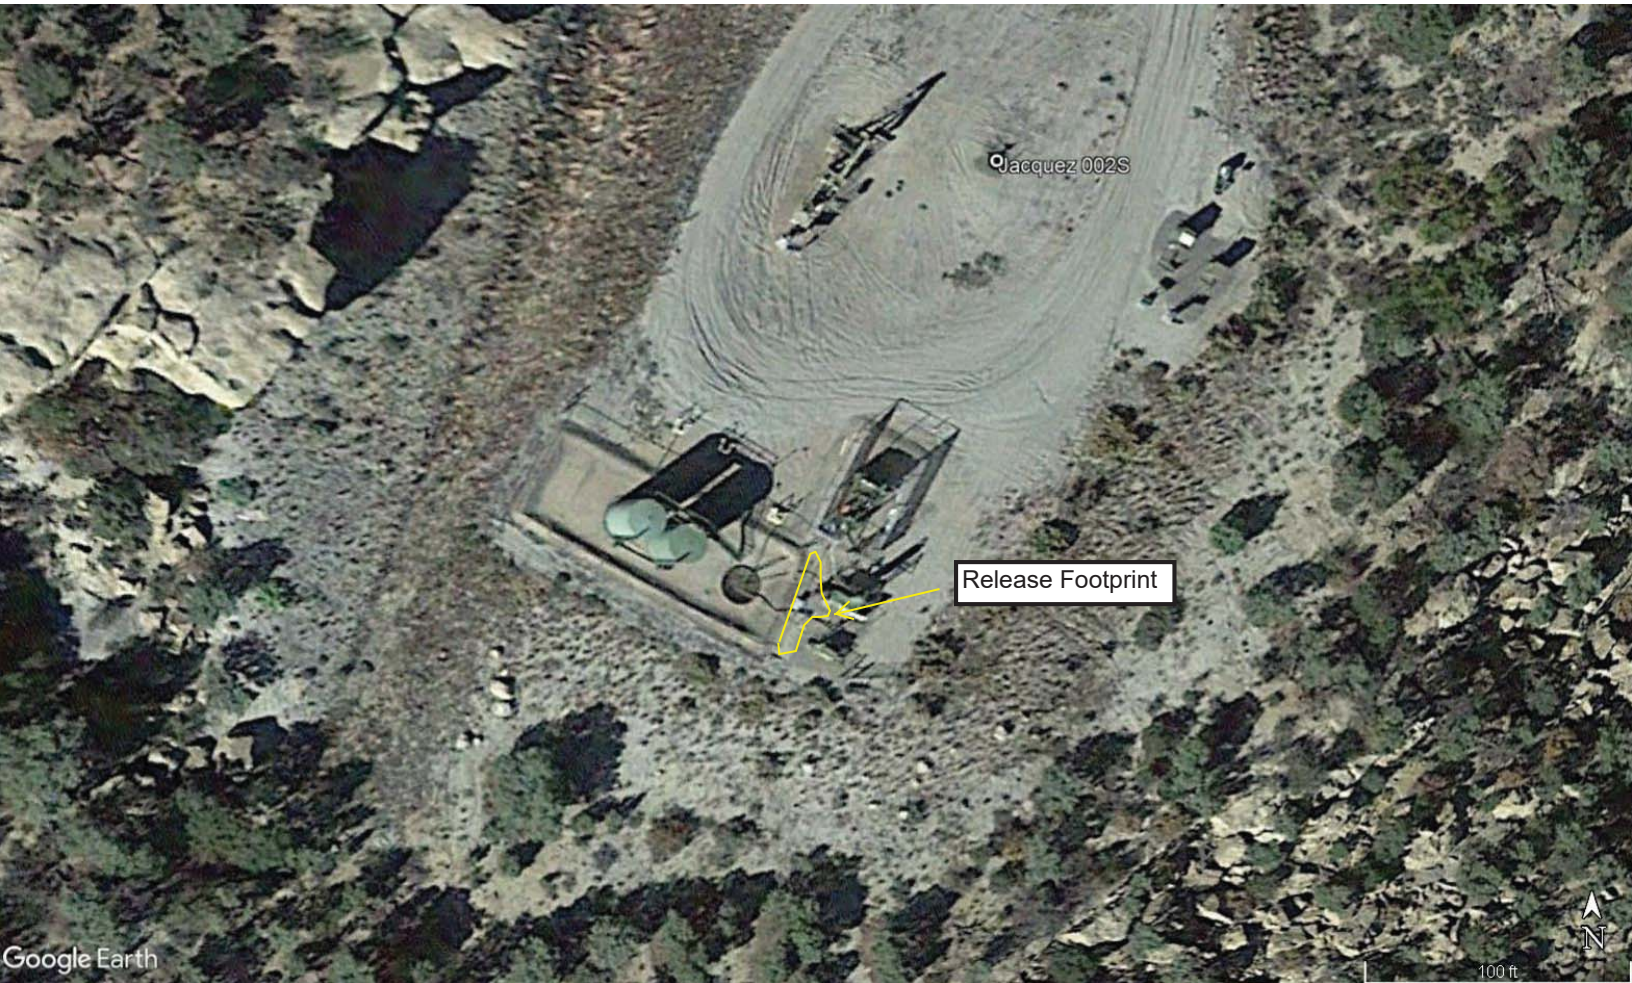
Release of produced water caused from cracked gas eliminator on water transfer line.

SITE OBSERVATIONS: LOST INTEGRITY OF EQUIPMENT: <u>YES</u> / NO EXPLANATION: <u>VALVE</u> APPARENT EVIDENCE OF A RELEASE OBSERVED AND/OR OCCURRED: <u>YES</u> / NO EXPLANATION: <u>Water Saturated Soils</u> EQUIPMENT SET OVER RECLAIMED AREA: <u>YES</u> / NO EXPLANATION: <u>SEPARATION</u> OTHER: _____		
SOIL IMPACT DIMENSION ESTIMATION: <u>35" ft. X 6" ft. X 2"</u> EXCAVATION ESTIMATION (Cubic Yards): _____ DEPTH TO GROUNDWATER: <u>>100</u> NEAREST WATER SOURCE: <u>>1000</u> NEAREST SURFACE WATER: <u>>1000</u> NMOC DTPH CLOSURE STD: <u>1000/2500</u> ppm		
SITE SKETCH		BGT Located: <u>off</u> / on site PLOT PLAN circle: <u>attached</u>
		OVM CALIB. READ. = _____ ppm RF = 0.52 OVM CALIB. GAS = _____ ppm TIME: _____ am/pm DATE: _____
NOTES: BGT = BELOW-GRADE TANK; E.D. = EXCAVATION DEPRESSION; B.G. = BELOW GRADE; B = BELOW; T.H. = TEST HOLE; -- = APPROX.; W.H. = WELL HEAD; T.B. = TANK BOTTOM; PBGTL = PREVIOUS BELOW-GRADE TANK LOCATION; SPD = SAMPLE POINT DESIGNATION; R.W. = RETAINING WALL; NA = NOT APPLICABLE OR NOT AVAILABLE; SW - SINGLE WALL; DW - DOUBLE WALL; SB - SINGLE BOTTOM; DB - DOUBLE BOTTOM		MISCELL. NOTES WO: _____ PO #: _____ PK: _____ PJ #: _____ Permit date(s): _____ OCD Appr. date(s): _____ Tank ID: _____ OVM = Organic Vapor Meter ppm = parts per million BGT Sidewalls Visible: Y / N BGT Sidewalls Visible: Y / N BGT Sidewalls Visible: Y / N Magnetic declination: <u>10° E</u>

Based on the attached lab data and siting criteria, the release requires no further action. The area of the release will be amended with hydrocarbon enzymes and raked in place.

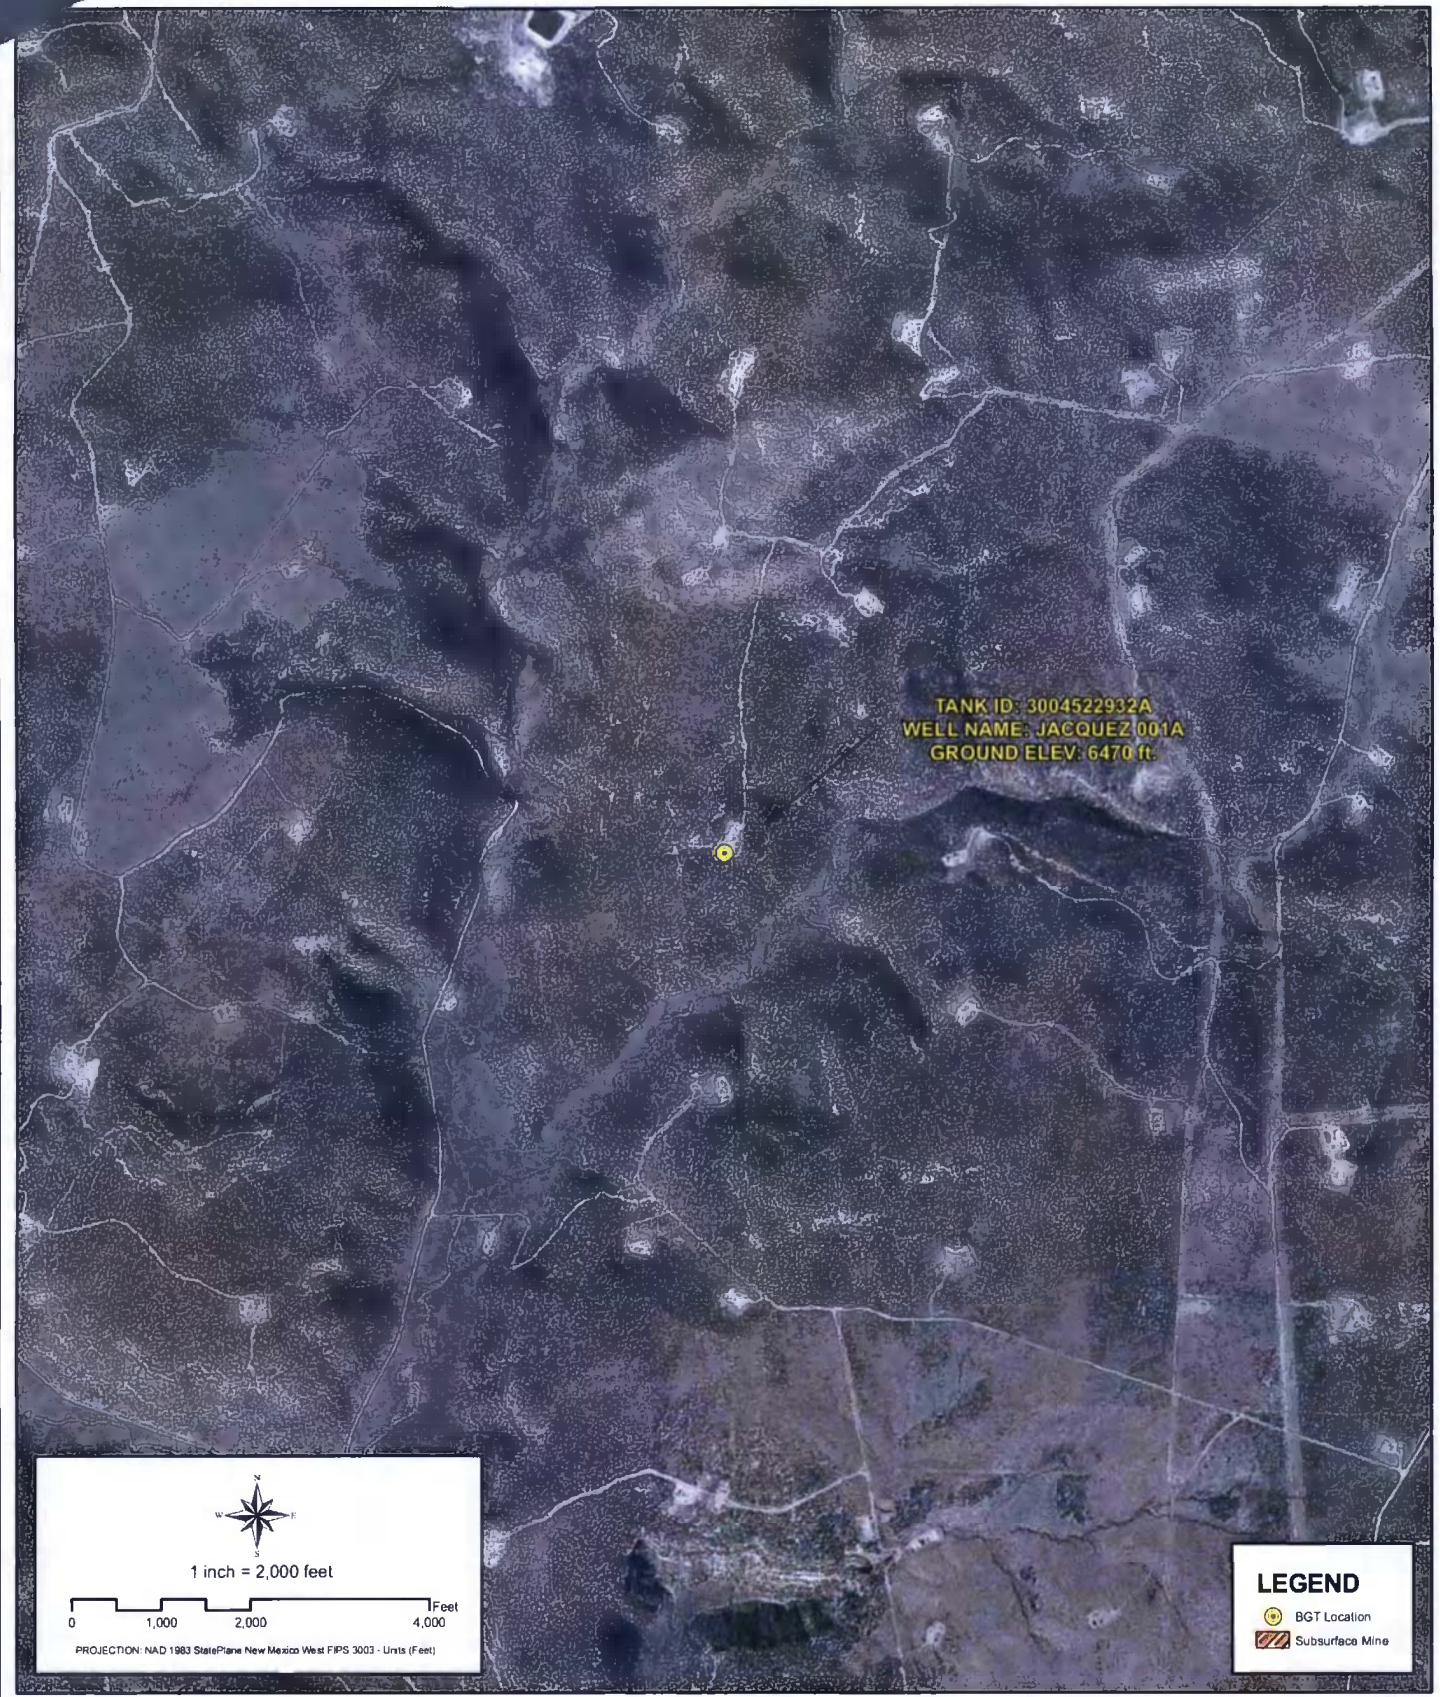
FIGURE

PROXIMITY TO SUBSURFACE MINES

Figure 7: Proximity to Subsurface Mine**Layers:****Subsurface Mine:****NM Mining and Minerals Division (2010)**

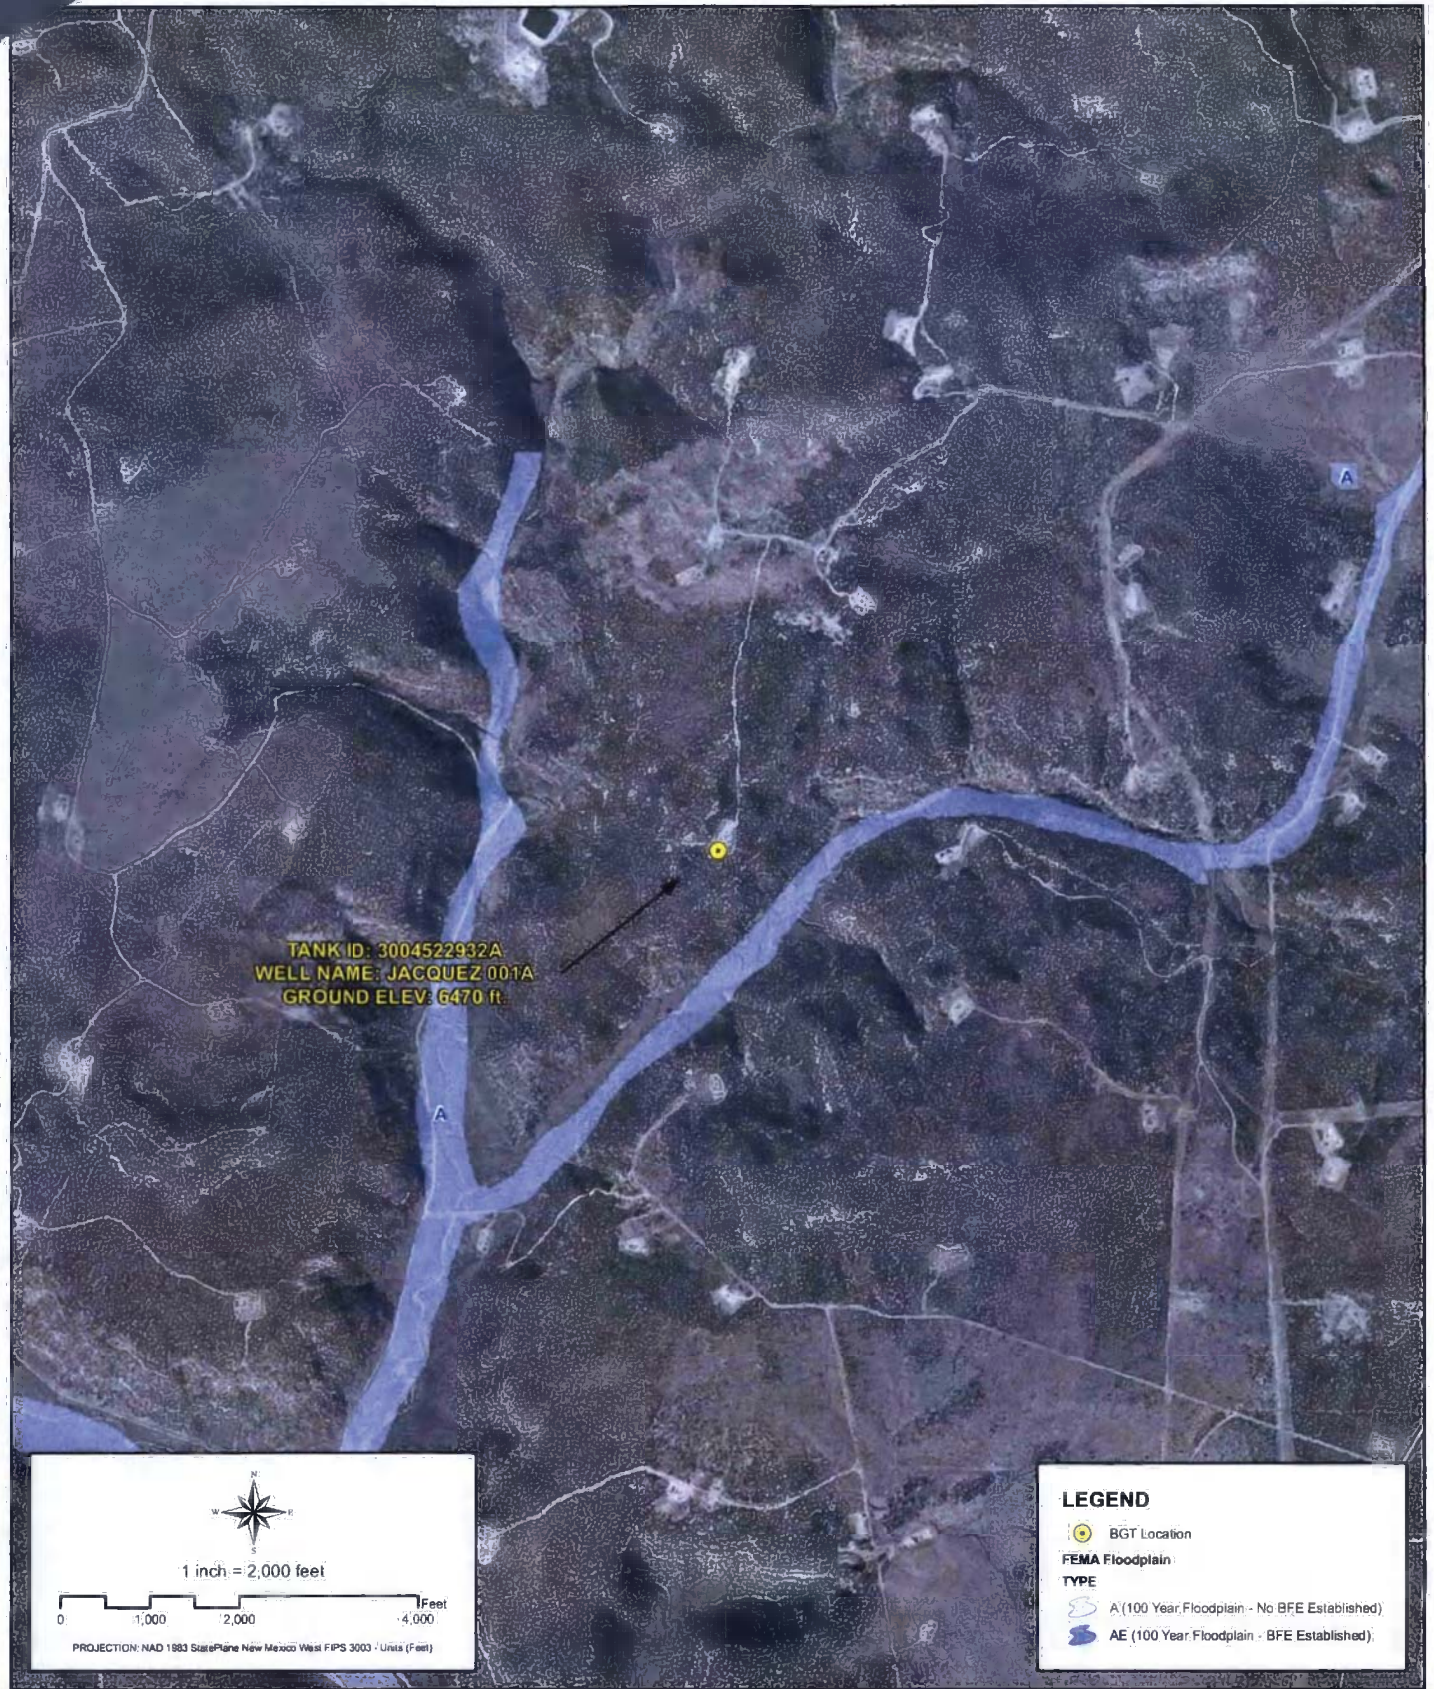
FIGURE**8**

PROXIMITY TO FLOODPLAIN

Figure 8: Proximity to FEMA Floodplain**Layers:****FEMA Floodplain:****FEMA (varying years)**
