# Closure of Release Investigation and Remedial Action Plan

Lobo 285 SWD (NMOCD Reference #: 2RP-5463)

Terracon Project No. AR197256

**RE: Closure of Release Investigation and Remedial Action Plan**  
Lobo 285 SWD Produced Water Release (2RP-5463)  
Unit A Section 22, T25S, R28E, N.M.P.M., Eddy County, New Mexico  
Terracon Project No. AR197256

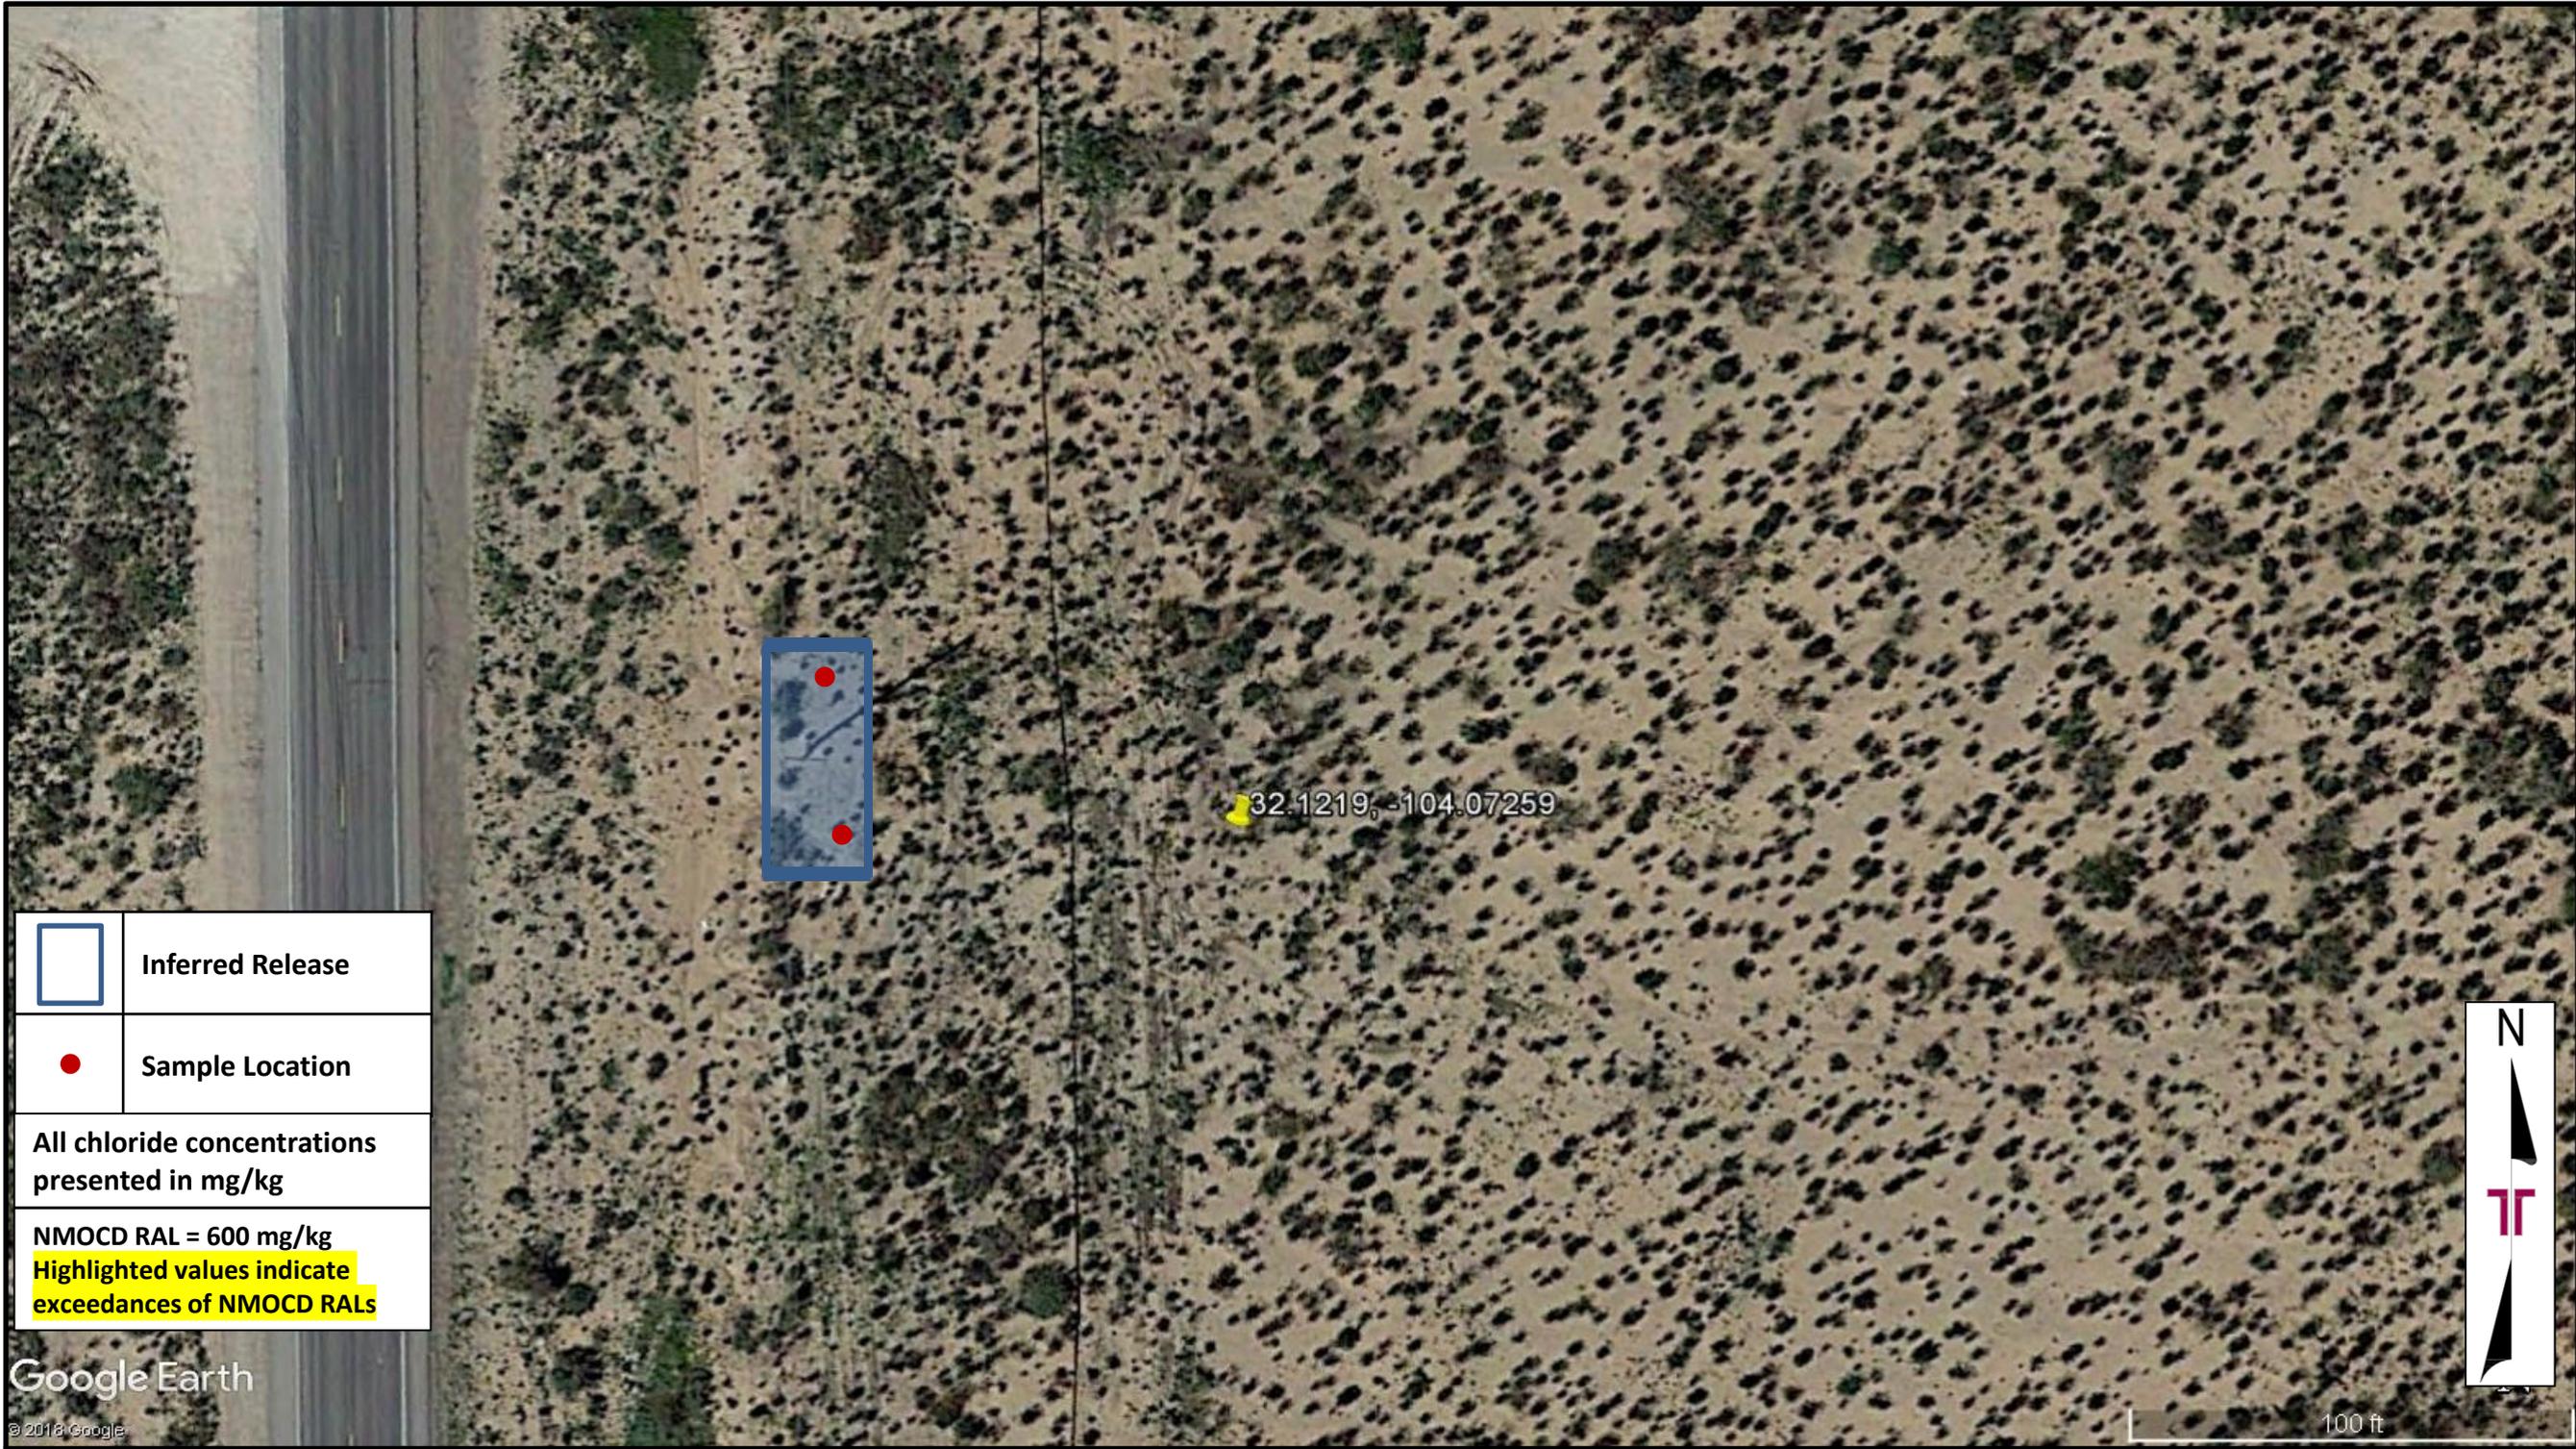
Figure 2 – Site Map  
 Lobo 285 SWD  
 32.12190°, -104.07259°  
 Eddy County, New Mexico

Inferred Release

Required Information	Site and Release information	
Responsible party	The facility is operated by Solaris Water Midstream	
Local contact	Contact: Mr. Rob Kirk	P: (469) 978-5620 E: <a href="mailto:rob.kirk@solarismidstream.com">rob.kirk@solarismidstream.com</a>
NMOCD Notification	Notice of the release was provided to the NMOCD District 2 Artesia Office by Rob Kirk (Solaris) on May 23, 2019.	
Facility description	The facility is comprised of a flowback line associated with the Lobo 285 SWD and surrounding impacted soils which are located in Eddy County, New Mexico. More specifically, the Site is an approximate 1-acre area comprised of undeveloped range land utilized as a pipeline right-of-way located within the Unit B Section 22, Township 25 South, Range 28 East, N.M.P.M., approximately 7.2 miles south of Malaga, New Mexico.	
Time of incident	May 5, 2019, discovered at 7:00 a.m.	
Discharge event	Release of produced water originating from a malfunctioning joint on a pipeline riser of a Solaris transfer flowback line. The release origin occurred west of the facility pad, under development at the time of the release. The release area, near the origin of the release, was limited to an approximately 700sq. ft. area; however, a portion of the release traveled along the surface for approximately 20 ft. to the north. The width of the release being approximately 15 ft. The release margins are illustrated on Figure 2 of Appendix A.

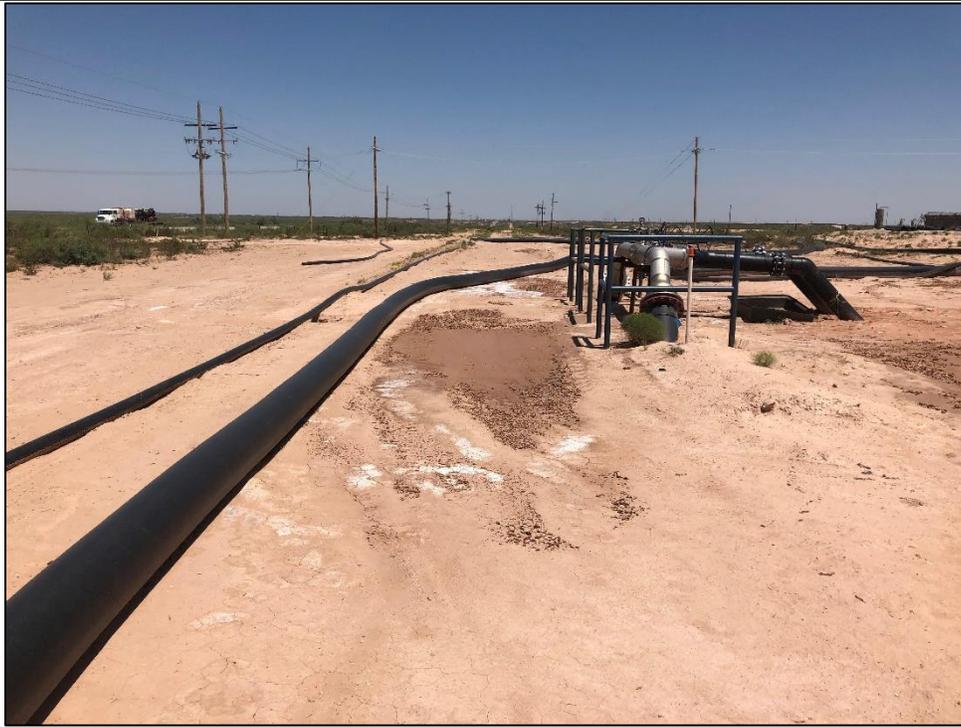
**PHOTO 1:** View of site, facing north. 7/25/2019 / **TIME:** 1:11PM / **GPS:** 32.1217 -1104.0726

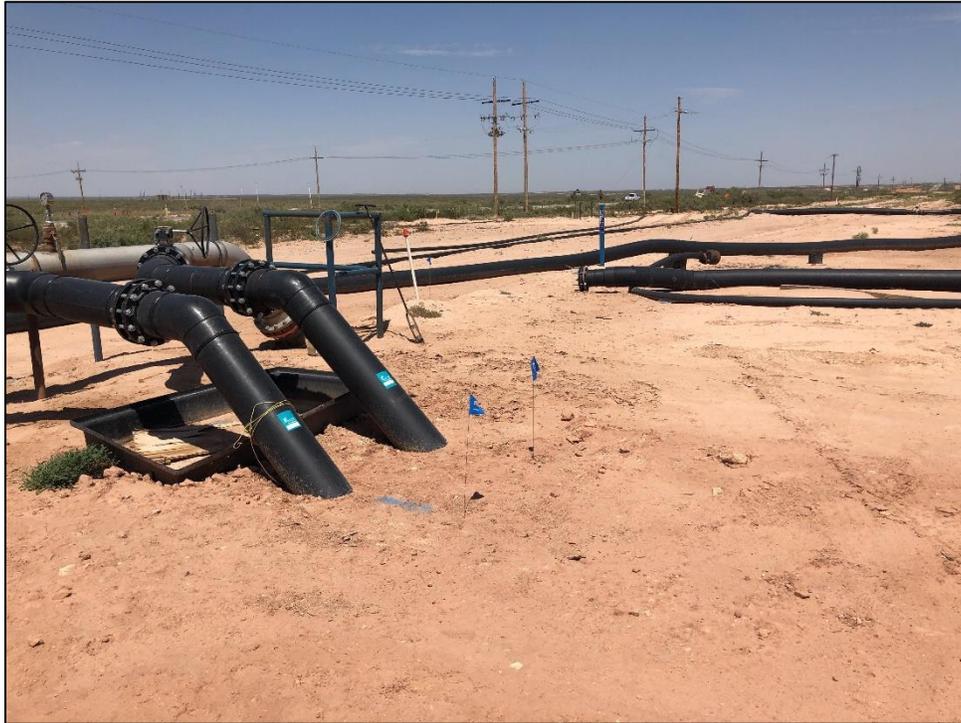
**PHOTO 2:** View of site, facing northwest. 8/21/2019 / **TIME:** 1:07PM / **GPS:** 32.1218 -1104.0725

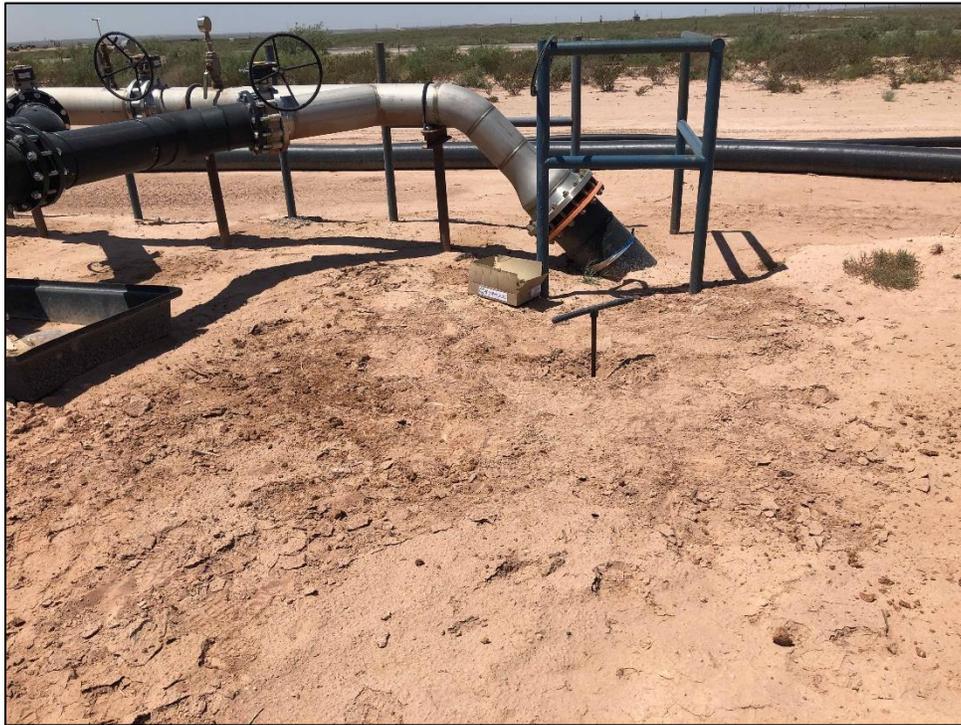
**PHOTO 3:** View of HA-1, facing west. 8/21/2019 / **TIME:** 1:21PM / **GPS:** 32.1218 -1104.0725

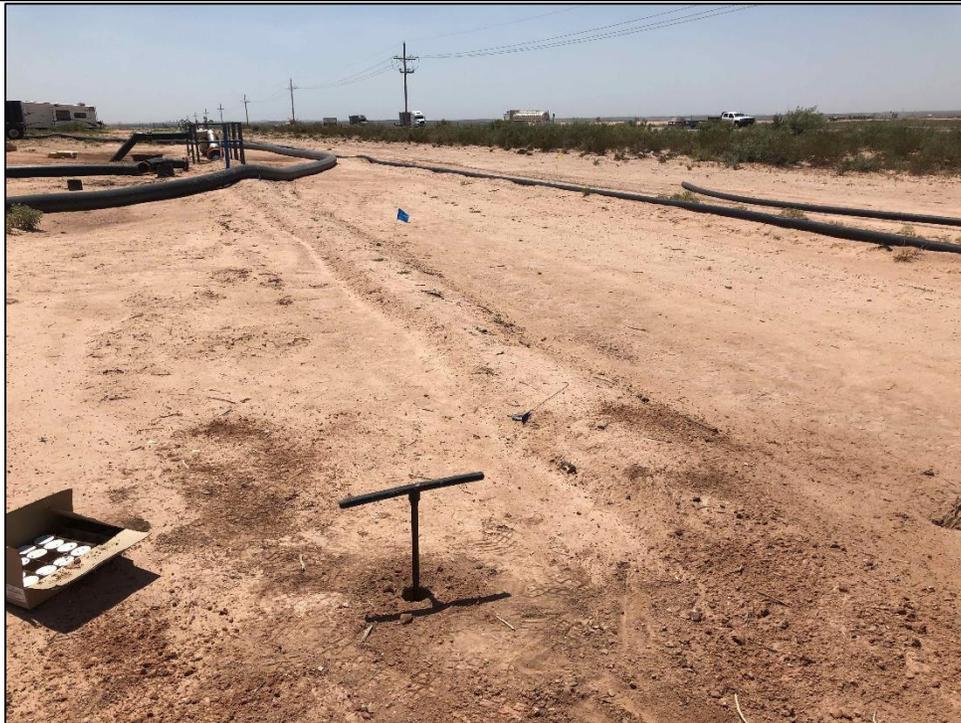
**PHOTO 4:** View of site and HA-2, facing south. 8/21/2019 / **TIME:** 1:36PM / **GPS:** 32.1221 -1104.0725

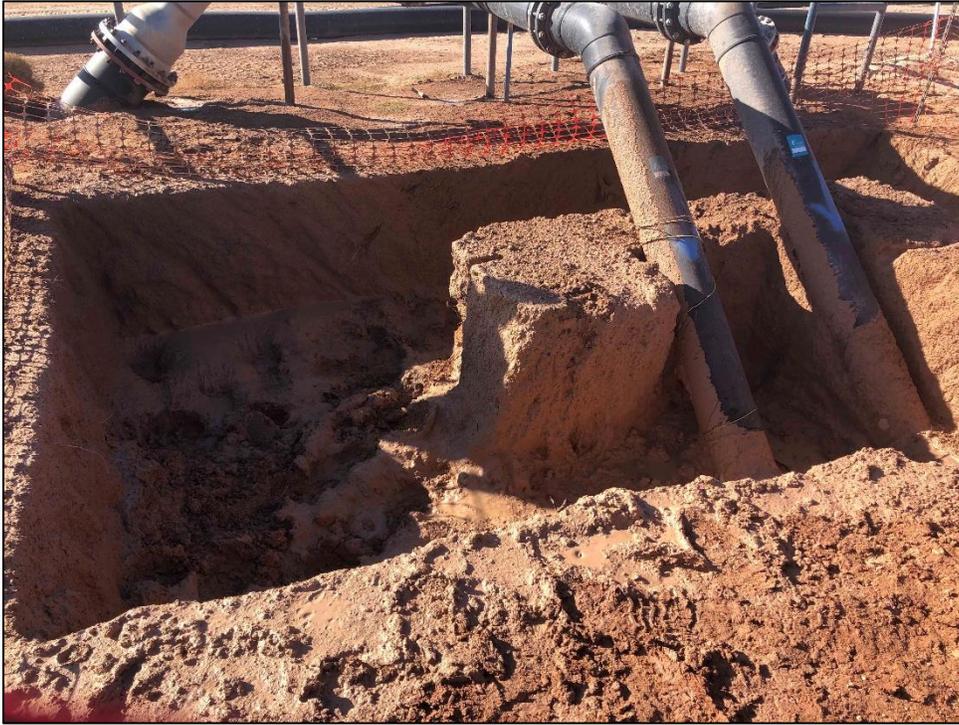
**PHOTO 5:** View of remediation, facing west. 11/22/2019 / TIME: 1:11PM / GPS: 32.1217 -1104.0726

- Based on the magnitude of chloride concentrations detected within the release margins to depths subject to NMOCD Reclamation requirements, approximately 23 cubic yards (cy) of chloride impacted material were required to be excavated and disposed of at a permitted disposal facility under manifest.
- Following excavation to recommended Reclamation depths, vertical and horizontal excavation confirmation samples were collected from the base and walls of the excavation to confirm the remaining levels of soil contaminants are below the desired NMOCD remediation action levels (RAL).
- Based on the release response actions (including excavation and disposition) taken corroborated with the confirmed vertical delineation, a remedial response was warranted within soils at depths greater than 4 ft. bgs, and was achieved utilizing granulated gypsum at the base of the excavation.

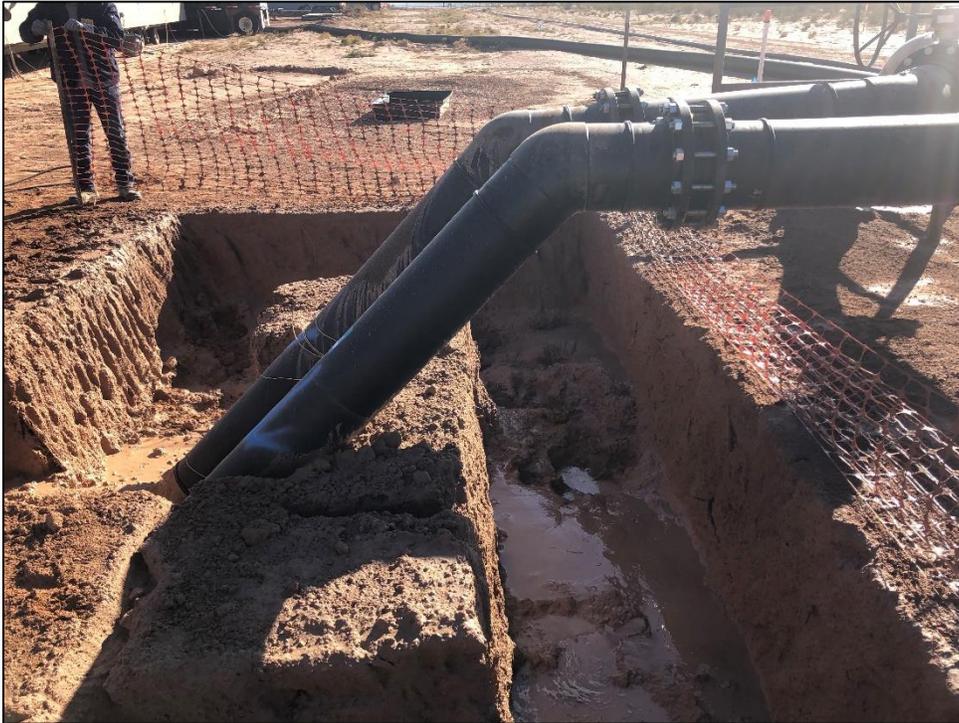
**PHOTO 6:** View of remediation, facing south. 11/22/2019 / TIME: 1:07PM / GPS: 32.1218 -1104.0725

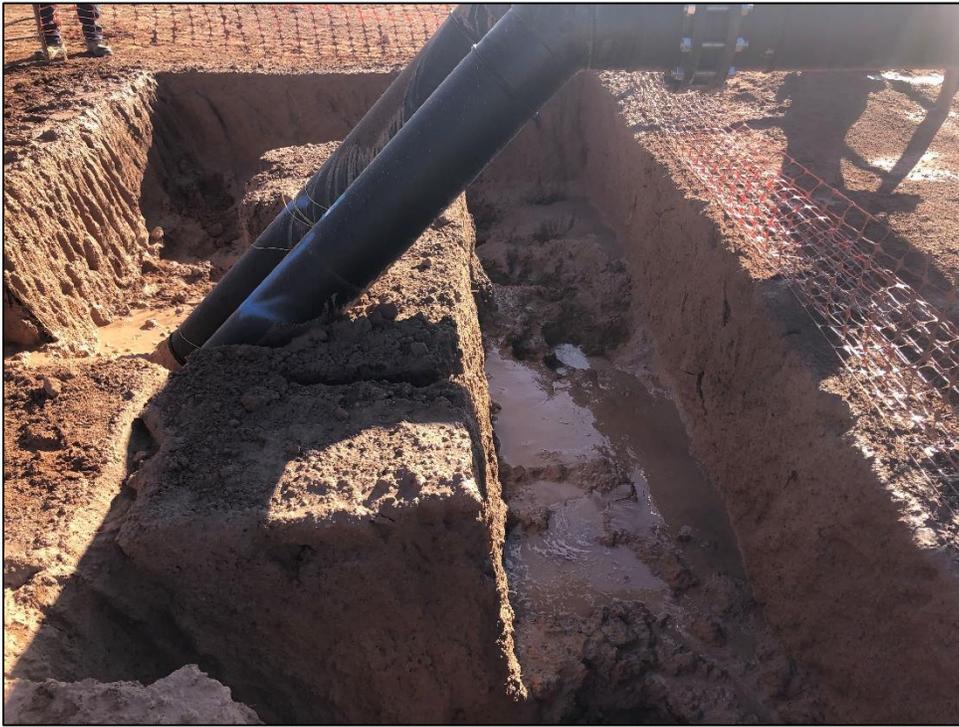
**PHOTO 7:** View of base of excavation, facing south. 11/22/2019 / **TIME:** 1:21PM / **GPS:** 32.1218 -1104.0725

Following hydro excavation to recommended Reclamation depths, vertical and horizontal delineation samples were collected from the base and walls of the excavation to confirm the remaining levels of soil contaminants are below the desired NMOCD RALs.

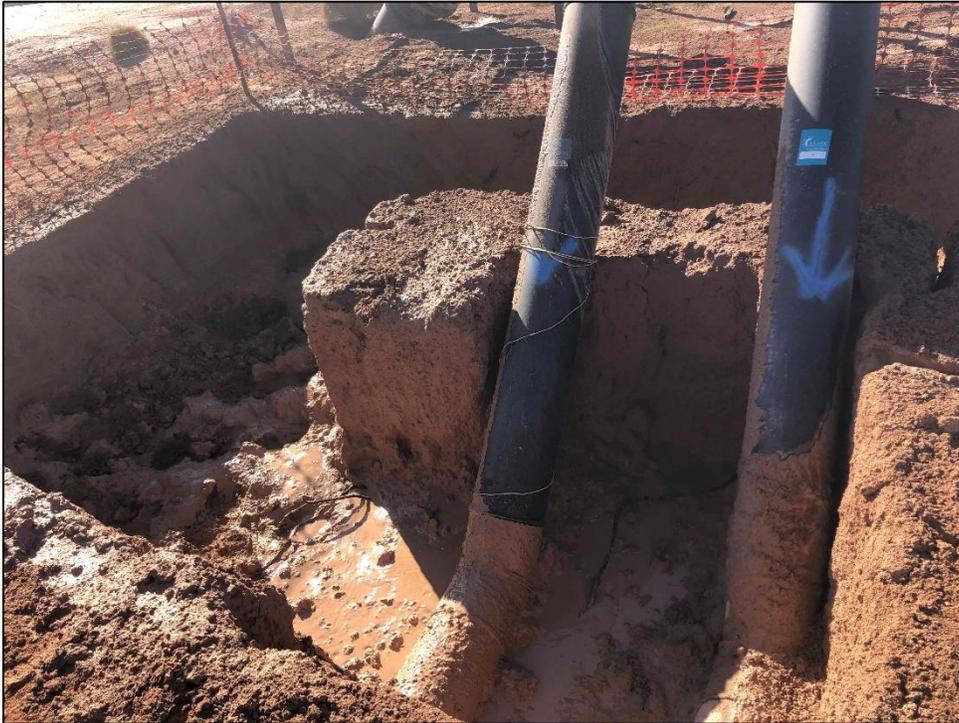
**PHOTO 8:** View of excavation, facing west. 11/22/2019 / **TIME:** 1:36PM / **GPS:** 32.1221 -1104.0725
