SVE PILOT TEST REPORT

NVF 1602039091

**RE: Pilot Test Results
OH Randel #5
API #30-045-05964
Hilcorp Energy Company
San Juan County, New Mexico**

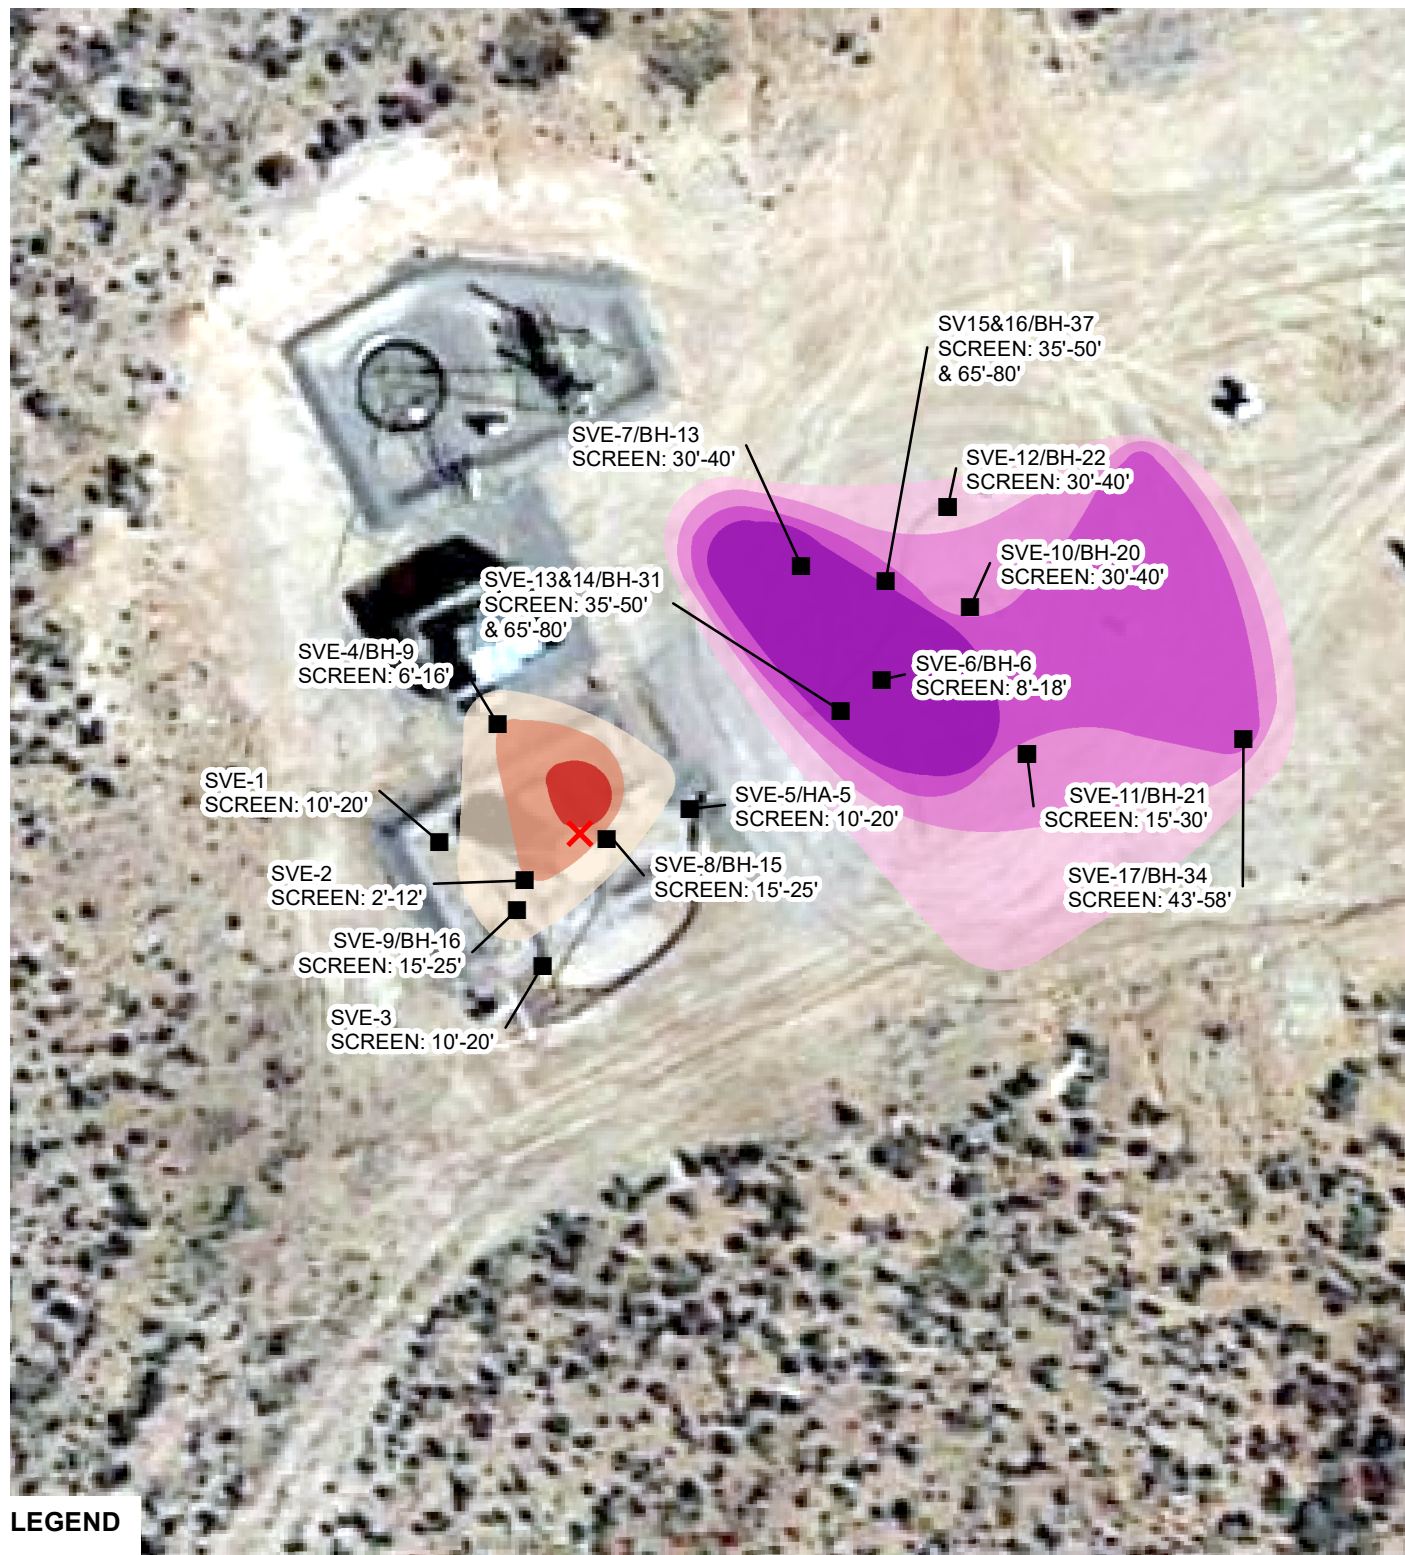
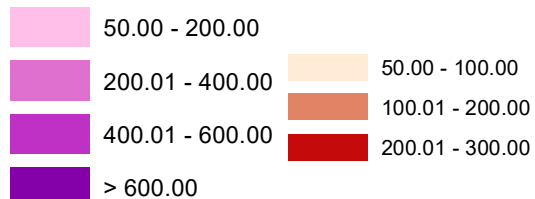
FIGURE 2
PILOT TEST SVE LAYOUT
OH RANDEL #5
NWNW SEC 10 T26N R11W
SAN JUAN COUNTY, NEW MEXICO
HILCORP ENERGY COMPANY

SOIL VAPOR EXTRACTION (SVE) WELL

INFERRED BTEX ISOCONCENTRATION (PARTS PER MILLION)

SVE pilot testing was conducted to evaluate the flow rate and applied vacuum required to influence the subsurface and volatilize the petroleum hydrocarbons entrained in the soil. Five SVE wells (SVE-13 through SVE-17) were installed at the site on May 13, 2019 as pilot test wells and observation wells. Wells SVE-13 and SVE-14 were installed in the previous boring BH-31 and wells SVE-15 and SVE-16 were installed in the previous boring BH-37. SVE-17 was installed in

The existing SVE system that is remediating the Primary and Secondary sources was utilized for the pilot test. The existing system is a two horsepower Atlantic AB-301 regenerative blower capable of a maximum applied 72 inches water column vacuum (IWC). The blower was connected to each pilot SVE well with aboveground piping and observations of vacuum were measured throughout the subsurface utilizing the other pilot test SVE wells and existing well infrastructure.

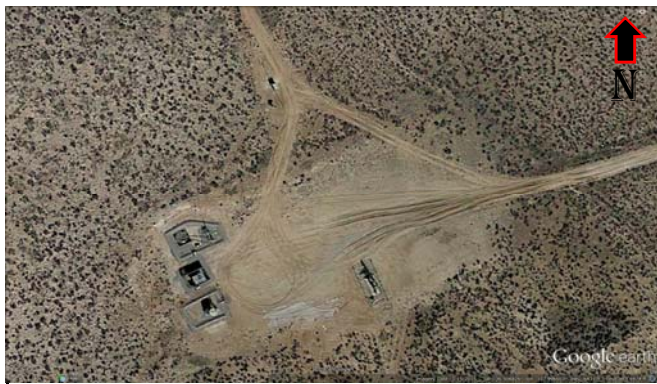
BORING LOG/MONITORING WELL COMPLETION DIAGRAM

Boring/Well Number: BH-31, SVE 13 and SVE 14		Project: OH Randel #5	
Date: 12/16/18, 12/18/18, 5/13/2019		Project Number: 017818016	
Logged By: EC/JA		Drilled By: Layne/Cascade	
Drilling Method: Sonic		Sampling Method: Core Barrel	
Seal: 30-33', 60-63'		Grout: 0-30', 50-60'	
Diameter: 2"	Length: 0-35', 0-65'	Hole Diameter: 8"	Depth to Liquid: NA
Diameter: 2"	Length: 35-50', 65-80'	Total Depth: 96'	Depth to Water: NA

Penetration Resistance	Moisture Content	Vapor (ppm)	HC Staining?	Sample #	Depth (ft. bgs.)	Sample Run	Recovery	Soil/Rock Type	Lithology/Remarks	Well Completion Gray= grout Brown=sand Blue=Bentonite
					0					SVE14 SVE13
					1					
					2					
					3					
					4					
	M	0.5	No		5	0-10		SM	Dark reddish brown silty sand <15% silt. No stain or odor	
					6					
					7					
					8					
					9					
					10					
					11					
	Dry	548	No		12	10-20			Dense light reddish brown silty sand, No staining, slight HC odor	
					13					
					14					
					15

previous borehole BH-34. The wells were installed with a sonic drill rig to depths of 50 feet to 80 feet below ground surface (bgs). Two of the boring locations had SVE wells installed in a nested configuration (SVE-13/SVE-14 and SVE-15/SVE-16). Each nested well contains 15 feet of screen that was separated from the other well inside the boring with a bentonite chip seal and a bentonite grout mixture to prevent short circuiting. The nested configuration was designed to allow greater operational adjustments and ensure influence throughout the entire impacted interval. One of the goals of the pilot test was to confirm the feasibility of the nested wells. Well completion diagrams are included as Attachment 1.

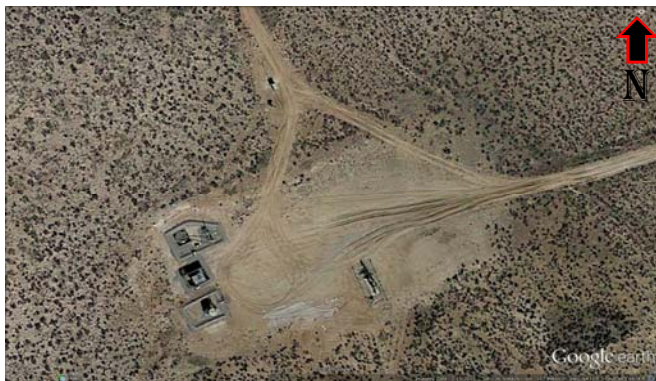
BORING LOG/MONITORING WELL COMPLETION DIAGRAM

Boring/Well Number: BH-34 and SVE 17		Project: OH Randel #5	
Date: 12/15/2018		Project Number: 017818016	
Logged By: EC/JA		Drilled By: Layne	
Drilling Method: Sonic		Sampling Method: Core Barrel	
Seal: 38-41'		Grout: 0-38'	
Diameter: 2"	Length: 0-43'	Hole Diameter: 8"	Depth to Liquid: NA
Diameter: 2"	Length: 58-43'	Total Depth: 76'	Depth to Water: NA

Penetration Resistance	Moisture Content	Vapor (ppm)	HC Staining?	Sample #	Depth (ft. bgs.)	Sample Run	Recovery	Soil/Rock Type	Lithology/Remarks	Well Completion Gray= grout Brown=sand Blue=Bentonite
					0					SVE17
					1					
					2					
	M	0.0	No		3				Dark red/brown silty sand, no stain or odor	
					4					
					5	0-10		SM		
					6					
					7					
	M	0.0	No		8				Dense yellow brown silty sand <30% silt, no stain or odor	
					9					
					10					
					11					
					12					
	M	0.0	No		13	10-15		SP/CL	Dense light gray/white sand w/ some interbedded clay <1", no stain or odor	
					14					
					15

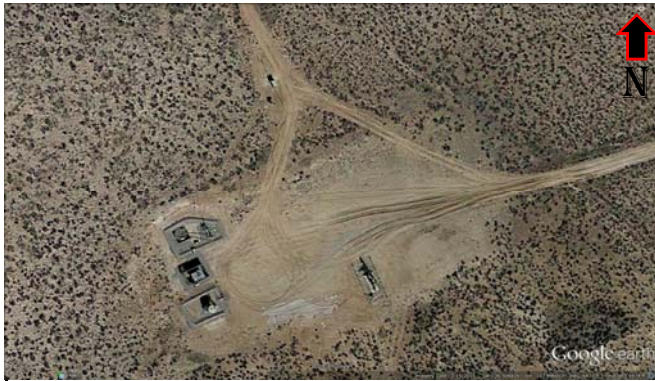
BORING LOG/MONITORING WELL COMPLETION DIAGRAM

Boring/Well Number: BH-37, SVE 15 and SVE 16		Project: OH Randel #5	
Date: 5/09/19 to 5/10/19		Project Number: 017818016	
Logged By: EC/JA		Drilled By: Cascade	
Drilling Method: Sonic		Sampling Method: Core Barrel	
Seal: 30-33', 60-63'		Grout: 0-30', 50-60'	
Diameter: 2"	Length: 0-35', 0-65'	Hole Diameter: 8"	Depth to Liquid: NA
Diameter: 2"	Length: 35-50', 65-80'	Total Depth: 80'	Depth to Water: NA

Penetration Resistance	Moisture Content	Vapor (ppm)	HC Staining?	Sample #	Depth (ft. bgs.)	Sample Run	Recovery	Soil/Rock Type	Lithology/Remarks	Well Completion Gray= grout Brown=sand Blue=Bentonite
					0					SVE16 SVE15
					1					
					2					
	Dry	0.0	No		3	0-5			Compact, reddish brown silty sand	
					4					
					5					
					6					
	M	6.8	No		7				Reddish brown silty sand, white mottling, no stain or odor	
					8	5-10				
					9					
	M	12.3	No		10				Compact, yellow brown silty sand, trace clay <5% no stain/odor	
					11					
					12					
	M	478	No		13	10-15			Light brown coarse sand some silt <15%, HC staining, strong odor	
					14					
					15
