**PIT REMEDIATION AND CLOSURE REPORT**

30-039-21287

Facility Or: SJ 29-6 # 46A  
Well Name

Location: Unit or Qtr/Qtr Sec D Sec 27 T 29 N R 6 W County Rio Arriba

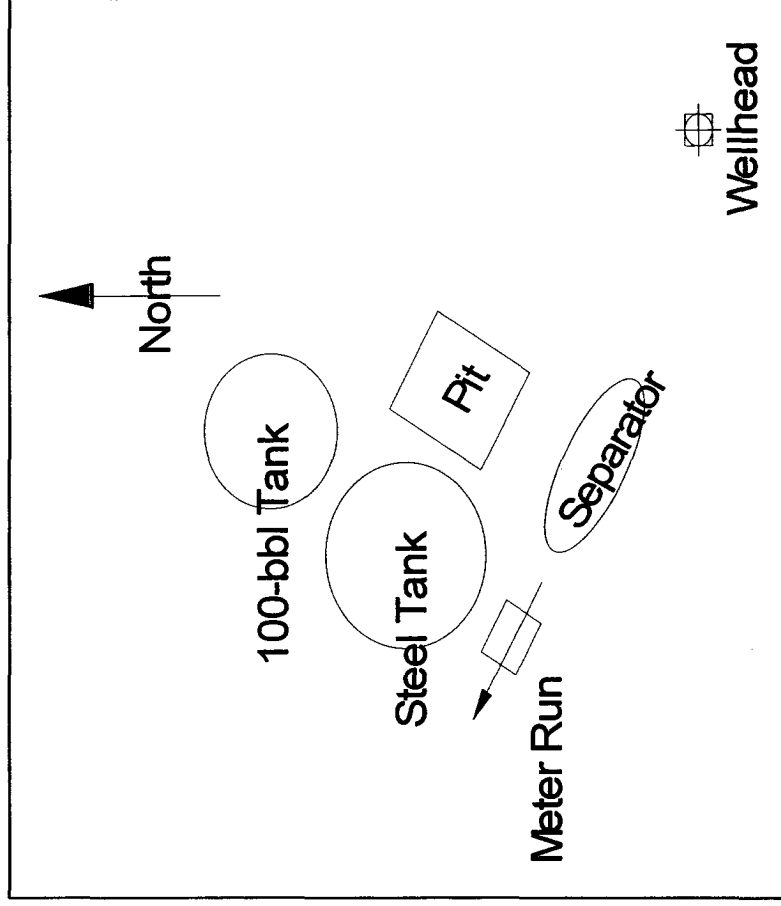
## Site Diagram:

Final Pit: Sample location Soil sample collected from center of pit with hand probe

Sample depth 3-feet below pit bottom

Initial size: 25' X 15' X 3' deep

Final Size: 25' X 15' X 3' deep
