Pit, Below-Grade Tank, or
Proposed Alternative Method Permit or Closure Plan Application

1.
Operator: Burlington Resources OGRID #: 14538
Address: PO BOX 4289, Farmington, NM 87499
Facility or well name: Kattler 1
API Number: 3004508844 OCD Permit Number: _____
U/L or Qtr/Qtr C (NENW) Section 2 Township 29N Range 12W County: San Juan
Center of Proposed Design: Latitude 36.75908000 °N Longitude -107.07066000 °W NAD: ☒ 1927 ☐ 1983
Surface Owner: ☐ Federal ☐ State ☒ Private ☐ Tribal Trust or Indian Allotment

Burlington Resources Oil Gas Company, LP
San Juan Basin
Below Grade Tank Closure Report
(Without Reclamation)

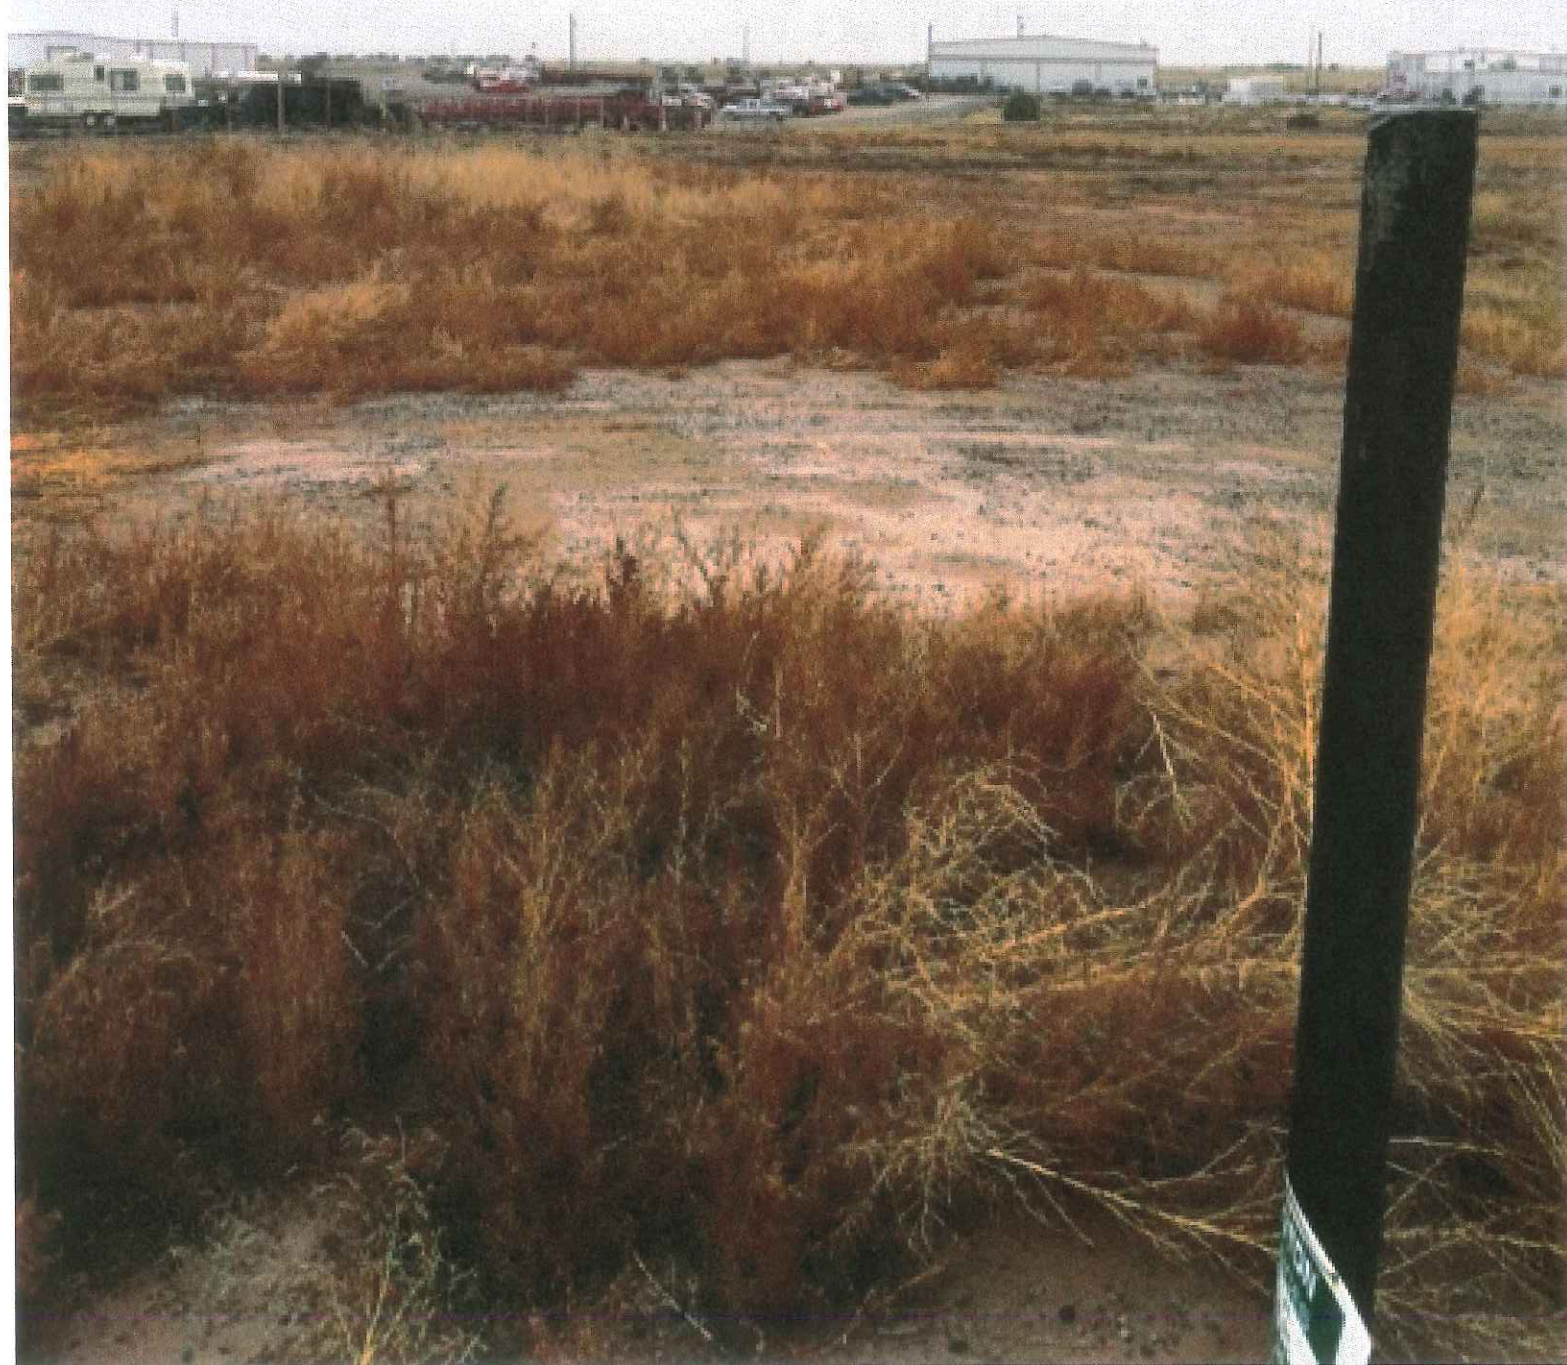
BURLINGTON
RESOURCES
KATTLER #1
FORMATION FC
LATITUDE N 36° 45.5
LONGITUDE W 108° 4.29
990' FNL 1650' FWL
SEC. 02 T029N R012W
LEASE NO. FEE ELEV 5855
API NO. 30-045-08844
SAN JUAN COUNTY, NEW MEXICO
BURLINGTON RESOURCES 10001 336-0177
