Burlington Resources Oil Gas Company, LP San Juan Basin Below Grade Tank Closure Report

Lease Name: Grenier 13 API No.: 30-045-10483

Below Grade Tank Closure Report

Grenier #13

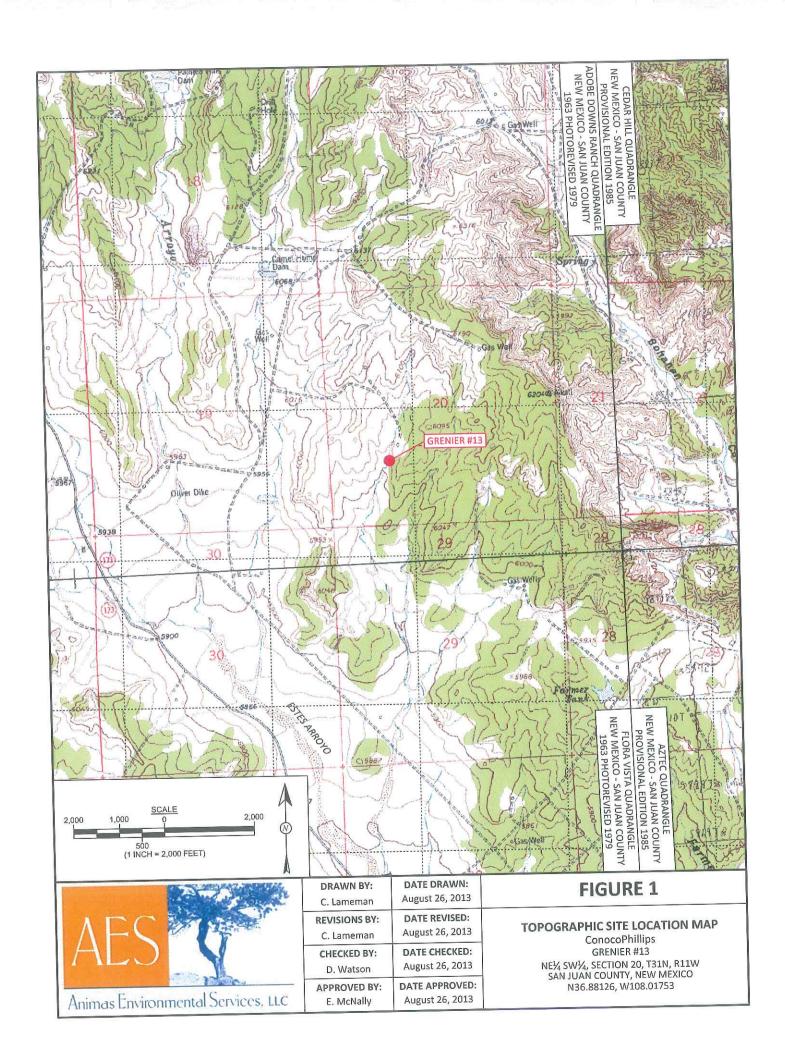
Site Name – Grenier #13
Legal Description – NE¼ SW¼, Section 20, T31N, R11W, San Juan County, New Mexico Well Latitude/Longitude – N36.88126 and W108.01753, respectively BGT Latitude/Longitude – N36.88152 and W108.01750, respectively Land Jurisdiction – Bureau of Land Management (BLM)
Figure 1. Topographic Site Location Map Figure 2. Aerial Site Map, August 2013

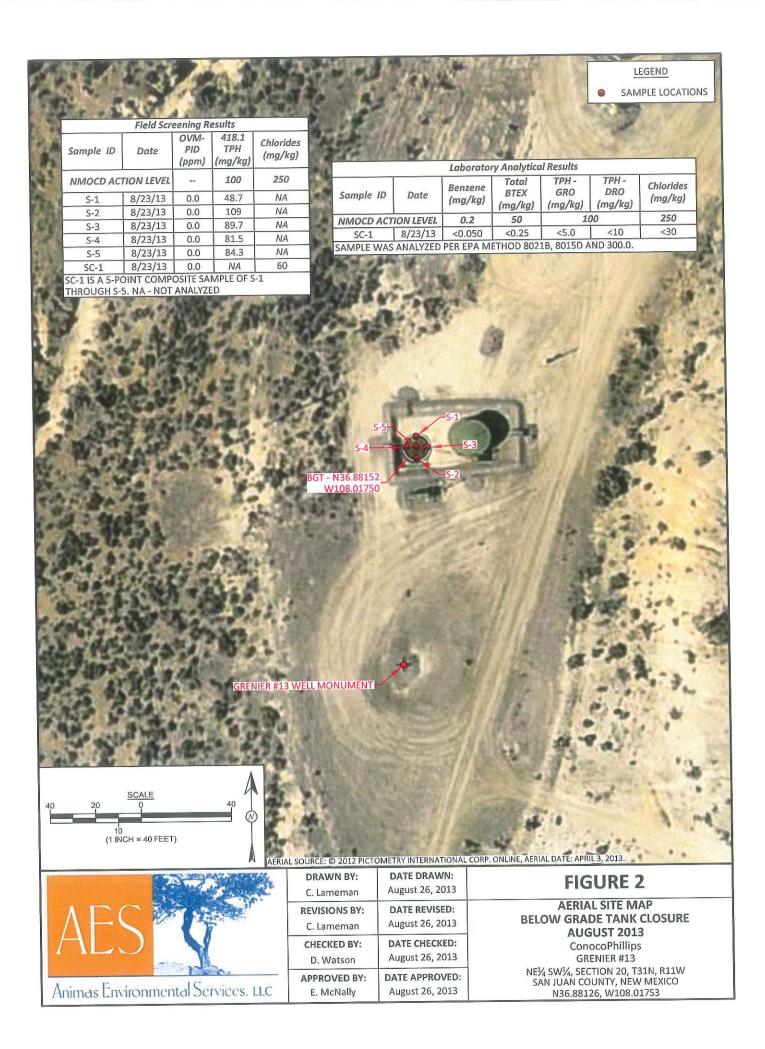
On August 23, 2013, AES personnel conducted field screening and collected five soil samples (S-1 through S-5) and one 5-point composite (SC-1) from below the BGT. Soil samples were collected from approximately 0.5 feet below the former BGT for field screening of volatile organic compounds (VOCs) and total petroleum hydrocarbon (TPH). Soil sample SC-1 was field screened for VOCs and chloride and was submitted for confirmation laboratory analysis. Soil sample locations are included on Figure 2.

Field screening readings for VOCs via OVM were 0.0 ppm in all samples. Field TPH concentrations ranged from 48.7 mg/kg in S-1 up to 109 mg/kg in S-2. The field chloride concentration in SC-1 was 60 mg/kg. Field screening results are summarized in Table 1 and presented on Figure 2. The AES Field Screening Report is attached.

Laboratory analytical results reported benzene and total BTEX concentrations in SC-1 as less than 0.050 mg/kg and 0.25 mg/kg, respectively. TPH concentrations as GRO and DRO were reported at less than 5.0 mg/kg and 10 mg/kg, respectively. The laboratory chloride concentration was reported below the laboratory detection limit of 30 mg/kg. Laboratory analytical results are summarized in Table 2 and included on Figure 2. Laboratory analytical reports are attached.

NMOCD action levels for BGT closures are specified in New Mexico Administrative Code (NMAC) 19.15.17.13E. Field TPH concentrations exceeded the NMOCD action level of 100 mg/kg in one sample, S-1, with 109 mg/kg. However, laboratory analytical results for TPH (as GRO/DRO) in SC-1 were reported below the NMOCD action level of 100 mg/kg). Benzene and total BTEX concentrations in SC-1 were below the NMOCD action levels of 0.2 mg/kg and 50 mg/kg, respectively. Chloride concentrations in SC-1 were below the NMOCD action level of 250 mg/kg. Based on field screening and laboratory analytical results for benzene, total BTEX, TPH, and chlorides, no further work is recommended at Grenier #13.
