# Burlington Resources Oil Gas Company, LP San Juan Basin Below Grade Tank Closure Report

Lease Name: Atlantic C 4B API No.: 30-045-29298

**Below Grade Tank Closure Report**

Atlantic C #4B

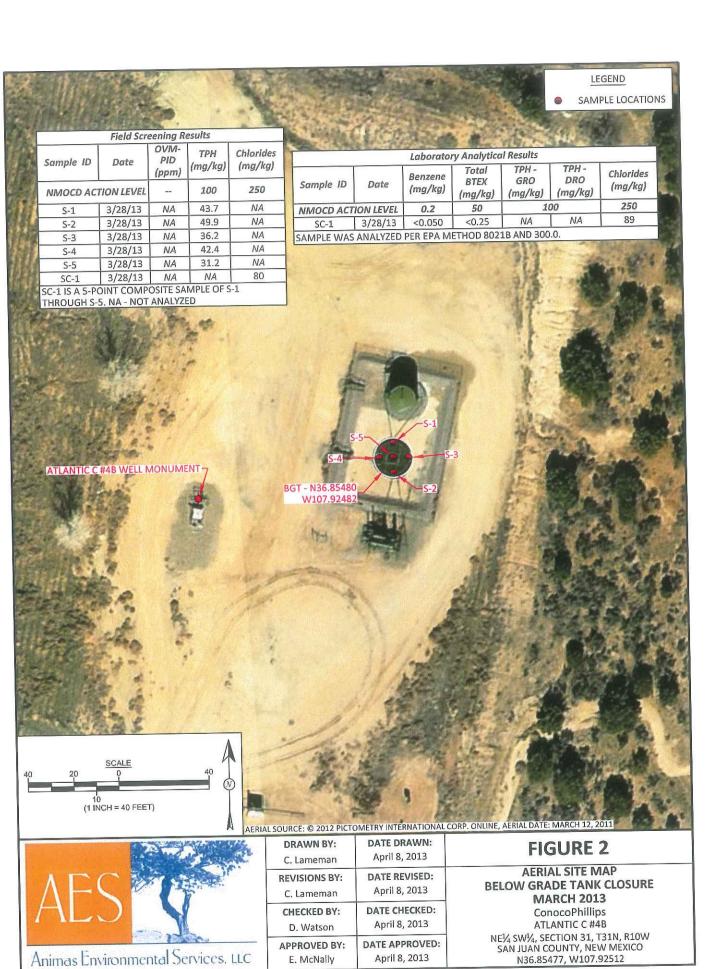
On March 28, 2013, AES personnel conducted field screening and collected five soil samples (S-1 through S-5) and one 5-point composite (SC-1) from below the BGT. Soil samples were collected from approximately 0.5 feet below the former BGT for field screening of total petroleum hydrocarbon (TPH). Soil sample SC-1 was field screened for chloride and was submitted for confirmation laboratory analysis. Soil sample locations are included on Figure 2.

Field TPH concentrations ranged from 31.2 mg/kg in S-5 up to 49.9 mg/kg in S-2. The field chloride concentration in SC-1 was 80 mg/kg. Field screening results are summarized in Table 1 and presented on Figure 2. The AES Field Screening Report is attached.

Laboratory analytical results reported benzene and total BTEX concentrations in SC-1 as less than 0.050 mg/kg and 0.25 mg/kg, respectively. The laboratory chloride concentration was reported at 89 mg/kg. Laboratory analytical results are summarized in Table 2 and included on Figure 2. Laboratory analytical reports are attached.
