Pit, Below-Grade Tank, or
Proposed Alternative Method Permit or Closure Plan Application

Burlington Resources Oil & Gas Company, LP
San Juan Basin
Below Grade Tank Closure Report

Lease Name: Chacon Hill 2
API No.: 30-039-22136

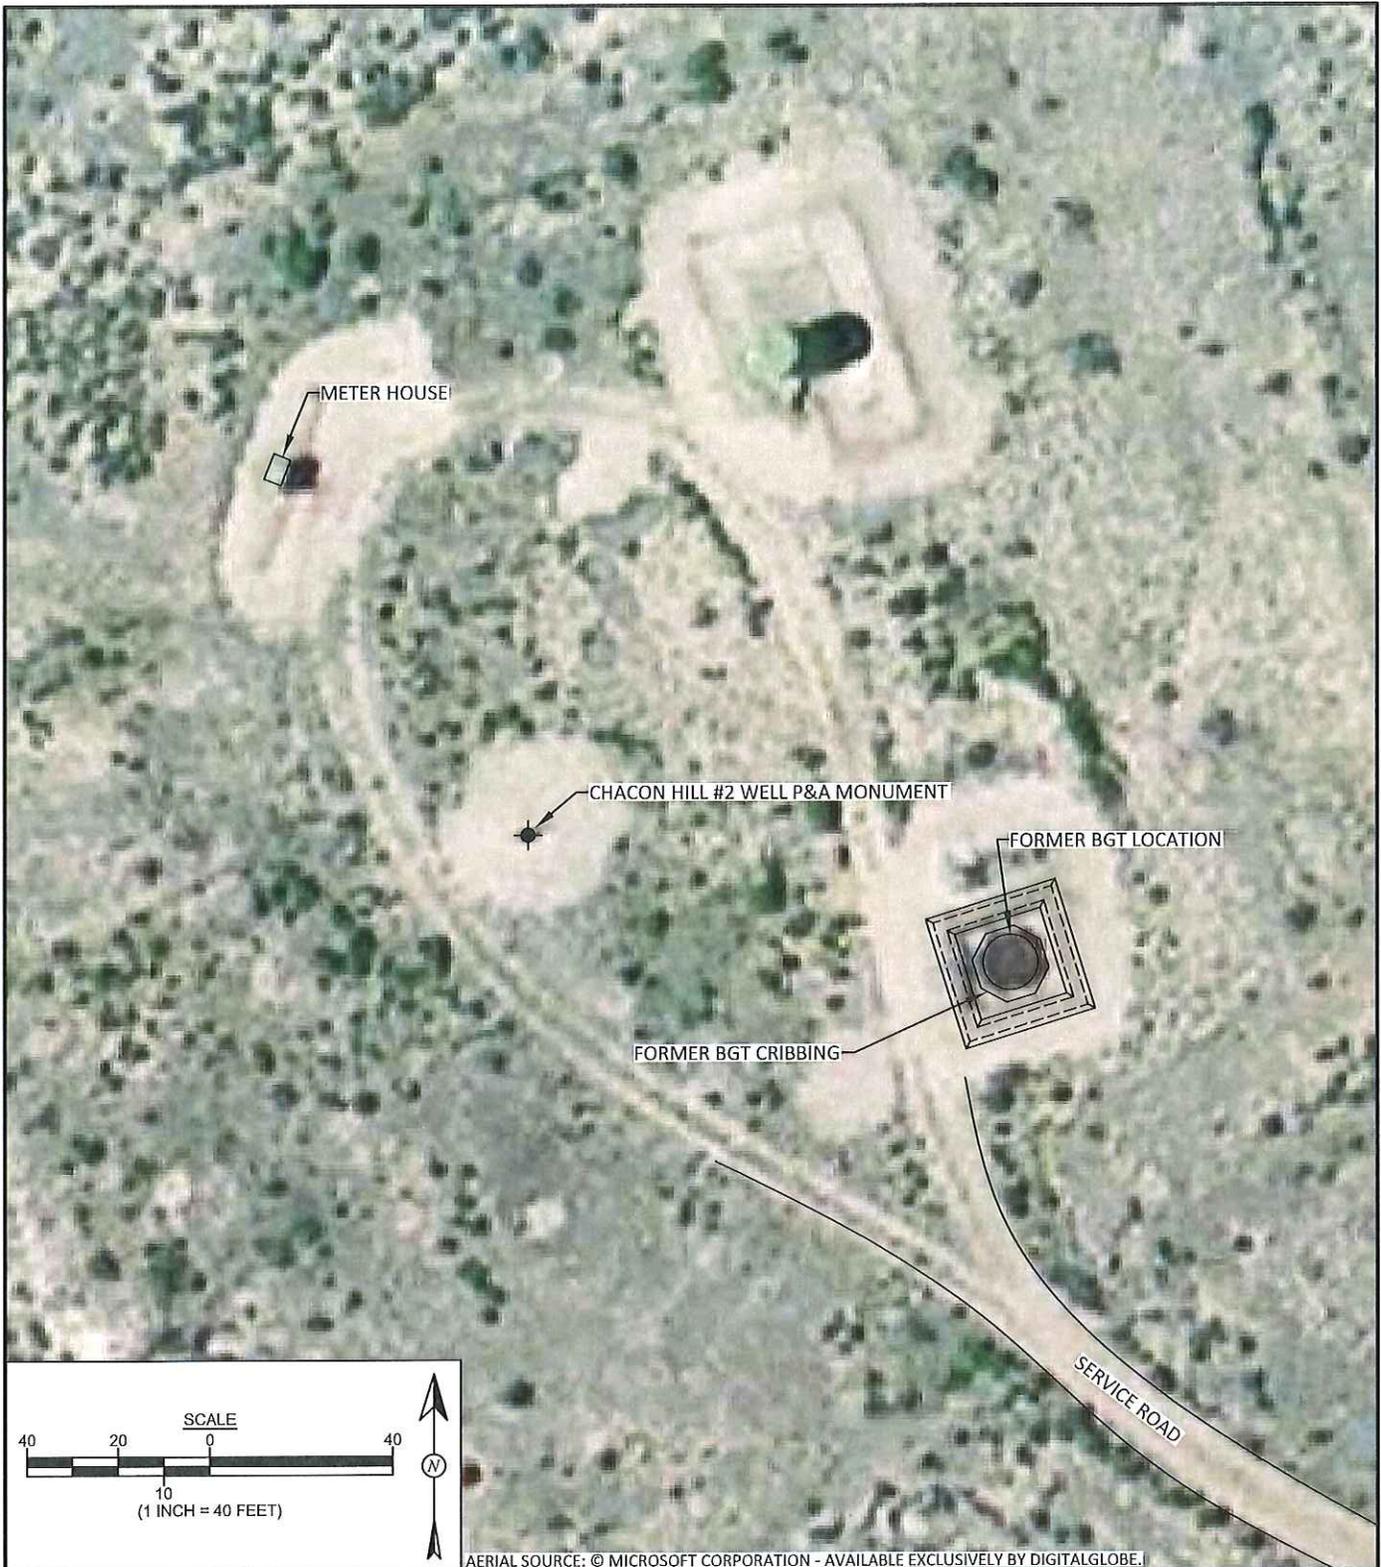
AES was initially contacted by Ashley Maxwell of CoP on August 1, 2012, and on August 7, 2012, Heather Woods and Zachary Trujillo of AES completed the release assessment field work. The assessment included collection and field screening of 44 soil samples (SB-1 through SB-11) from 11 soil borings in and around the release area. Based on the field screening results, AES recommended an area of excavation. Sample locations are shown on Figure 3.

Sample ID	Field Screening Results			TPH (mg/kg)
	Date	Depth (ft)	OVN- PID (ppm)	
SB-1	8/7/12	7	4,110	NA
		10	1,411	NA
		11	113	1,030
SB-2	8/7/12	14	136	266
		16	44.1	117
		6	24.5	NA
		8	349	NA
SB-3	8/7/12	11	20.2	1,230
		14	13.6	94.6
SB-4	8/7/12	6	1.5	NA
		10	3.9	NA
SB-5	8/7/12	12	4.1	108
		6	3.5	NA
		8	3.2	NA
SB-6	8/7/12	10	18.1	>2,500
		12	6.0	118
SB-7	8/7/12	6	6.0	NA
		8	13.3	NA
SB-8	8/7/12	12	11.5	127
		4	747	NA
SB-9	8/7/12	6	3,859	NA
		8	556	NA
SB-10	8/7/12	10	247	NA
		12	564	1,220
SB-11	8/7/12	2	7.9	NA
		4	10.8	NA
SB-12	8/7/12	7	10.0	NA
		10	6.0	98.5
SB-13	8/7/12	3	5.7	NA
		6	6.2	136
SB-14	8/7/12	2	7.2	NA
		4	8.3	NA
SB-15	8/7/12	2	7.4	NA
		4	8.9	NA
SB-16	8/7/12	6	9.9	NA
		8	8.2	NA
SB-17	8/7/12	10	6.9	117
		12	7.2	NA
SB-18	8/7/12	2	2.5	NA
		4	3.8	NA
SB-19	8/7/12	6	5.3	NA
		8	3.5	NA
SB-20	8/7/12	10	5.2	NA
		12	3.4	135

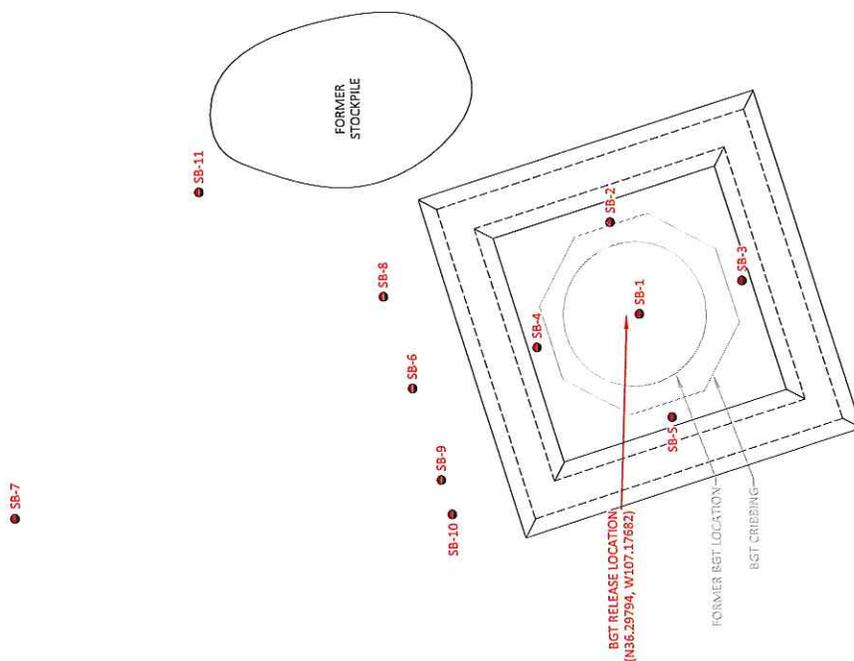
FIGURE 4

**FINAL EXCAVATION SOIL
SAMPLE LOCATIONS AND RESULTS
SEPTEMBER 2012**

Sample ID	Date	Depth (ft)	TPH- GHO (mg/kg)	TPH- DNO (mg/kg)
			NMOC ACTION LEVEL 100	100
SC-6	9/11/12	1 to 12	<5.0	25
SC-7	9/11/12	1 to 12	<5.0	<9.9

ALL SAMPLES WERE ANALYZED PER EPA METHOD 8015B.

Based on the final field screening results of the excavation of petroleum contaminated soils at the Chacon Hill #2, VOC and TPH concentrations were below applicable NMOCD action levels for each of the sidewalls and the base of the excavation. No further work is recommended.
