Pit, Below-Grade Tank, or
Proposed Alternative Method Permit or Closure Plan Application

Release Notification and Corrective Action

**RE: Initial Release Assessment and Final Excavation Report
San Juan 27-4 Com #137
Rio Arriba County, New Mexico**

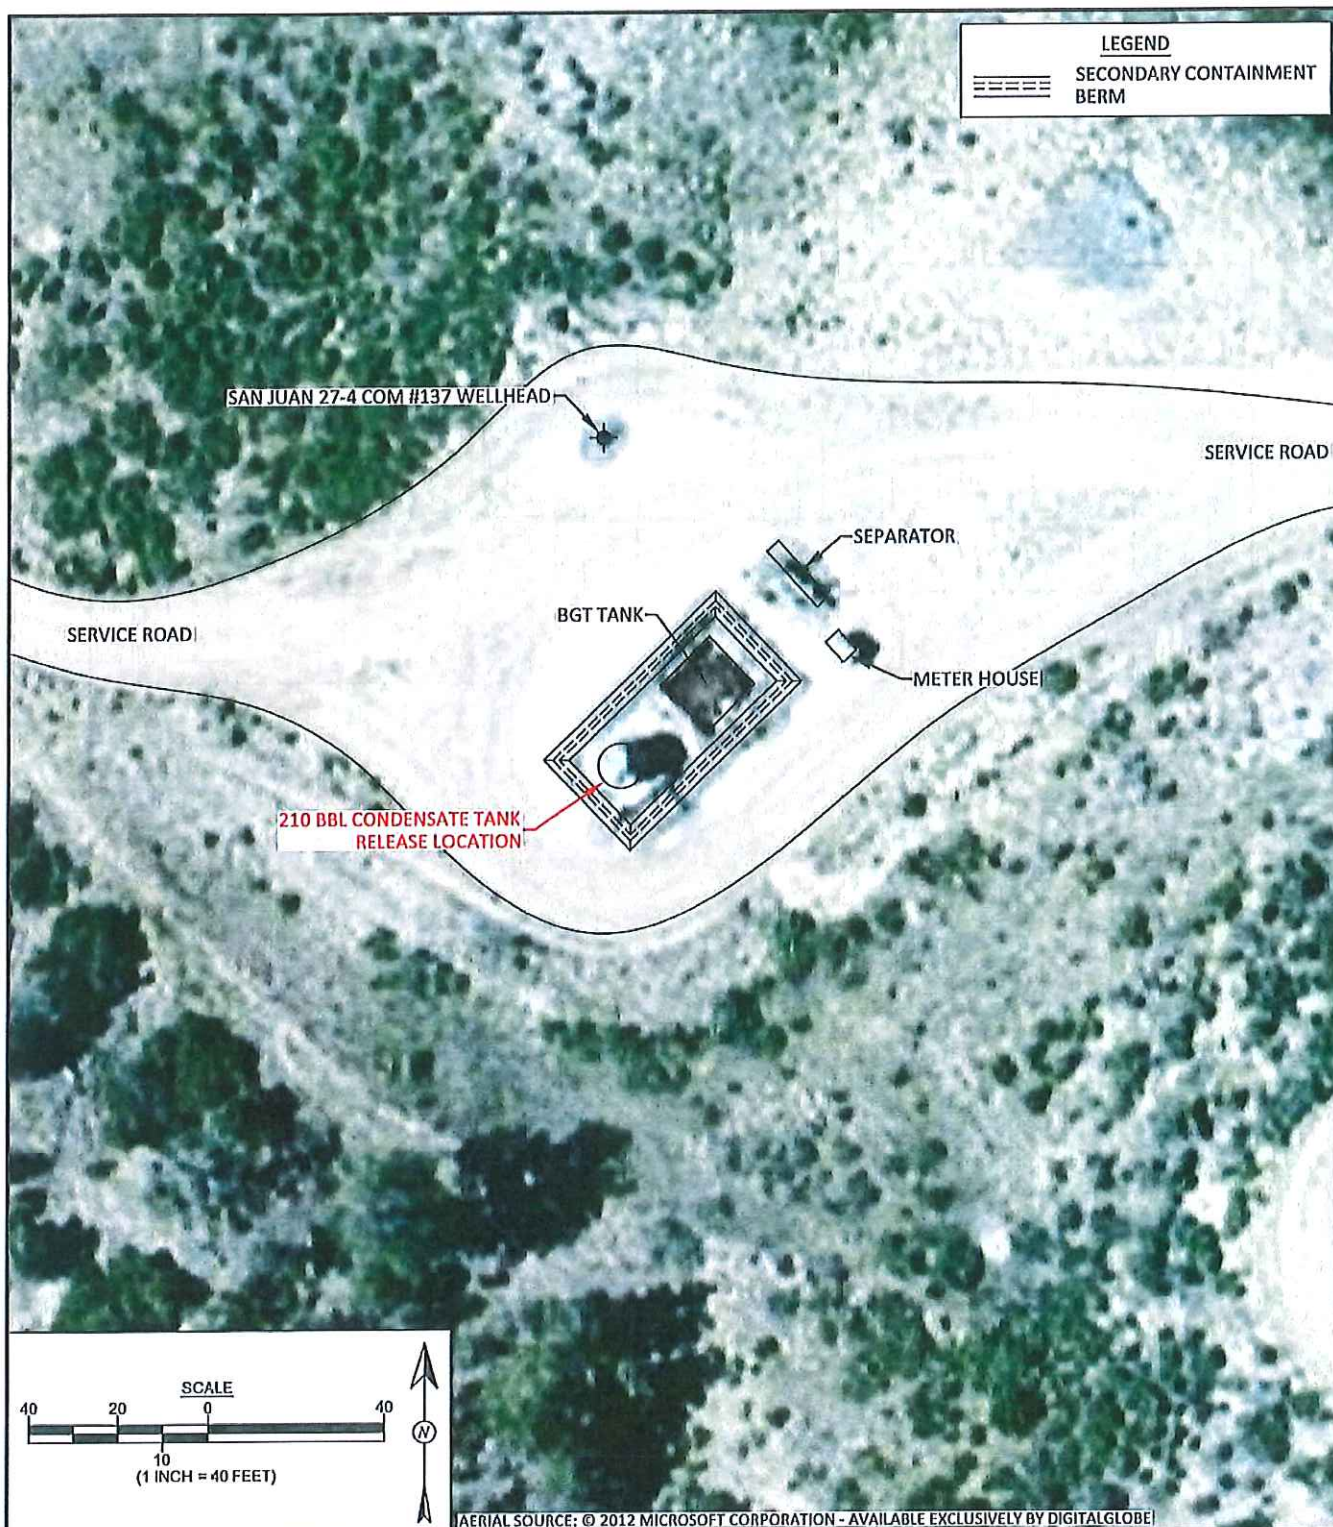
SAN JUAN 27-4 COM #137
WELL MONUMENT
