Pit, Below-Grade Tank, or
Proposed Alternative Method Permit or Closure Plan Application

Facility or well name: HUERFANO UNIT #15

Burlington Resources Oil Gas Company, LP
San Juan Basin
Below Grade Tank Closure Report

Lease Name: HUERFANO UNIT #15
API No.: 30-045-06187

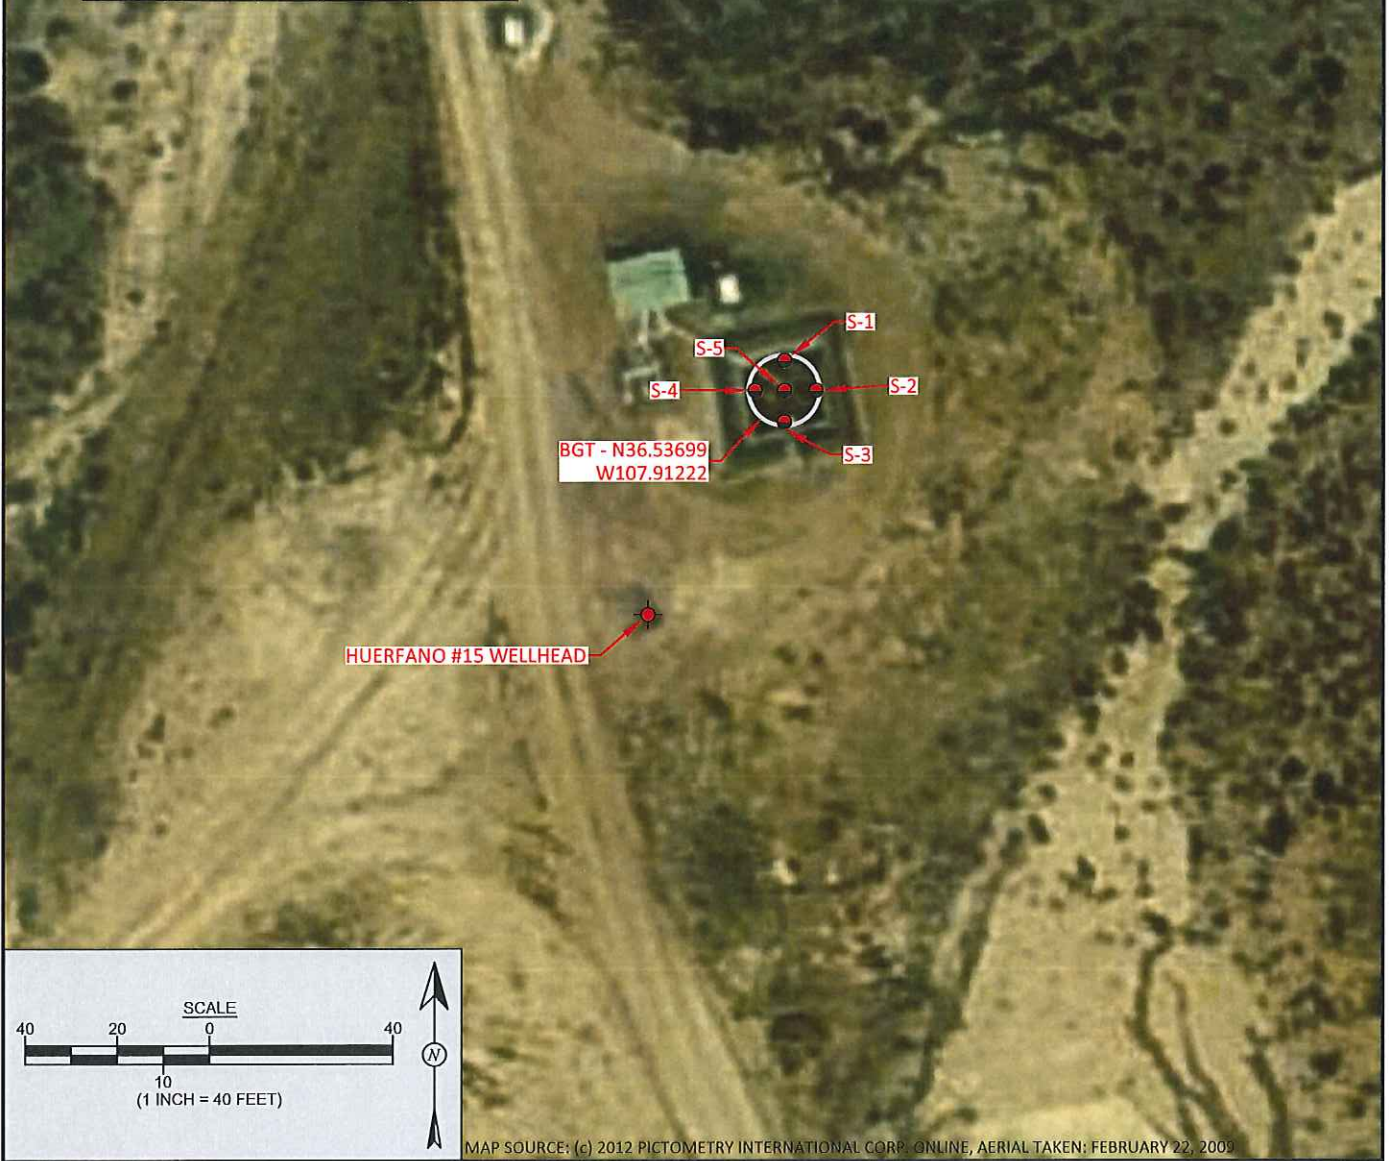
LABORATORY ANALYTICAL RESULTS						
SAMPLE ID	DATE	BENZENE (mg/kg)	TOTAL BTEX (mg/kg)	TPH - GRO (mg/kg)	TPH - DRO (mg/kg)	CHLORIDES (mg/kg)
NMOCD ACTION LEVEL		0.2	50	100		250
SC-1	3/20/12	<0.10	<0.50	<10	680	230

NOTE: ALL SAMPLES WERE ANALYZED PER EPA METHOD 8021B, 8015B AND 300.0. SC-1 IS A 5 POINT COMPOSITE SAMPLE OF S-1 THROUGH S-5.
