Burlington Resources Oil & Gas Company, LP San Juan Basin Below Grade Tank Closure Report

Lease Name: LODEWICK 8 API No.: 30-045-06326

RE: Lodewick #8 Below Grade Tank Closure, Release and Asbestos Sampling Report San Juan County, New Mexico

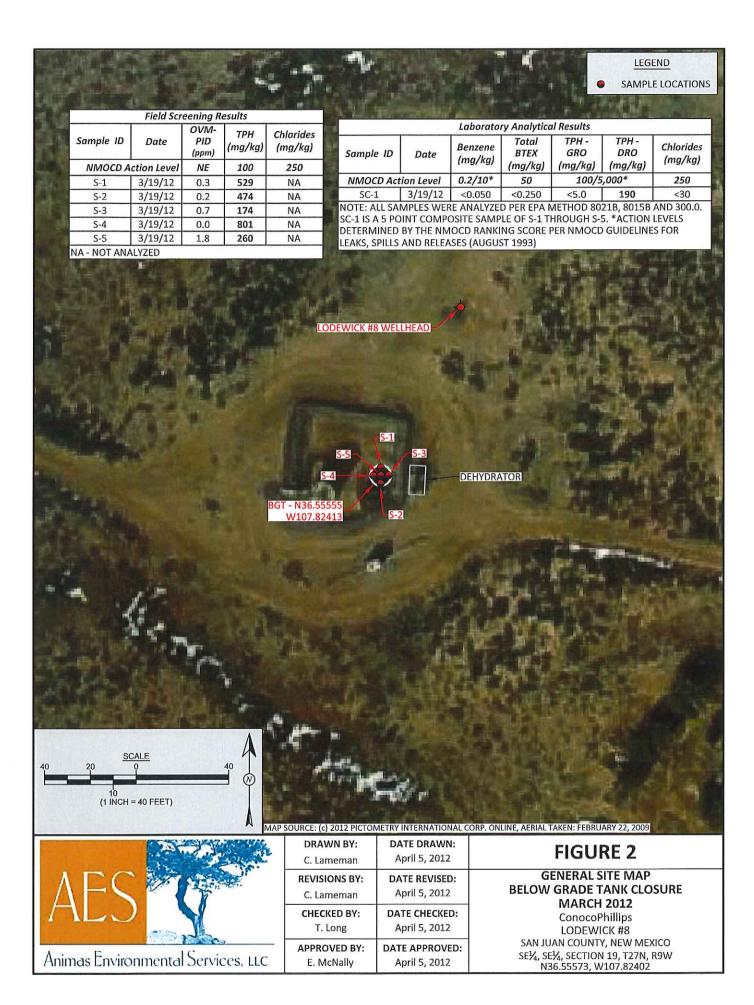
Figure 2 - General Site Map (BGT), March 2012

On March 19, 2012, AES personnel conducted field screening and collected five soil samples (S-1 through S-5) from below the BGT. Soil samples were collected from approximately 0.5 feet below the former BGT for field screening of volatile organic compounds (VOCs) and total petroleum hydrocarbon (TPH). Soil sample locations are included on Figure 2.

Field screening for VOCs via OVM showed readings ranging from 0.0 ppm in S-4 up to 1.8 ppm in S-5. Field TPH concentrations ranged from 174 mg/kg in S-3 up to 801 mg/kg in S-4. Field screening VOC and TPH results are summarized in Table 1 and on Figure 2. The AES field screening report is attached.

Laboratory analytical results for SC-1 showed that the benzene was below the laboratory detection limit of 0.050 mg/kg, and total BTEX concentrations were below the laboratory detection of 0.25 mg/kg. TPH concentrations were reported below the laboratory detection limit of 5.0 mg/kg for GRO; however, 190 mg/kg was reported for DRO. The chloride concentration was also reported below the laboratory detection limit of 30 mg/kg. Laboratory analytical results are summarized in Table 2 and included on Figure 2. Laboratory analytical reports are attached.
