# Burlington Resources Oil & Gas Company, LP San Juan Basin Below Grade Tank Closure Report

Lease Name: Atlantic C 17 API No.: 30-045-23432

RE: Below Grade Tank Closure Report

Atlantic C #17

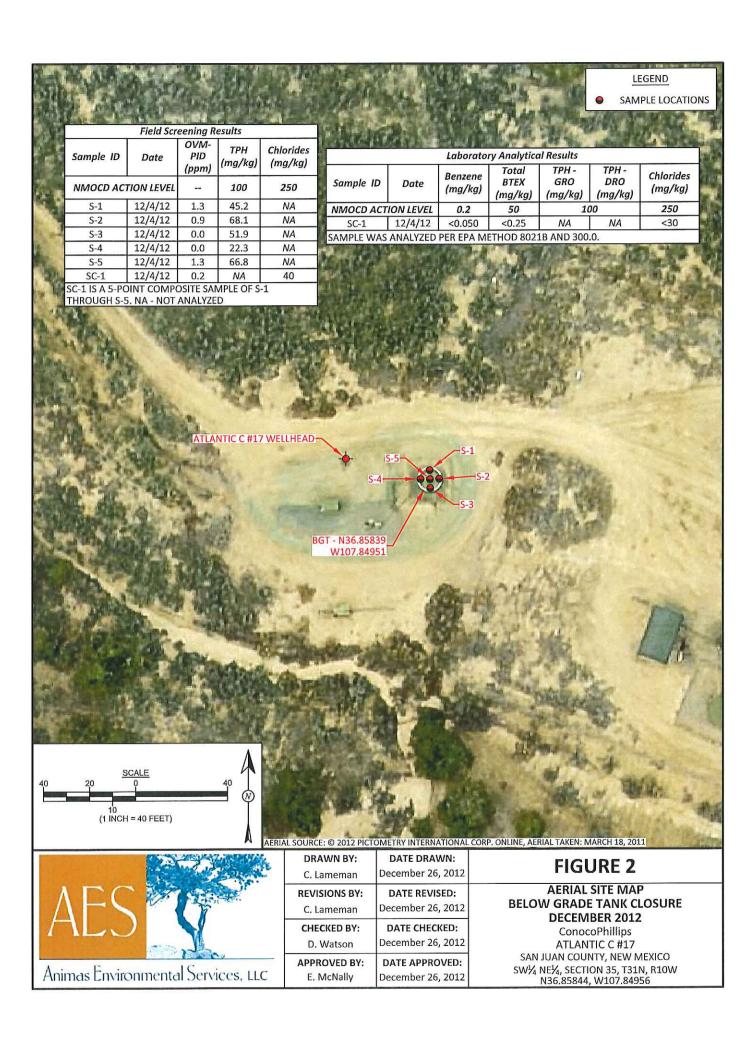
Figure 2. Aerial Site Map, December 2012

On December 4, 2012, AES personnel conducted field screening and collected five soil samples (S-1 through S-5) and one 5-point composite (SC-1) from below the BGT. Soil samples were collected from approximately 0.5 feet below the former BGT for field screening of volatile organic compounds (VOCs) and total petroleum hydrocarbon (TPH). Soil sample SC-1 was field screened for VOCs and chloride and was submitted for confirmation laboratory analysis. Soil sample locations are included on Figure 2.

Field screening readings for VOCs via OVM ranged from 0.0 ppm in S-3 and S-4 up to 1.3 ppm in S-1 and S-5. Field TPH concentrations ranged from 22.3 mg/kg in S-4 up to 68.1 mg/kg in S-2. The field chloride concentration in SC-1 was 40 mg/kg. Field screening results are summarized in Table 1 and presented on Figure 2. The AES Field Screening Report is attached.

Laboratory analytical results reported benzene and total BTEX concentrations in SC-1 as less than 0.050 mg/kg and 0.25 mg/kg, respectively. The laboratory chloride concentration was less than 30 mg/kg. Laboratory analytical results are summarized in Table 2 and included on Figure 2. Laboratory analytical reports are attached.
