Burlington Resources Oil & Gas Company, LP San Juan Basin Below Grade Tank Closure Report

Lease Name: Trail Canyon 101S

RE: Below Grade Tank Closure Report

Trail Canyon #101S

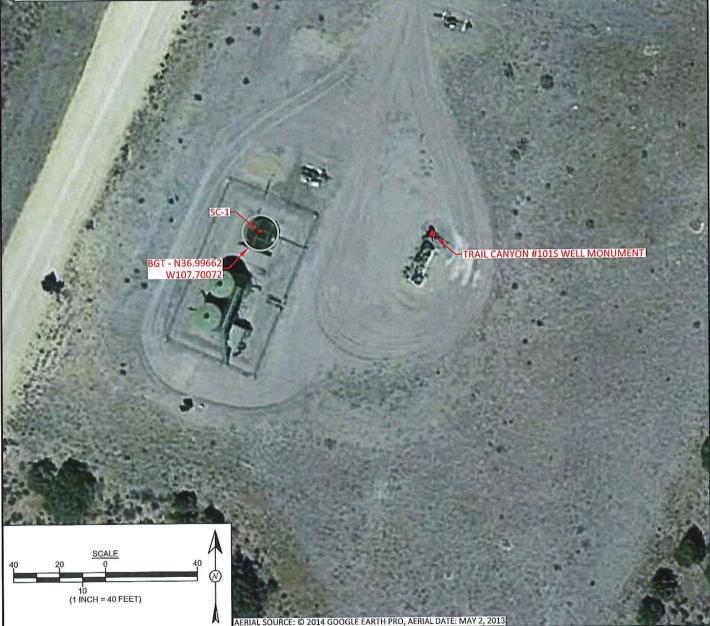
FIGURE 2

On April 16, 2015, AES personnel conducted field sampling and collected one 5-point composite (SC-1) from below the BGT. Soil was collected from approximately 0.5 feet below the former BGT. Soil sample SC-1 was field screened for volatile organic compounds (VOCs), total petroleum hydrocarbon (TPH), and chloride, and was submitted for confirmation laboratory analysis. Soil sample locations are included on Figure 2.

Field screening readings for VOCs via OVM were measured at 0.8 ppm in SC-1. Field TPH concentrations were reported at 45.6 mg/kg. The field chloride concentration was 60 mg/kg. Field sampling results are summarized in Table 1 and presented on Figure 2. The AES Field Sampling Report is attached.

AERIAL SITE MAP BELOW GRADE TANK CLOSURE APRIL 2015
