Burlington Resources Oil & Gas Company, LP San Juan Basin Below Grade Tank Closure Report

Lease Name: San Juan 32-9 Unit 257S

API No.: 30-045-32525

RE: San Juan 32-9 #257S Below Grade Tank Closure Report San Juan County, New Mexico

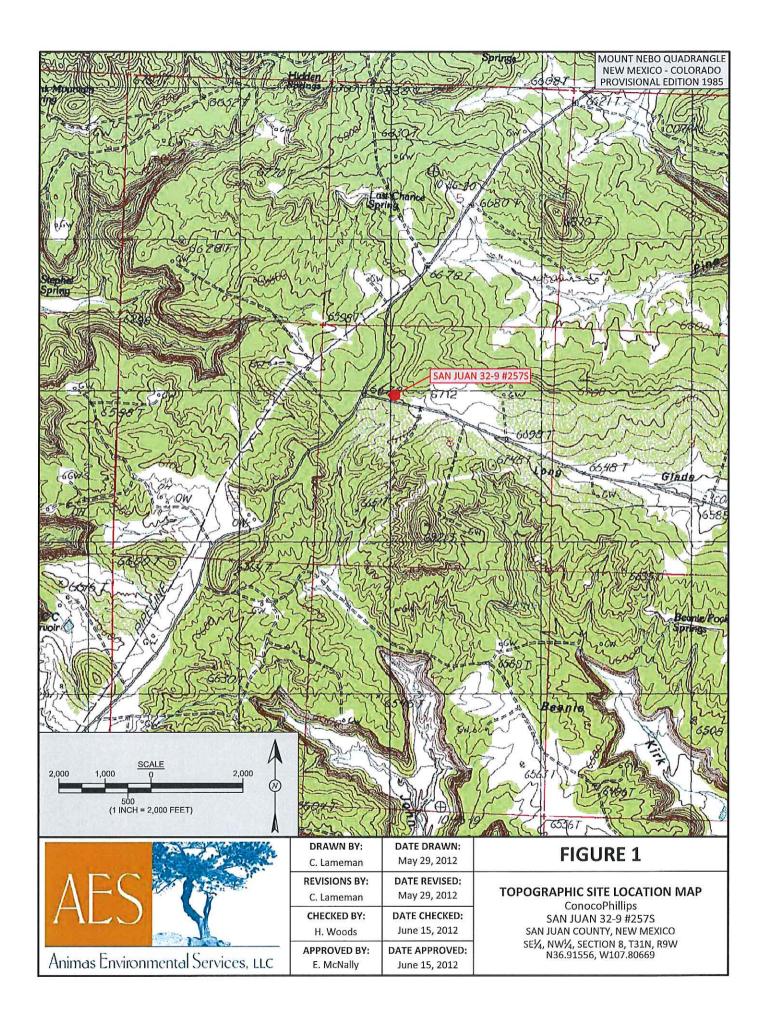
Site Name – San Juan 32-9 #257S
Legal Description - SE¼ NW¼, Section 8, T31N, R9W, San Juan County, New Mexico
Well Latitude/Longitude - N36.91556 and W107.80669, respectively
BGT Latitude/Longitude - N36.91580 and W107.80703, respectively
Land Jurisdiction - Bureau of Land Management (BLM)
Figure 1 – Topographic Site Location Map
Figure 2 – General Site Map, May 2012

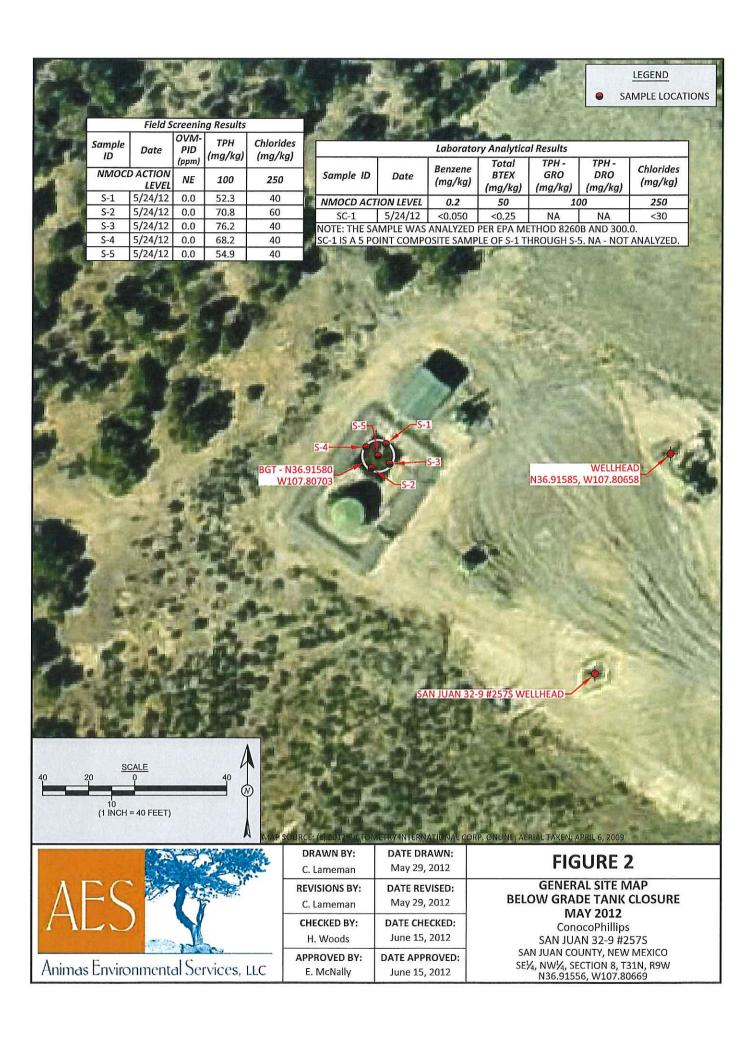
On May 24, 2012, AES personnel conducted field screening and collected five soil samples (S-1 through S-5) and one 5-point composite (SC-1) from below the BGT. Soil samples S-1 through S-5 were collected from approximately 0.5 feet below the former BGT for field screening of volatile organic compounds (VOCs), total petroleum hydrocarbon (TPH), and chlorides. Soil sample SC-1 was submitted for confirmation laboratory analysis. Soil sample locations are included on Figure 2.

Field screening for VOCs via OVM showed readings of 0.0 ppm for all soil samples (S-1 through S-5). Field TPH concentrations ranged from 52.3 mg/kg in S-1 up to 76.2 mg/kg in S-3. Field chloride concentrations were between 40 and 60 mg/kg. Field screening results are summarized in Table 1 and presented on Figure 2. The AES Field Screening Report is attached.

Laboratory analytical results showed that the benzene and total BTEX concentrations in SC-1 were less than 0.050 mg/kg and less than 0.25 mg/kg, respectively. The laboratory chloride concentration was below the laboratory detection limit of 30 mg/kg. Laboratory analytical results are summarized in Table 2 and included on Figure 2. Laboratory analytical reports are attached.

NMOCD action levels for BGT closures are specified in New Mexico Administrative Code (NMAC) 19.15.17.13E. Benzene concentrations in SC-1 were below the laboratory detection limit of 0.050 mg/kg, and total BTEX concentrations were below the NMOCD action level of 50 mg/kg. Field TPH concentrations were below the NMOCD action level of 100 mg/kg in samples S-1 through S-5. Chloride concentrations for all samples were below the NMOCD action level of 250 mg/kg. Based on field screening and laboratory analytical results for benzene, BTEX, TPH, and chlorides, no further work is recommended.
