Pit, Below-Grade Tank, or  
Proposed Alternative Method Permit or Closure Plan Application

**Burlington Resources Oil & Gas Company**  
**San Juan Basin: New Mexico Assets**  
Below Grade Tank Closure Report

**Lease Name:** Pinon Mesa C 2E  
**API No.:** 30-045-26650

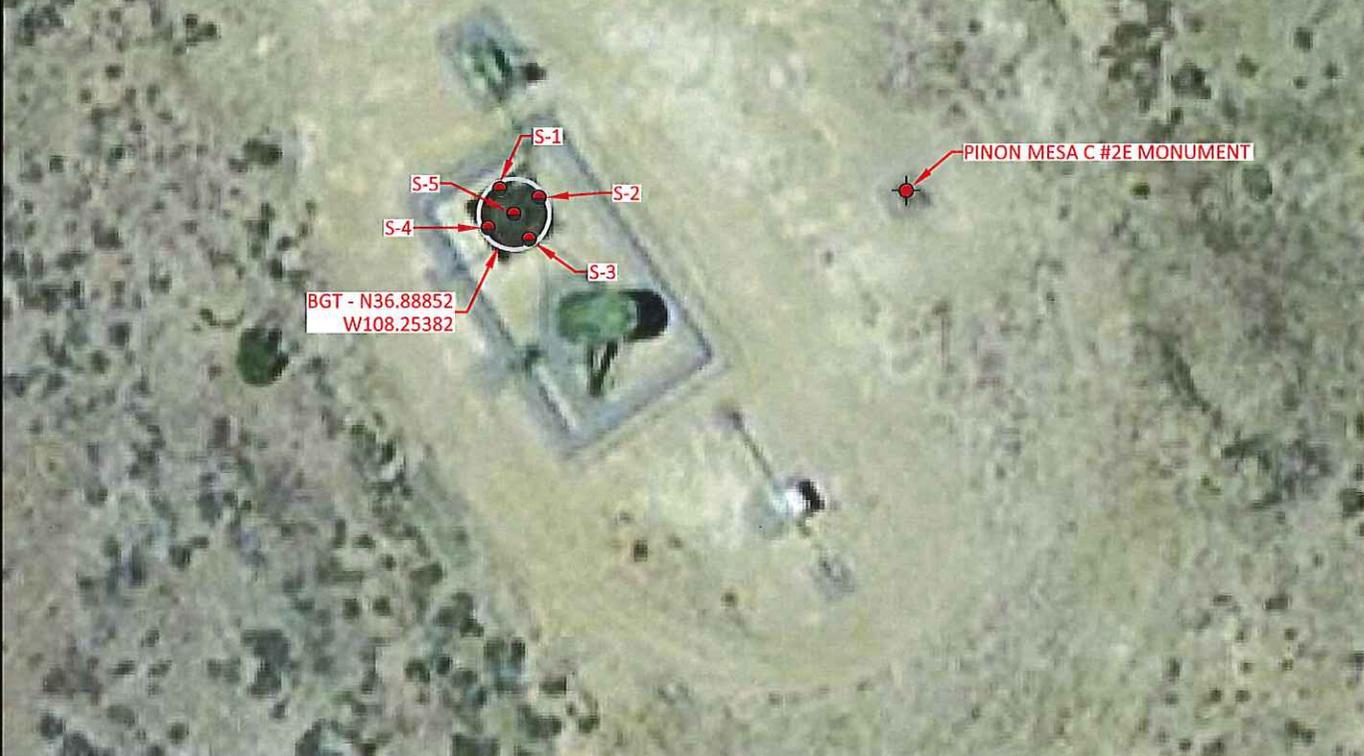
Laboratory Analytical Results						
Sample ID	Date	Benzene (mg/kg)	Total BTEX (mg/kg)	TPH - GRO (mg/kg)	TPH - DRO (mg/kg)	Chlorides (mg/kg)
<b>NMOCD ACTION LEVEL</b>		0.2	50	100		250
SC-1	10/19/12	<0.050	<0.25	NA	NA	80

SAMPLE WAS ANALYZED PER EPA METHOD 8021B AND 300.0.

Describe Area Affected and Cleanup Action Taken.\*  
**The regulatory standard for closure at this site was determined to be 100 ppm. A soil sample was taken and then transported to the lab and analytical results for TPH, BTEX and Chlorides were below the regulatory standards set forth in the NMOCD Guidelines for Remediation of Leaks, Spills and Release; therefore no further action is required. The final report is attached for review.**
