99A Pit, Closed-Loop System, Below-Grade Tank, or Proposed Alternative Method Permit or Closure Plan Application

1.
Operator: BPX ENERGY INC. (formerly BP America Production Co.) OGRID #: 778
Address: 1199 Main Ave., Suite 101, Durango, CO 81301
Facility or well name: GALLEGOS CANYON UNIT 359
API Number: 3004526430 OCD Permit Number: _____
U/L or Qtr/Qtr M Section 10.0 Township 28.0N Range 12W County: San Juan County
Center of Proposed Design: Latitude 36.67228 Longitude -108.10447 NAD: 1927 1983
Surface Owner: Federal State Private Tribal Trust or Indian Allotment

BELOW-GRADE TANK CLOSURE PLAN

Gallegos Canyon Unit # 359 – Tank ID: A
API #: 3004526430
Unit Letter M, Section 10, T28N, R12W

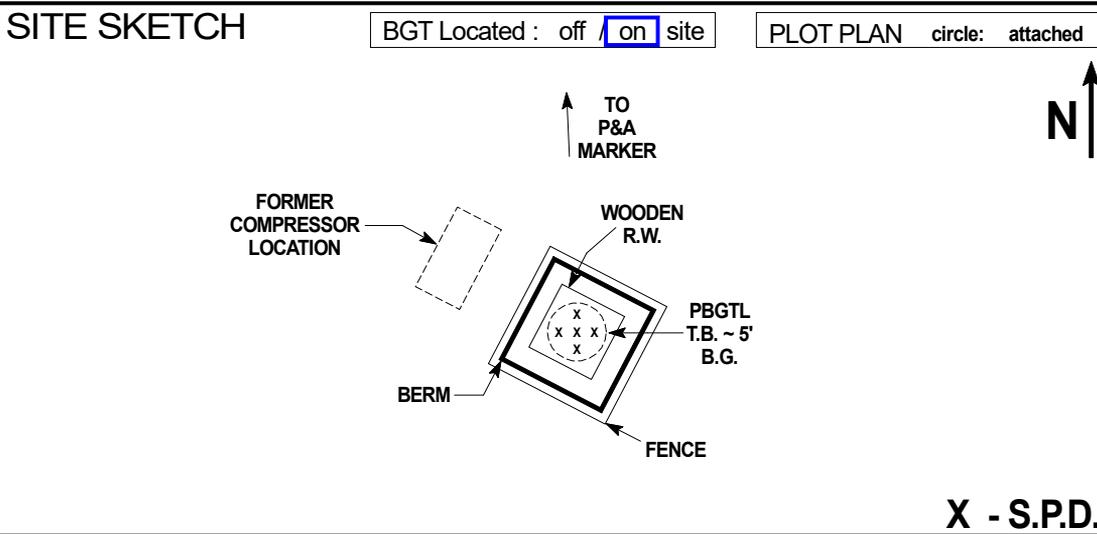
SOIL DESCRIPTION: SOIL TYPE: **SAND** / SILTY SAND / SILT / SILTY CLAY / CLAY / GRAVEL / OTHER _____
SOIL COLOR: **DARK YELLOWISH ORANGE** PLASTICITY (CLAYS): NON PLASTIC / SLIGHTLY PLASTIC / COHESIVE / MEDIUM PLASTIC / HIGHLY PLASTIC
COHESION (ALL OTHERS): **NON COHESIVE** / SLIGHTLY COHESIVE / COHESIVE / HIGHLY COHESIVE DENSITY (COHESIVE CLAYS & SILTS): SOFT / FIRM / STIFF / VERY STIFF / HARD
CONSISTENCY (NON COHESIVE SOILS): LOOSE / **FIRM** / DENSE / VERY DENSE HC ODOR DETECTED: YES **NO** EXPLANATION - _____
MOISTURE: DRY / **SLIGHTLY MOIST** / MOIST / WET / SATURATED / SUPER SATURATED
SAMPLE TYPE: GRAB / **COMPOSITE** # OF PTS. **5** ANY AREAS DISPLAYING WETNESS: YES **NO** EXPLANATION - _____
DISCOLORATION/STAINING OBSERVED: YES **NO** EXPLANATION - _____

SITE OBSERVATIONS: LOST INTEGRITY OF EQUIPMENT: YES **NO** EXPLANATION - _____
APPARENT EVIDENCE OF A RELEASE OBSERVED AND/OR OCCURRED: YES **NO** EXPLANATION: _____
EQUIPMENT SET OVER RECLAIMED AREA: YES **NO** EXPLANATION - _____
OTHER: **NMOC D OR BLM REPS. NOT PRESENT TO WITNESS CONFIRMATION SAMPLING. GAS WELL IS PLUGGED & ABANDONED (P&A).**

EXCAVATION DIMENSION ESTIMATION: **NA** ft. X **NA** ft. X **NA** ft. EXCAVATION ESTIMATION (Cubic Yards): **NA**
DEPTH TO GROUNDWATER: **>100'** NEAREST WATER SOURCE: **>1,000'** NEAREST SURFACE WATER: **300' < x <1,000'** NMOC D TPH CLOSURE STD: **2,500** ppm
