## Release Notification

**RE: Below Grade Tank and Separator Release Closure Report  
Dodd Geiger #1  
API #3004527234  
Incident No. NVF 1900749627  
San Juan County, New Mexico**

Animas Environmental Services, LLC (AES) is pleased to provide the final report associated with the below grade tank (BGT) closure and subsequent confirmed release at the DJR Operating (DJR) Dodd Geiger #1, located in San Juan County, New Mexico. Tank removal had been completed by DJR contractors prior to AES' arrival at the location. Additionally, this report includes the release excavation clearance of the separator at the subject site. The separator had been vandalized which resulted in a minor release.

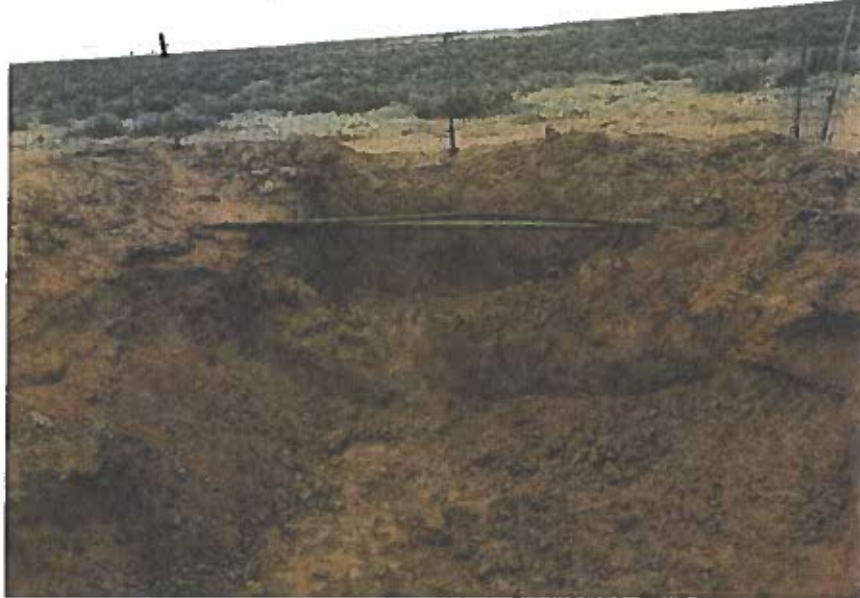
Photo 1: BGT excavation facing northeast. Photo taken December 21, 2018.

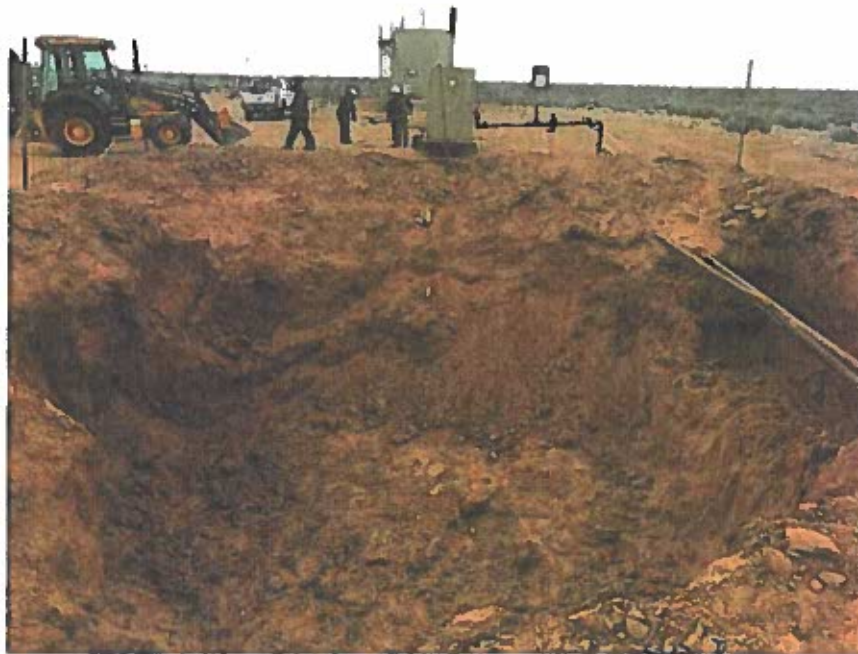
Photo 2: BGT excavation facing northwest towards the separator. Photo taken December 21, 2018.

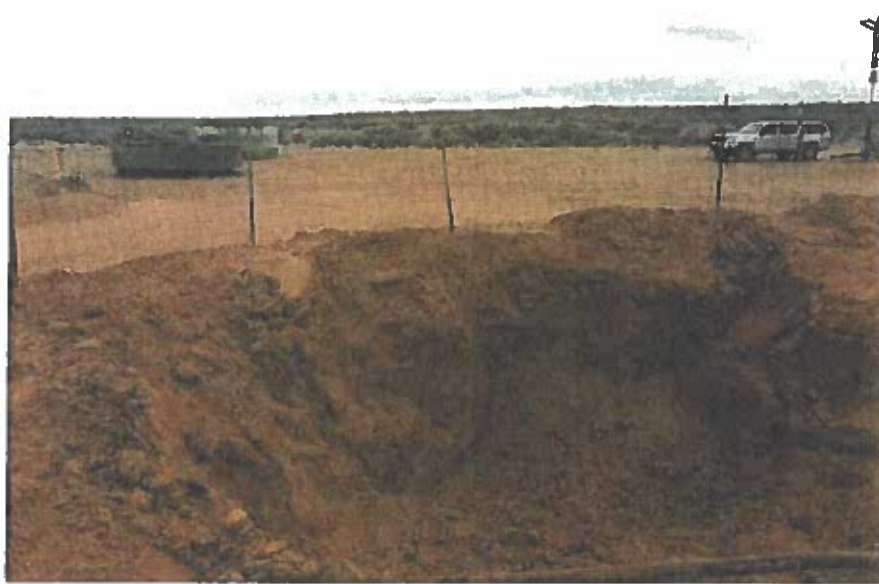
Photo 3: Looking east at BGT excavation. Photo taken December 21, 2018.

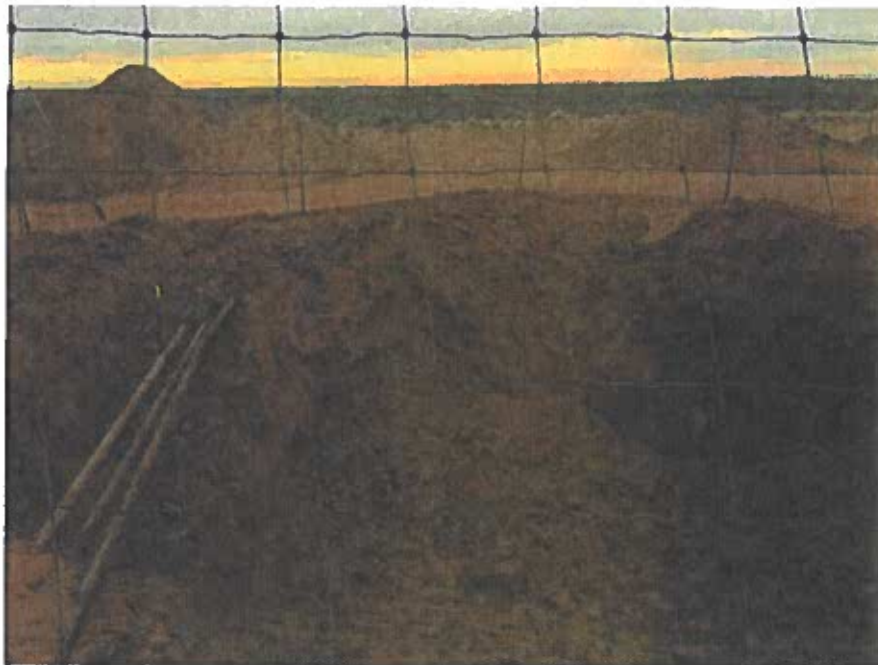
Photo 4: Looking southeast at the BGT excavation. Photo taken December 21, 2018.

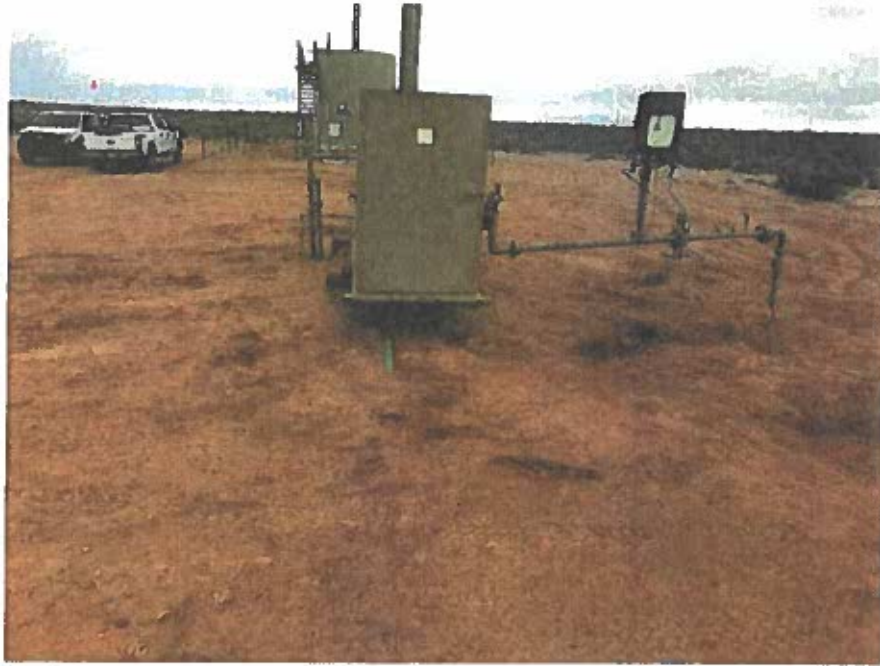
Photo 5: Excavation of surficial soils from separator release. Photo taken December 21, 2018.

The surficial excavation of the separator was re-graded, and the BGT excavation was backfilled with clean soil on January 14, 2019. The well location remains in use and a new aboveground waste tank was installed in the same location as the former BGT; therefore, reseeding was not necessary. No further work is recommended.

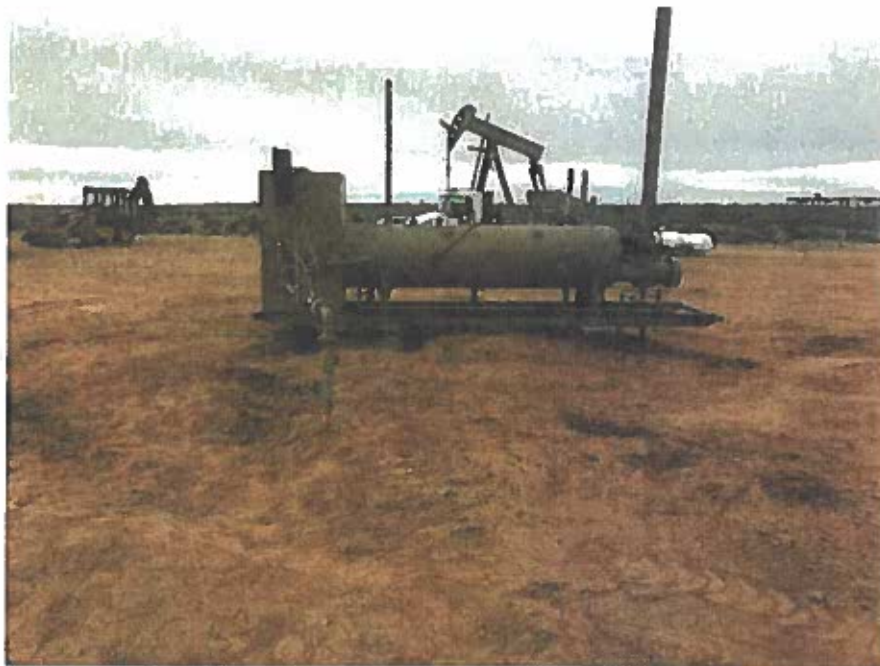
Photo 6: Excavation of surficial soils from separator release. Photo taken December 21, 2018.

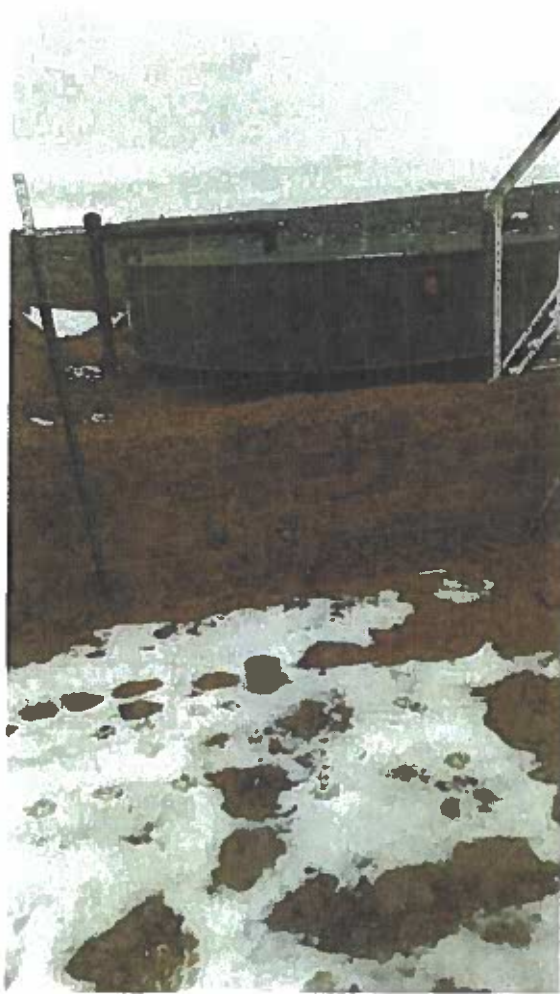
Photo 7: New above ground tank installed in the same location of the former BGT. Photo taken January 14, 2019.
