## Release Notification

| Site Name: Northeast Blanco Unit 477 | Site Type: Natural Gas Production Well Pad |

| <b>FIELD REPORT:</b> | (circle one): BGT CONFIRMATION / <u>RELEASE INVESTIGATION</u> / OTHER: | PAGE #: <u>1</u> of <u>1</u> |

NEBU 477  
(H) Sec 29 - T30N - R7W  
API: 30-039-24448

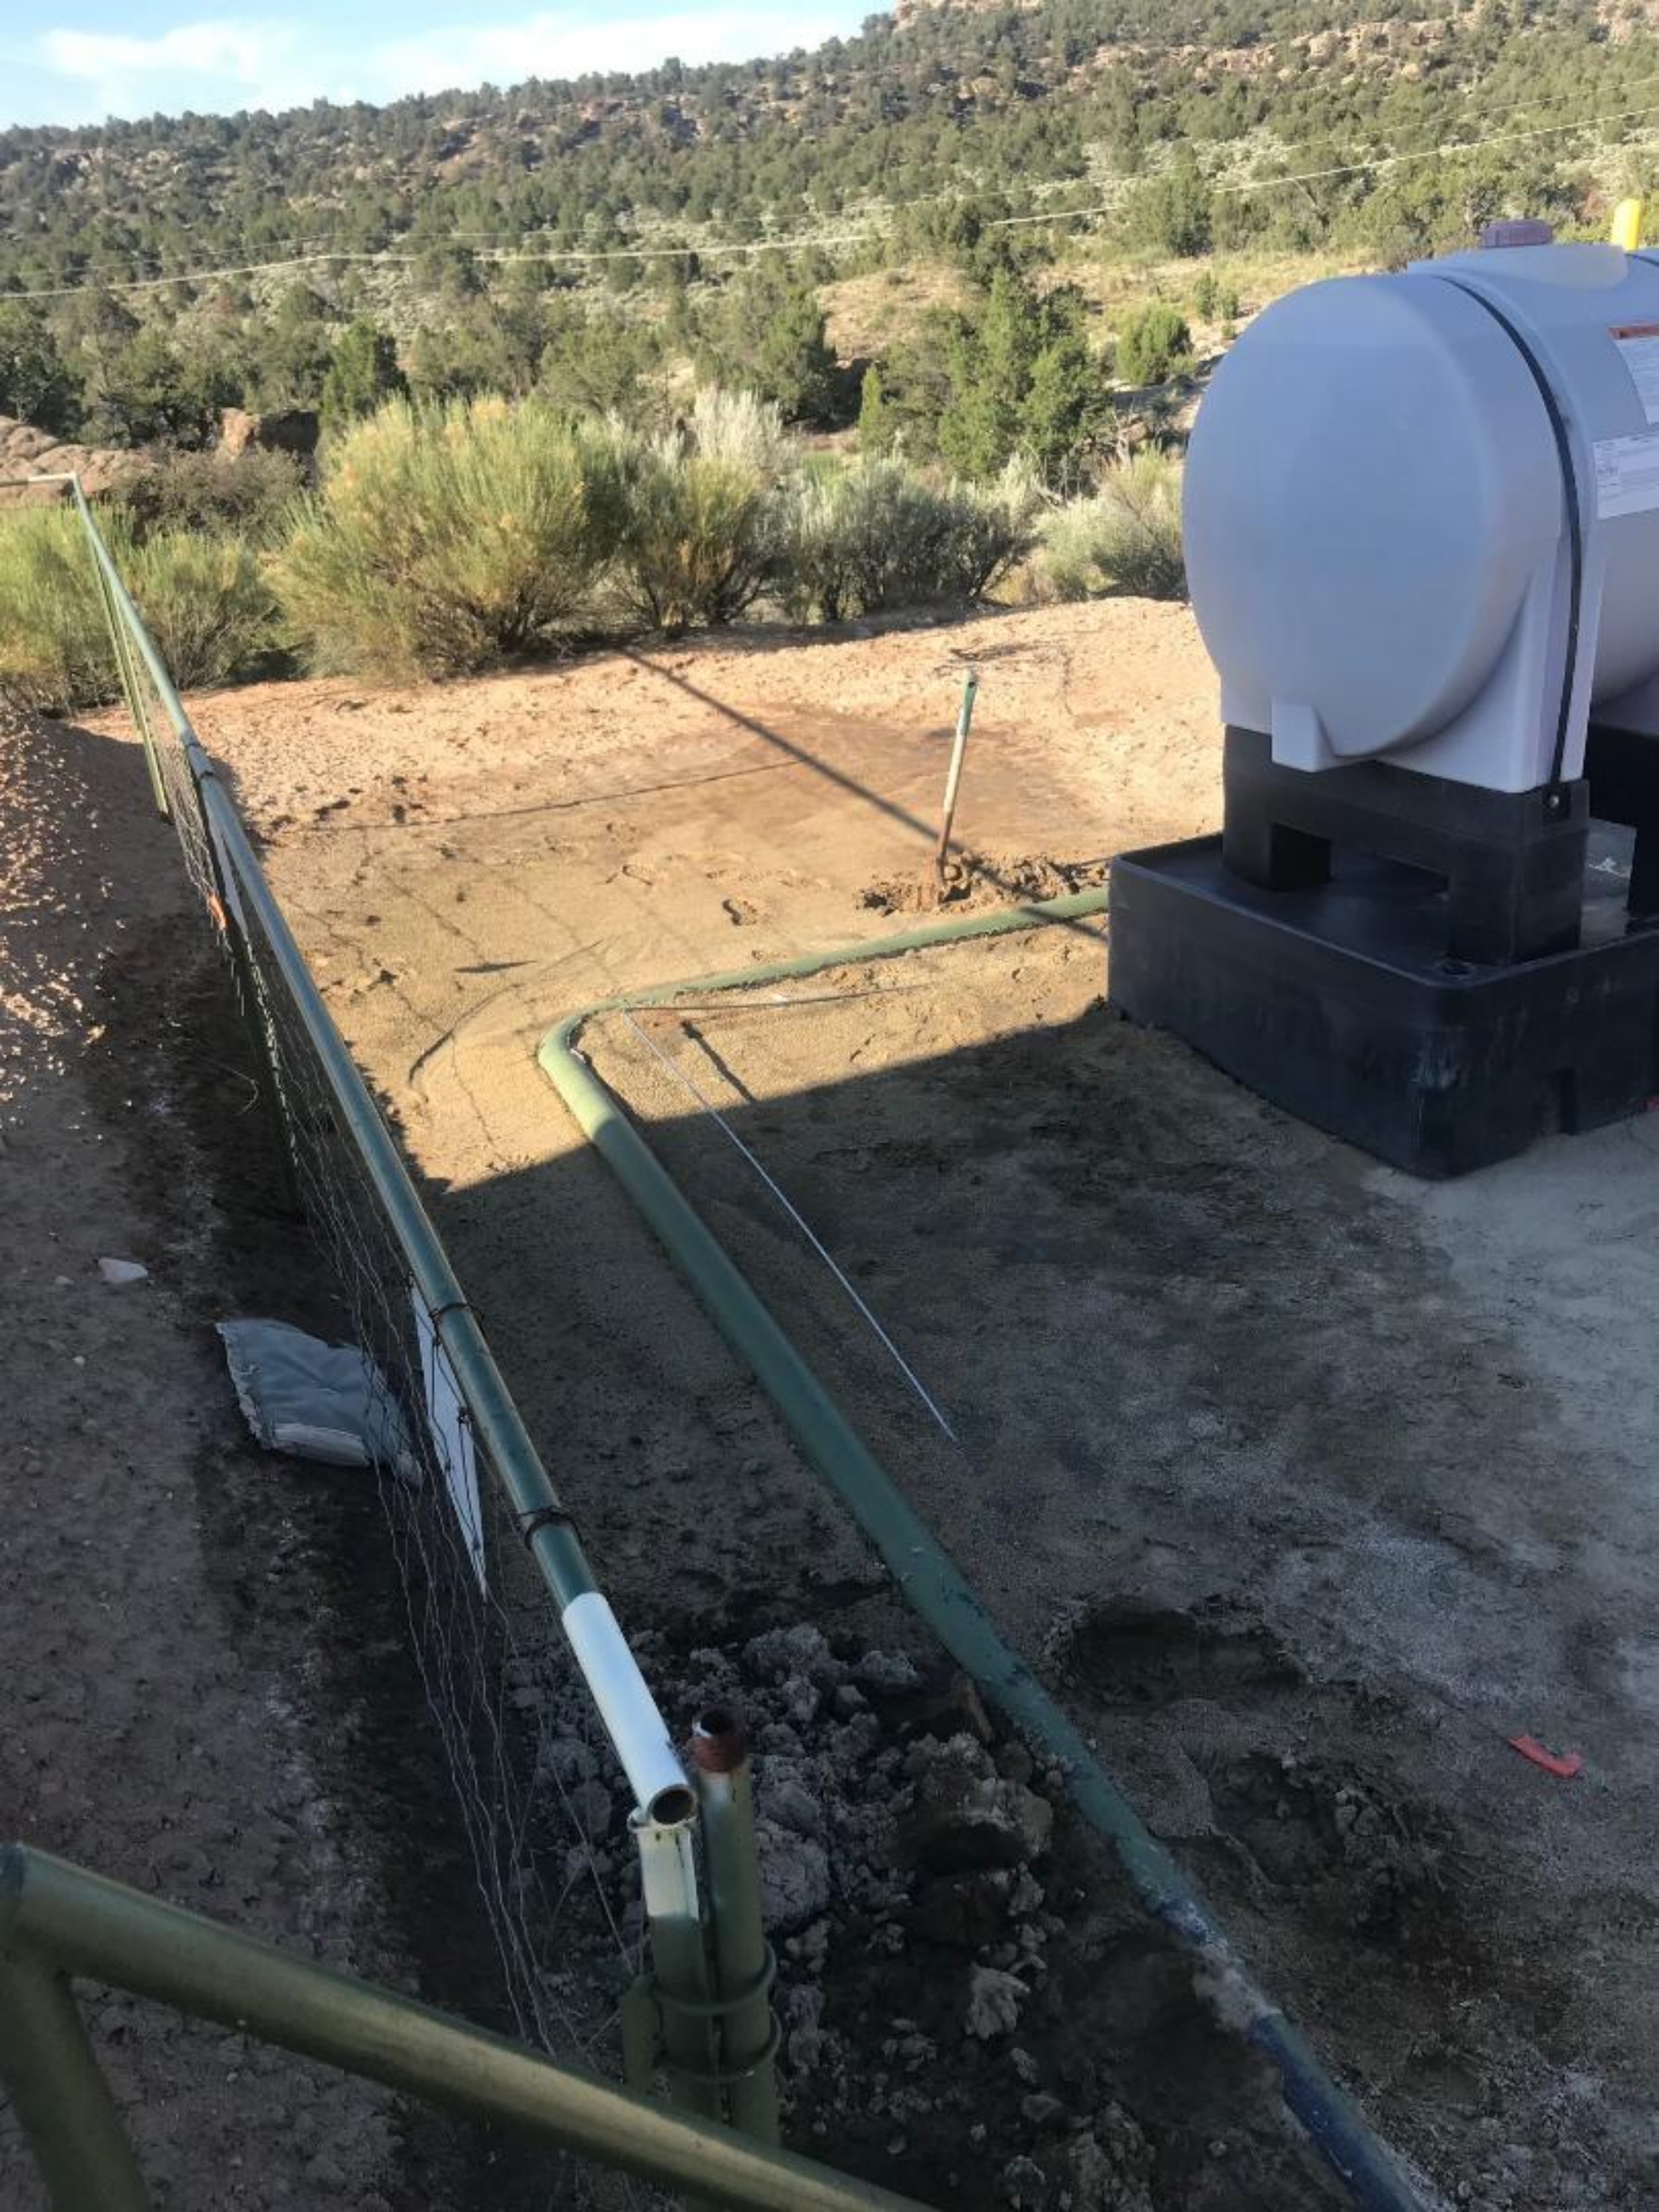
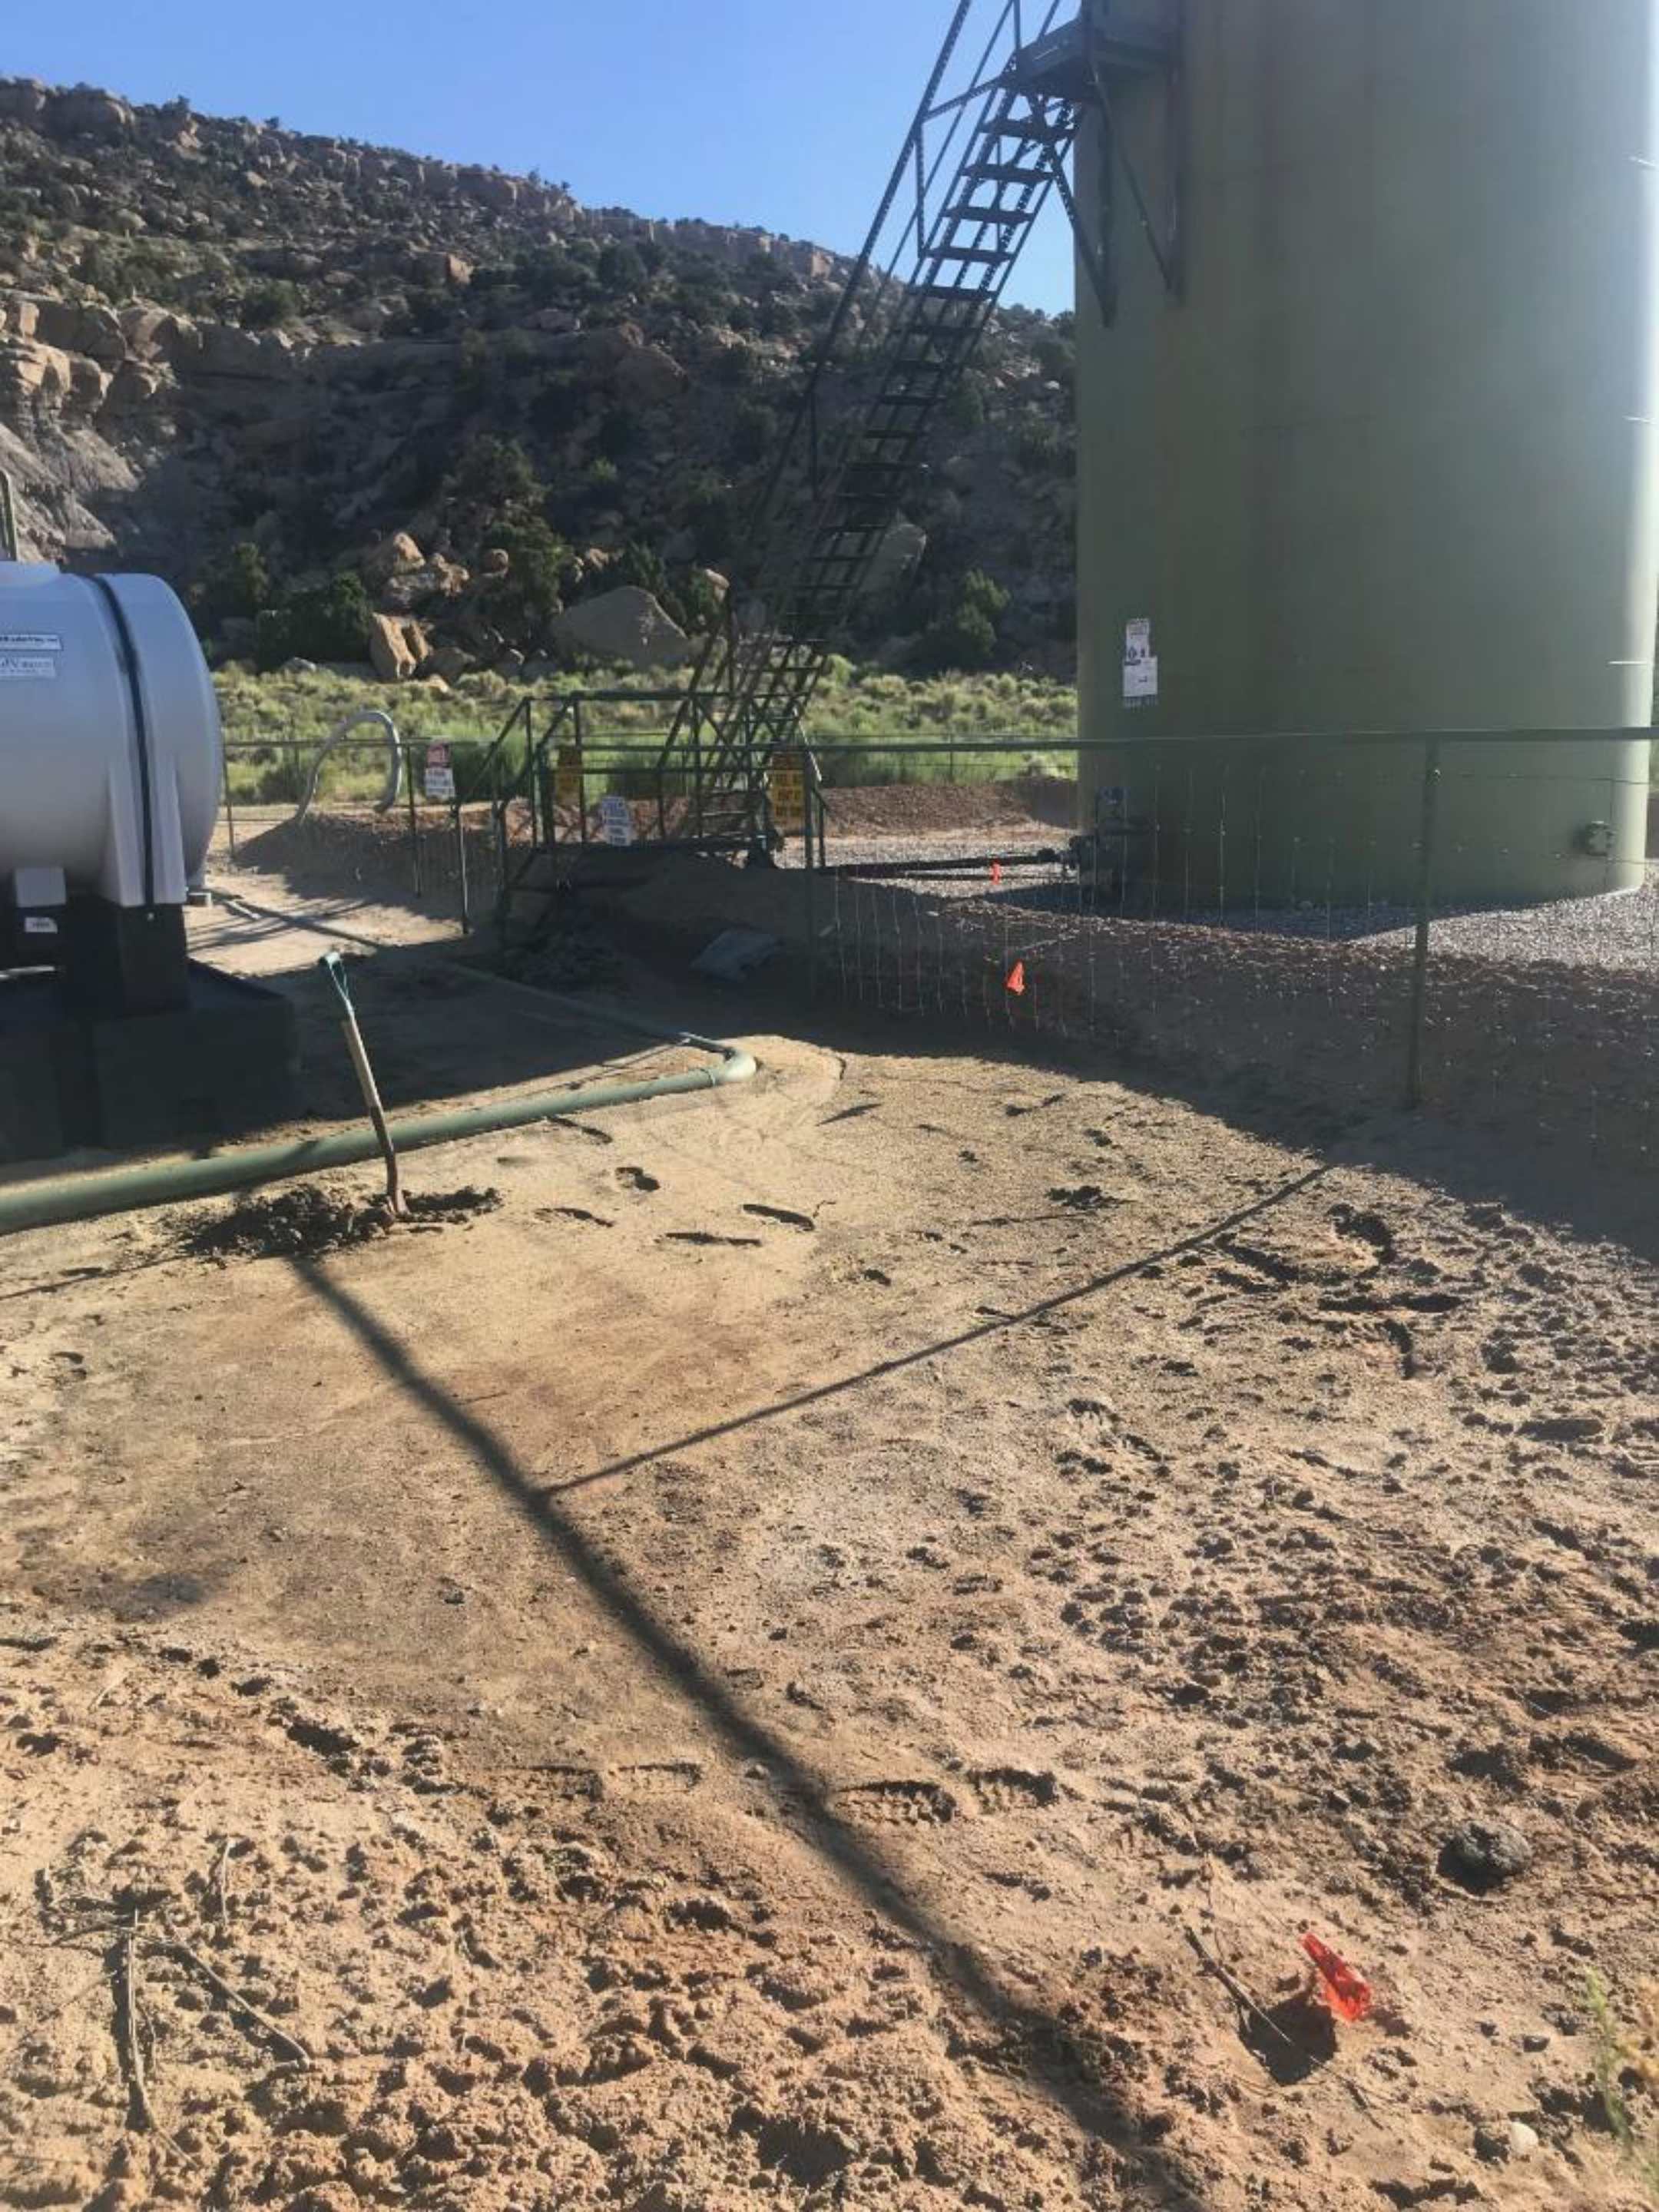
Release Footprint

| <b>SITE OBSERVATIONS:</b> | LOST INTEGRITY OF EQUIPMENT: YES / NO EXPLANATION -<br>APPARENT EVIDENCE OF A RELEASE OBSERVED AND/OR OCCURRED: <u>YES</u> / NO EXPLANATION: <u>MOIST GROUND SURFACE</u><br>EQUIPMENT SET OVER RECLAIMED AREA: YES / NO EXPLANATION -<br>OTHER: |

X = 5 pt Comp #1
