Release Notification

Site Name South Blanco 23 3	Site Type Oil
Date Release Discovered 9-20-2018	API# (if applicable) 30-045-28163

A flowline split occurred when the well was returned to production.

South Blanco 23 2 Second Release 6-03-2019

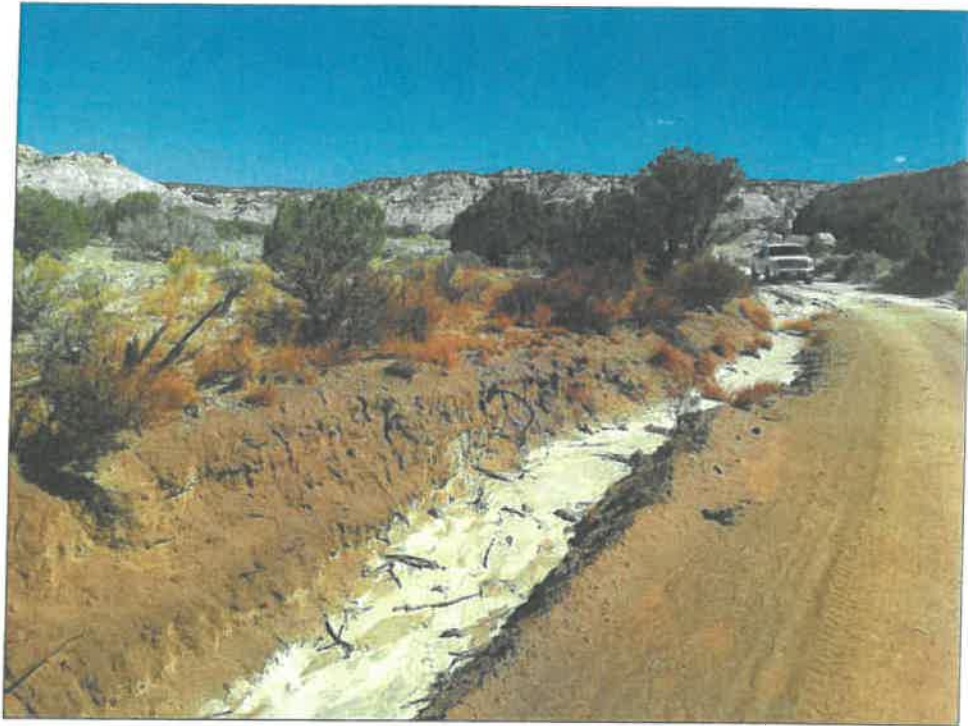
DJR Operating, LLC South Blanco 23 3 2nd Release Point

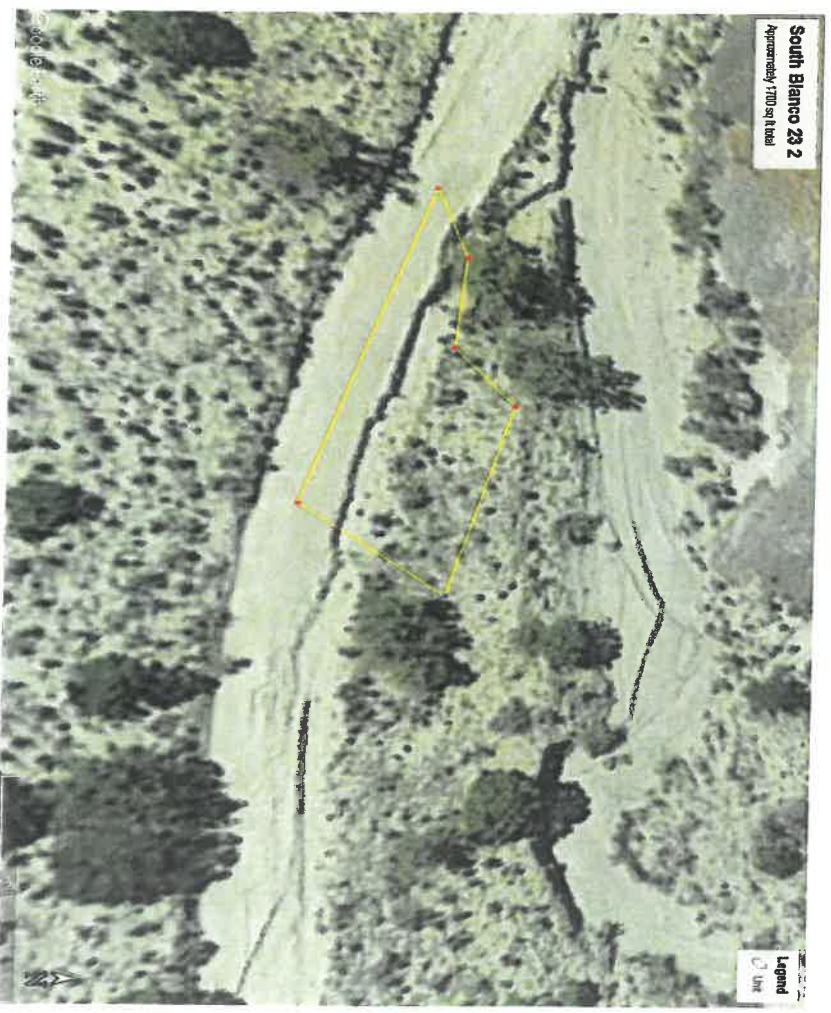
- This site was remediated on October 11, 2018. The amount excavated was 8 yards. This was originally thought to be a non-reportable release (due to the amount of the release). It was later found this release occurred in the erosion ditch next to the road through photos that were sent to DJR by the BLM on 6-03-19. These photos determined this was in-fact a reportable release. After inspecting this site with Emmanuel Adeloye on 6-03-2019 it was learned most of the release had been cleaned. There was a small amount left on the road way and that contaminated soil was removed on 6-10-2019 and 6-11-2019 in the amount of 34 ydys. The site was sampled on 6-26-2019 and all results showed Non-Detect. There was not a need for fill soil at this location. DJR feels there is sufficient revegetation where needed at this time, per photos of samples SB-7 and SB-8.
