### Release Notification and Corrective Action

Name of Company: BP	Contact: Courtney Cochran
Address: 200 Energy Court, Farmington, NM 87401	Telephone No.: 326-9457
Facility Name: Hughes A2	Facility Type: natural gas well API # 3004523345
Surface Owner: Federal	Mineral Owner: Federal Lease No. SF 078049

CLIENT: <u>BP</u>	<b>BLAGG ENGINEERING, INC.</b> <b>P.O. BOX 87, BLOOMFIELD, NM 87413</b> <b>(505) 632-1199</b>	API #: <u>30-045-23345</u> TANK ID (if applicable): <u>NA</u>
<b>FIELD REPORT:</b> (circle one): BGT CONFIRMATION / <u>RELEASE INVESTIGATION</u> / OTHER: <u>300 AST Pinhole Leak</u>		PAGE #: <u>1</u> of <u>1</u>
<b>SITE INFORMATION:</b> SITE NAME: <u>HUGHES A #2</u> QUAD/UNIT: <u>B</u> SEC: <u>27</u> TWP: <u>29N</u> RNG: <u>8W</u> PM: <u>NM</u> CNTY: <u>SJ</u> ST: <u>NM</u> 1/4 - 1/4 FOOTAGE: LEASE TYPE: <u>FEDERAL</u> / STATE / FEE / INDIAN LEASE #: <u>NMSF 078049</u> PROD. FORMATION: CONTRACTOR: <u>ELKHORN</u>		DATE STARTED: <u>2-15-11</u> DATE FINISHED: <u>2-15-11</u> ENVIRONMENTAL SPECIALIST(S): <u>JCB</u>
<b>REFERENCE POINT:</b> WELL HEAD (W.H.) GPS COORD.: <u>36.70180 x 107.65974</u> GL ELEV.: <u>6739</u> 1) <u>Excavation Center</u> GPS COORD.: <u>36.70173 x 107.66

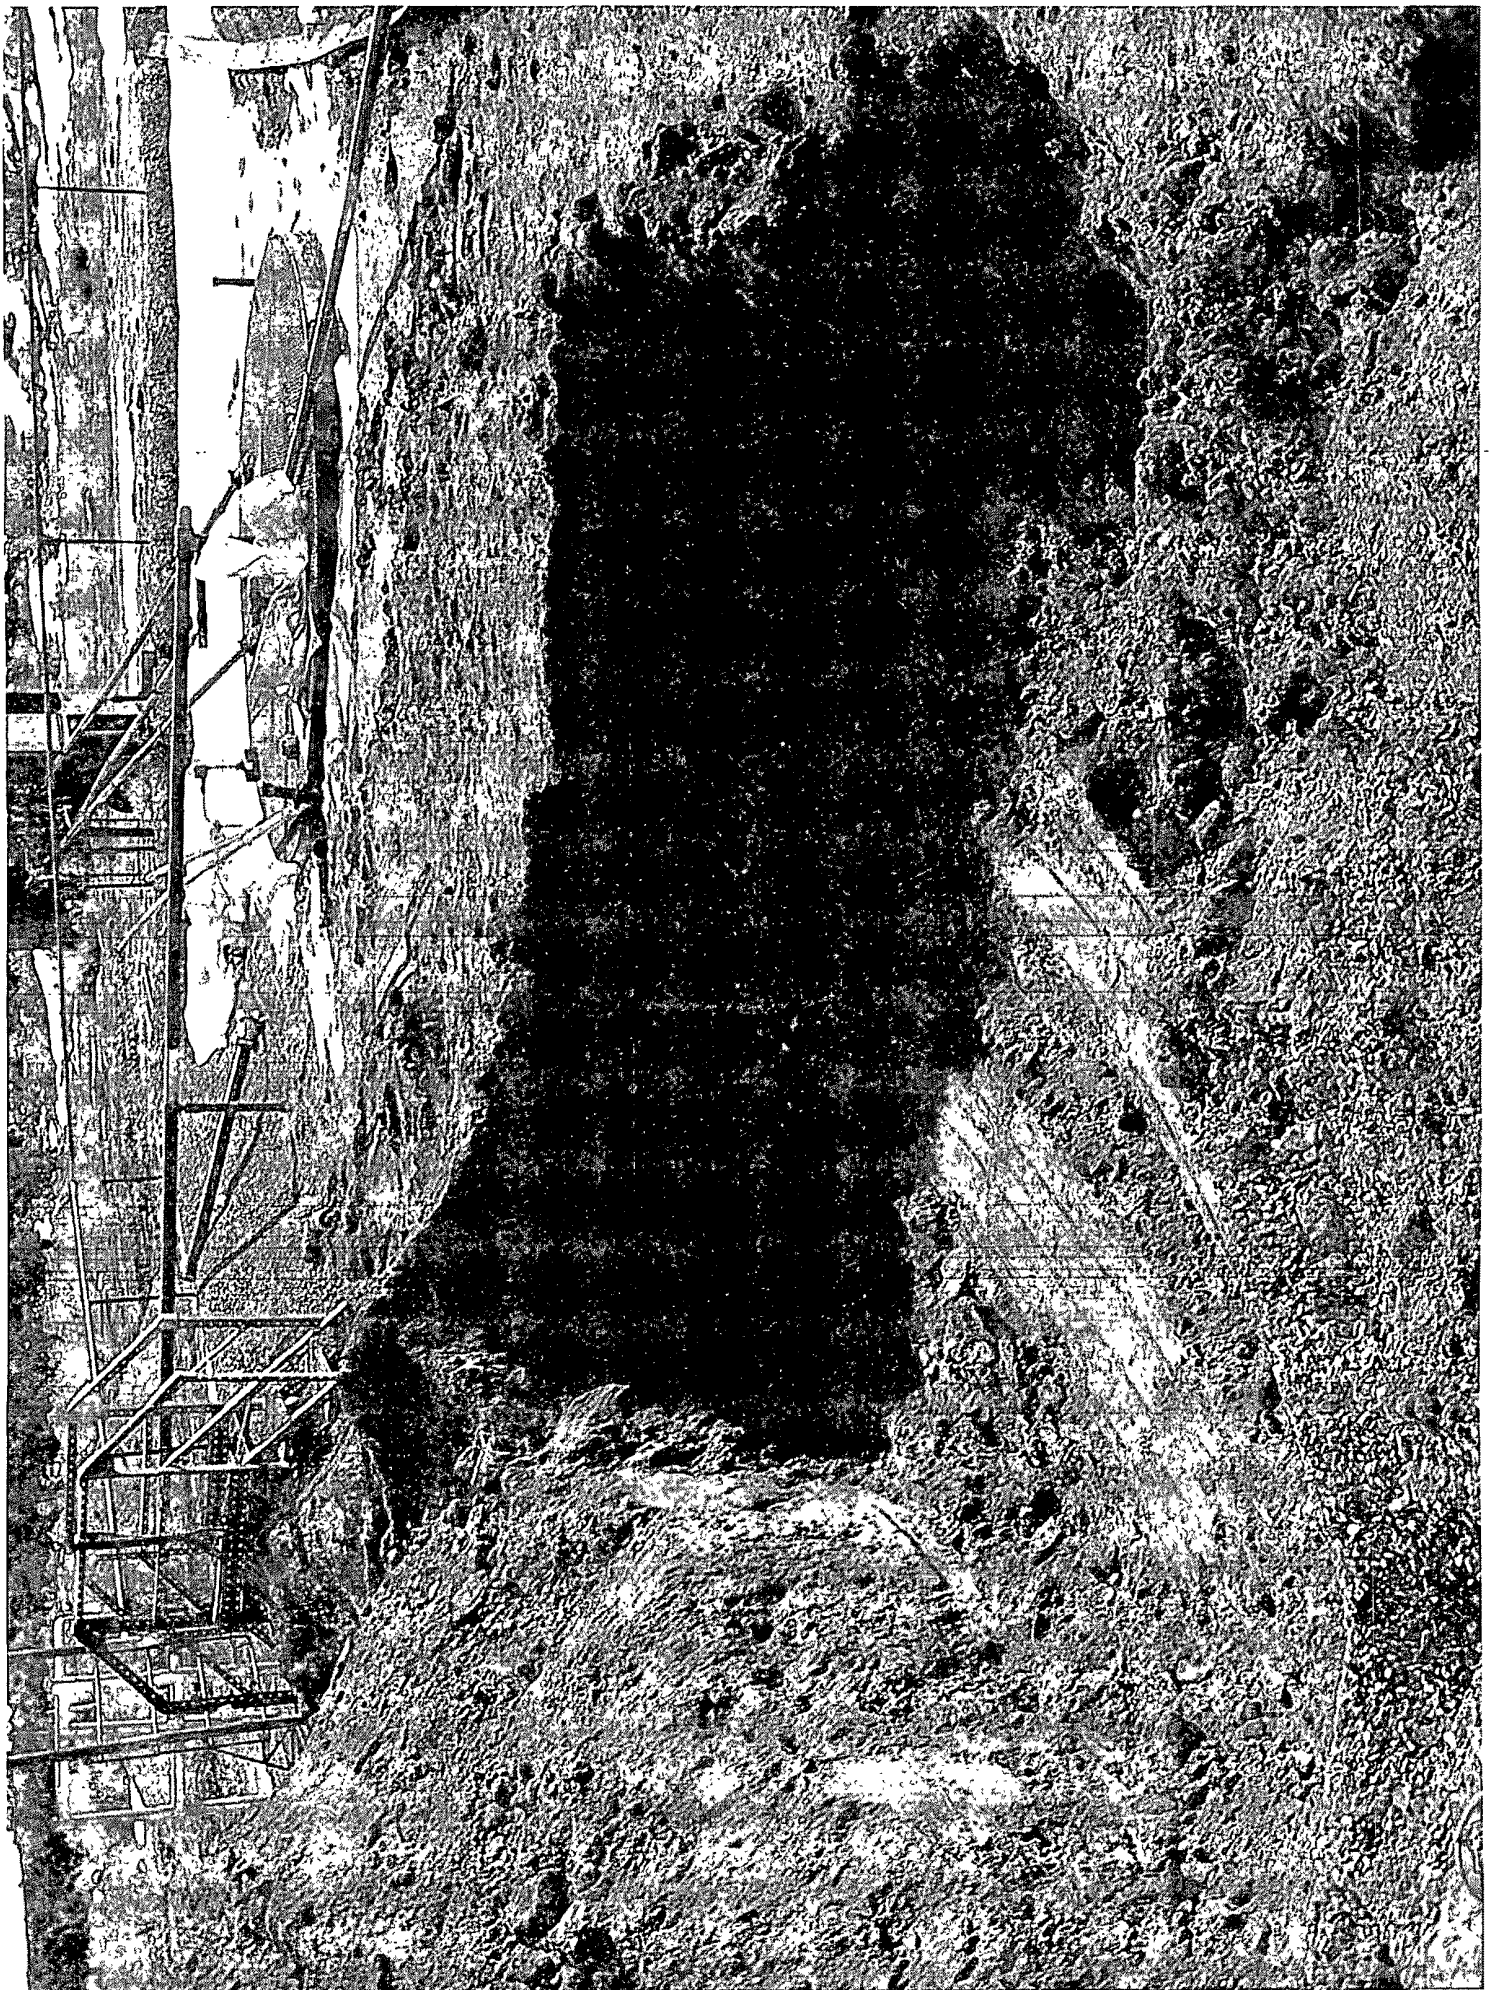
ANY AREAS DISPLAYING WETNESS: YES / <u>NO</u> EXPLANATION - ADDITIONAL COMMENTS: <u>FIRM BEDROCK SANDSTONE @ -4' Below Grade.</u>		
EXCAVATION DIMENSIONS (if applicable): <u>15</u> ft. X <u>14</u> ft. X <u>4</u> ft. cubic yards excavated (if applicable): <u>30±</u> DEPTH TO GROUNDWATER: <u>&gt;100</u> NEAREST WATER SOURCE: <u>&gt;1000</u> NEAREST SURFACE WATER: <u>&gt;1000</u> NMOC DTPH CLOSURE STD: <u>5000</u> PPM		
<b>SITE SKETCH</b>

<b>PLOT PLAN</b> circle: <u>attached</u> OVM CALIB READ = ppm RF = 0.52 OVM CALIB GAS = ppm TIME: apm DATE:
x = 5-POINT COMPOSITE SAMPLE POINT NOTES: BGT = BELOW-GRADE TANK; E.D. = EXCAVATION DEPRESSION; B.G. = BELOW GRADE; B = BELOW; T.H. = TEST HOLE; ~ = APPROX. T.B. = TANK BOTTOM; PBGT = PREVIOUS BELOW-GRADE TANK LOCATION; SPD = SAMPLE POINT DESIGNATION; R.W. = RETAINING WALL; NA - NOT APPLICABLE OR NOT AVAILABLE; SW - SINGLE WALL; DW - DOUBLE WALL; SB - SINGLE BOTTOM; DB - DOUBLE BOTTOM.		<b>MISCELL. NOTES</b> BGT Sidewalls Visible: Y / N / <u>NA</u> Magnetic declination: <u>10</u> ° E

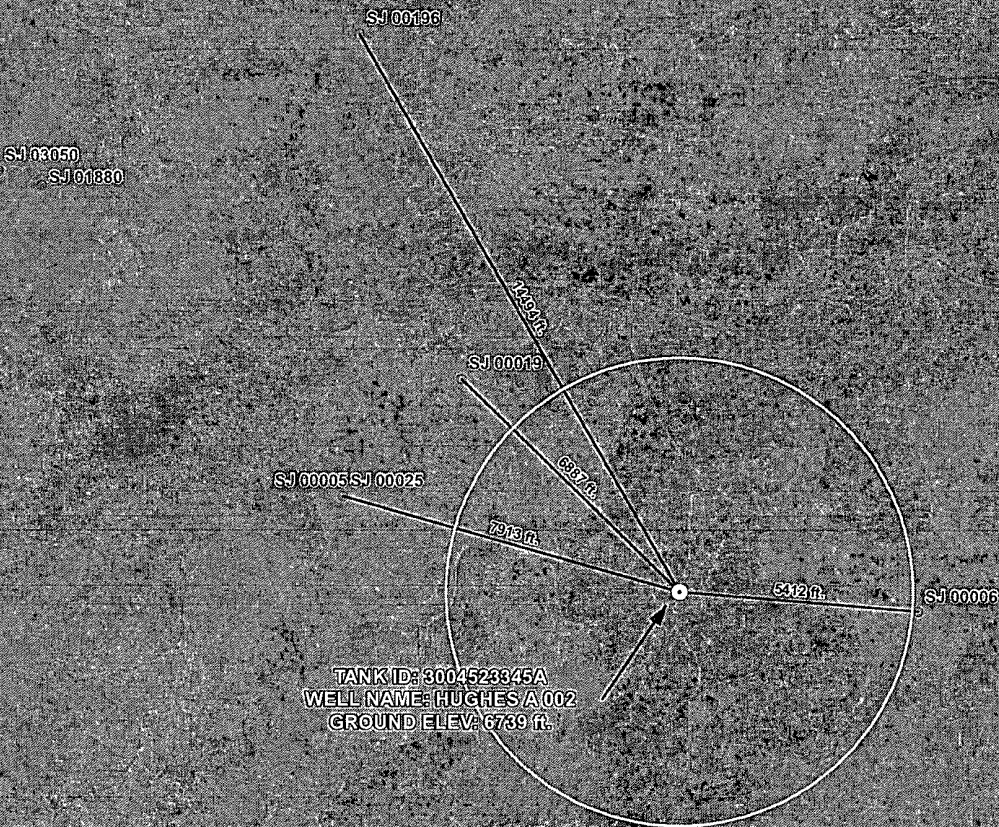
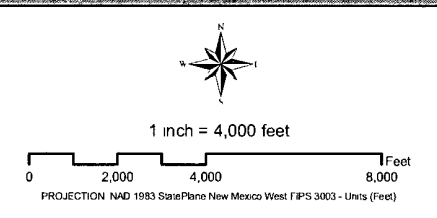
FIGURE

Depth to groundwater at the site is estimated to be greater than 100 feet. This estimation is based on data from Stone and others (1983), and depth to groundwater data obtained from water wells permitted by the New Mexico State Engineer's Office (OSE, Figure 1). Local topography and proximity to adjacent water features are also considered. A topographic map of the site is provided as Figure 2 and demonstrates that the below grade tank (BGT) is not within 300 feet of any continuously flowing watercourse, or within 200 feet of any other significant watercourse, lakebed, sinkhole or playa lake as measured from the ordinary high water mark. Figure 3 demonstrates that the BGT is not within 300 feet of a permanent residence, school, hospital, institution or church. Figure 4 demonstrates, based on a search of the OSE database and USGS topographic maps, that there are no freshwater wells or springs within 1000 feet of the BGT. Figure 5 demonstrates that the BGT is not within a municipal boundary or a defined municipal freshwater well field. Figure 6 demonstrates that the BGT is not within 500 feet of a wetland. Figure 7 demonstrates that the BGT is not in an area overlying a subsurface mine. The BGT is not located in an unstable area. Figure 8 demonstrates that the BGT is not within the mapped FEMA 100-year floodplain.

POD Number	Well Depth	Water Depth	Elevation
SJ 00006	560	0	6349
SJ 00005	606	406	6435
SJ 00025	606	406	6435
SJ 00019	502	0	6473
SJ 00196	1624	500	6489

## GROUNDWATER LESS THAN 50 FT.

### **Figure 1: Groundwater Less Than 50 ft.**

Results: Spatial Polygons representing "Groundwater likely to be less than 50 ft." and "Groundwater suspected to be less than 50 ft.".

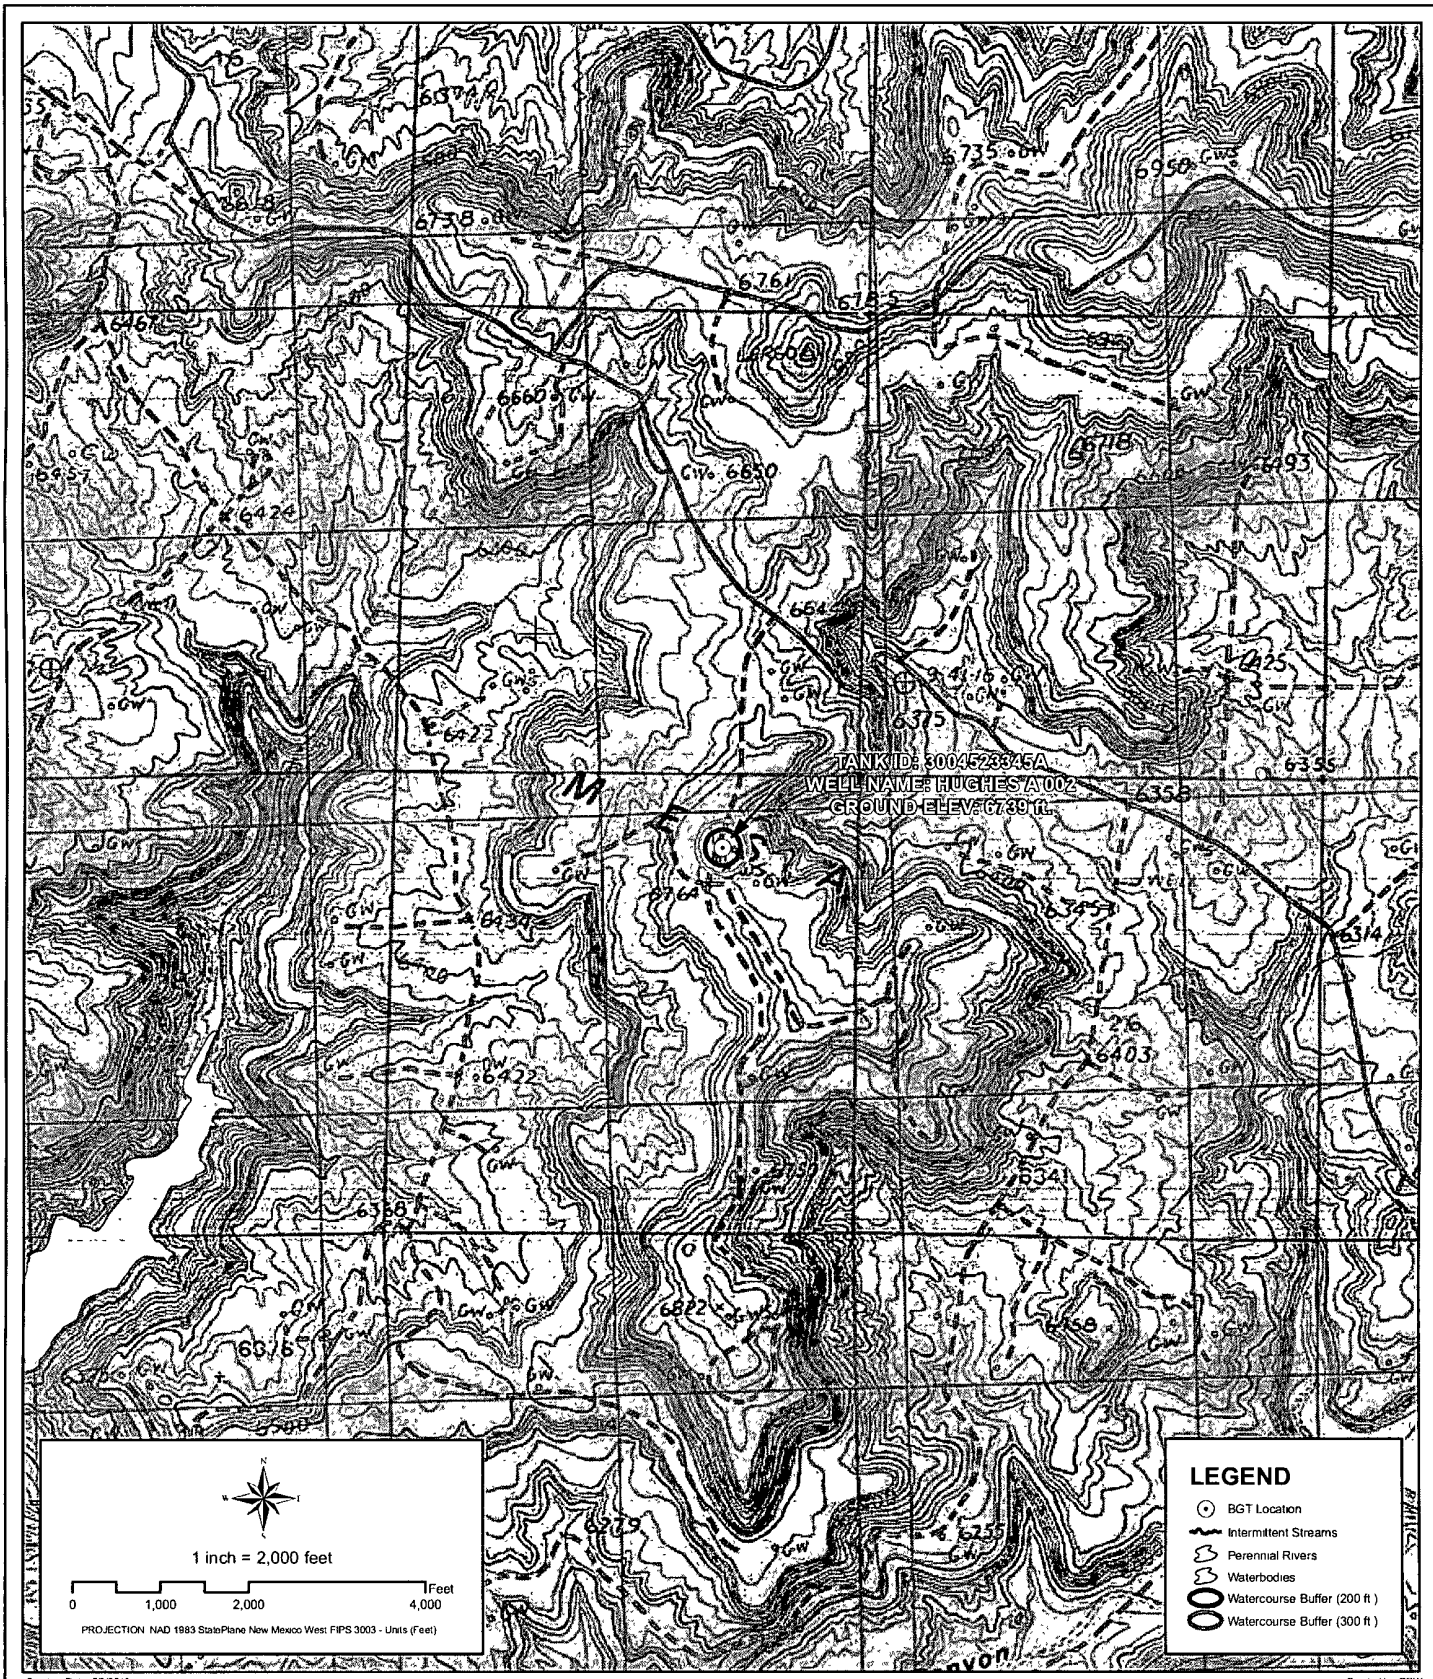
FIGURE

## PROXIMITY TO WATERCOURSES

## **Figure 2: Proximity to Watercourses**

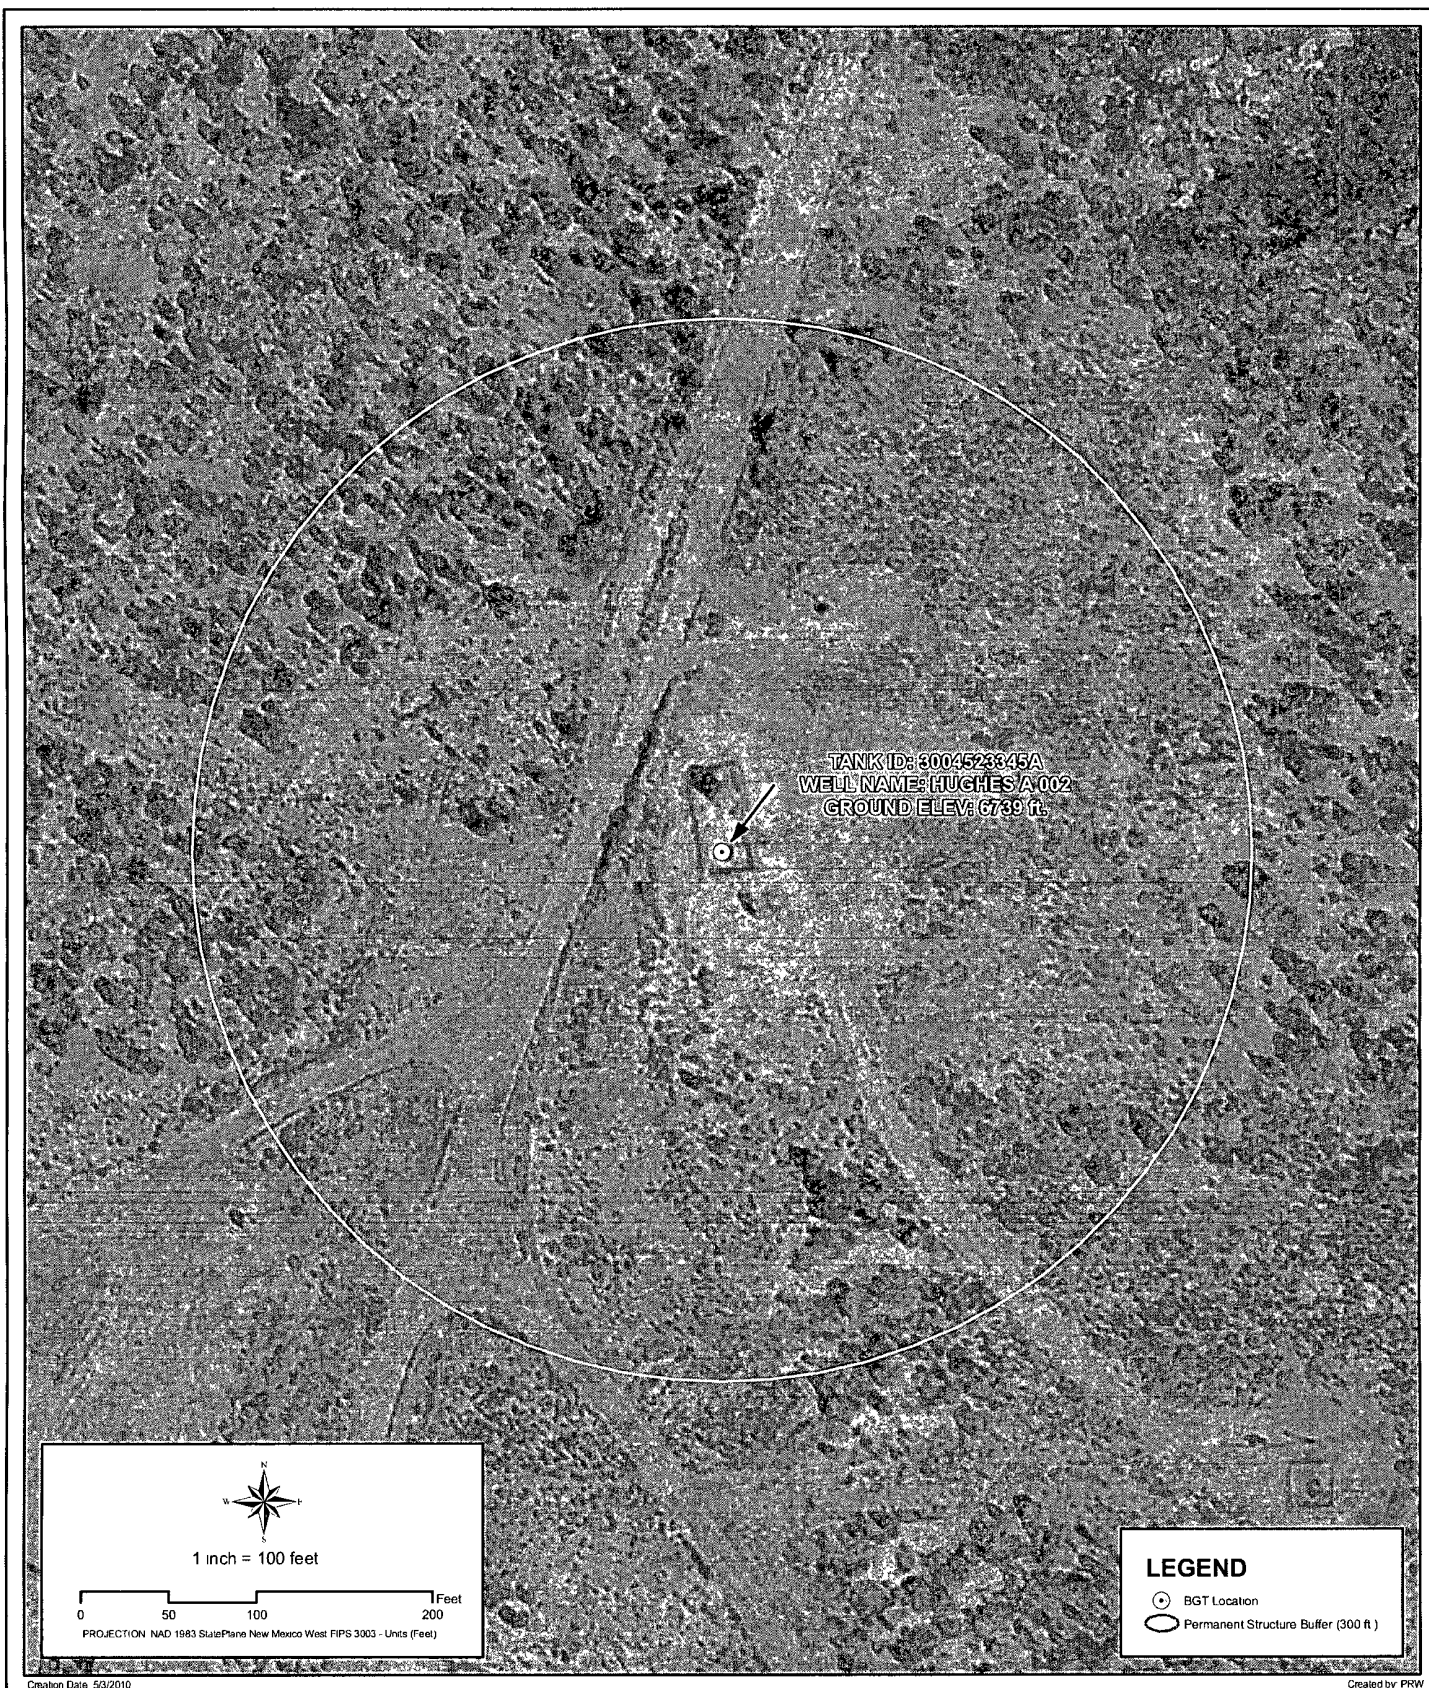
FIGURE

## PROXIMITY TO PERMANENT STRUCTURE

## **Figure 3: Proximity to Permanent Structure**

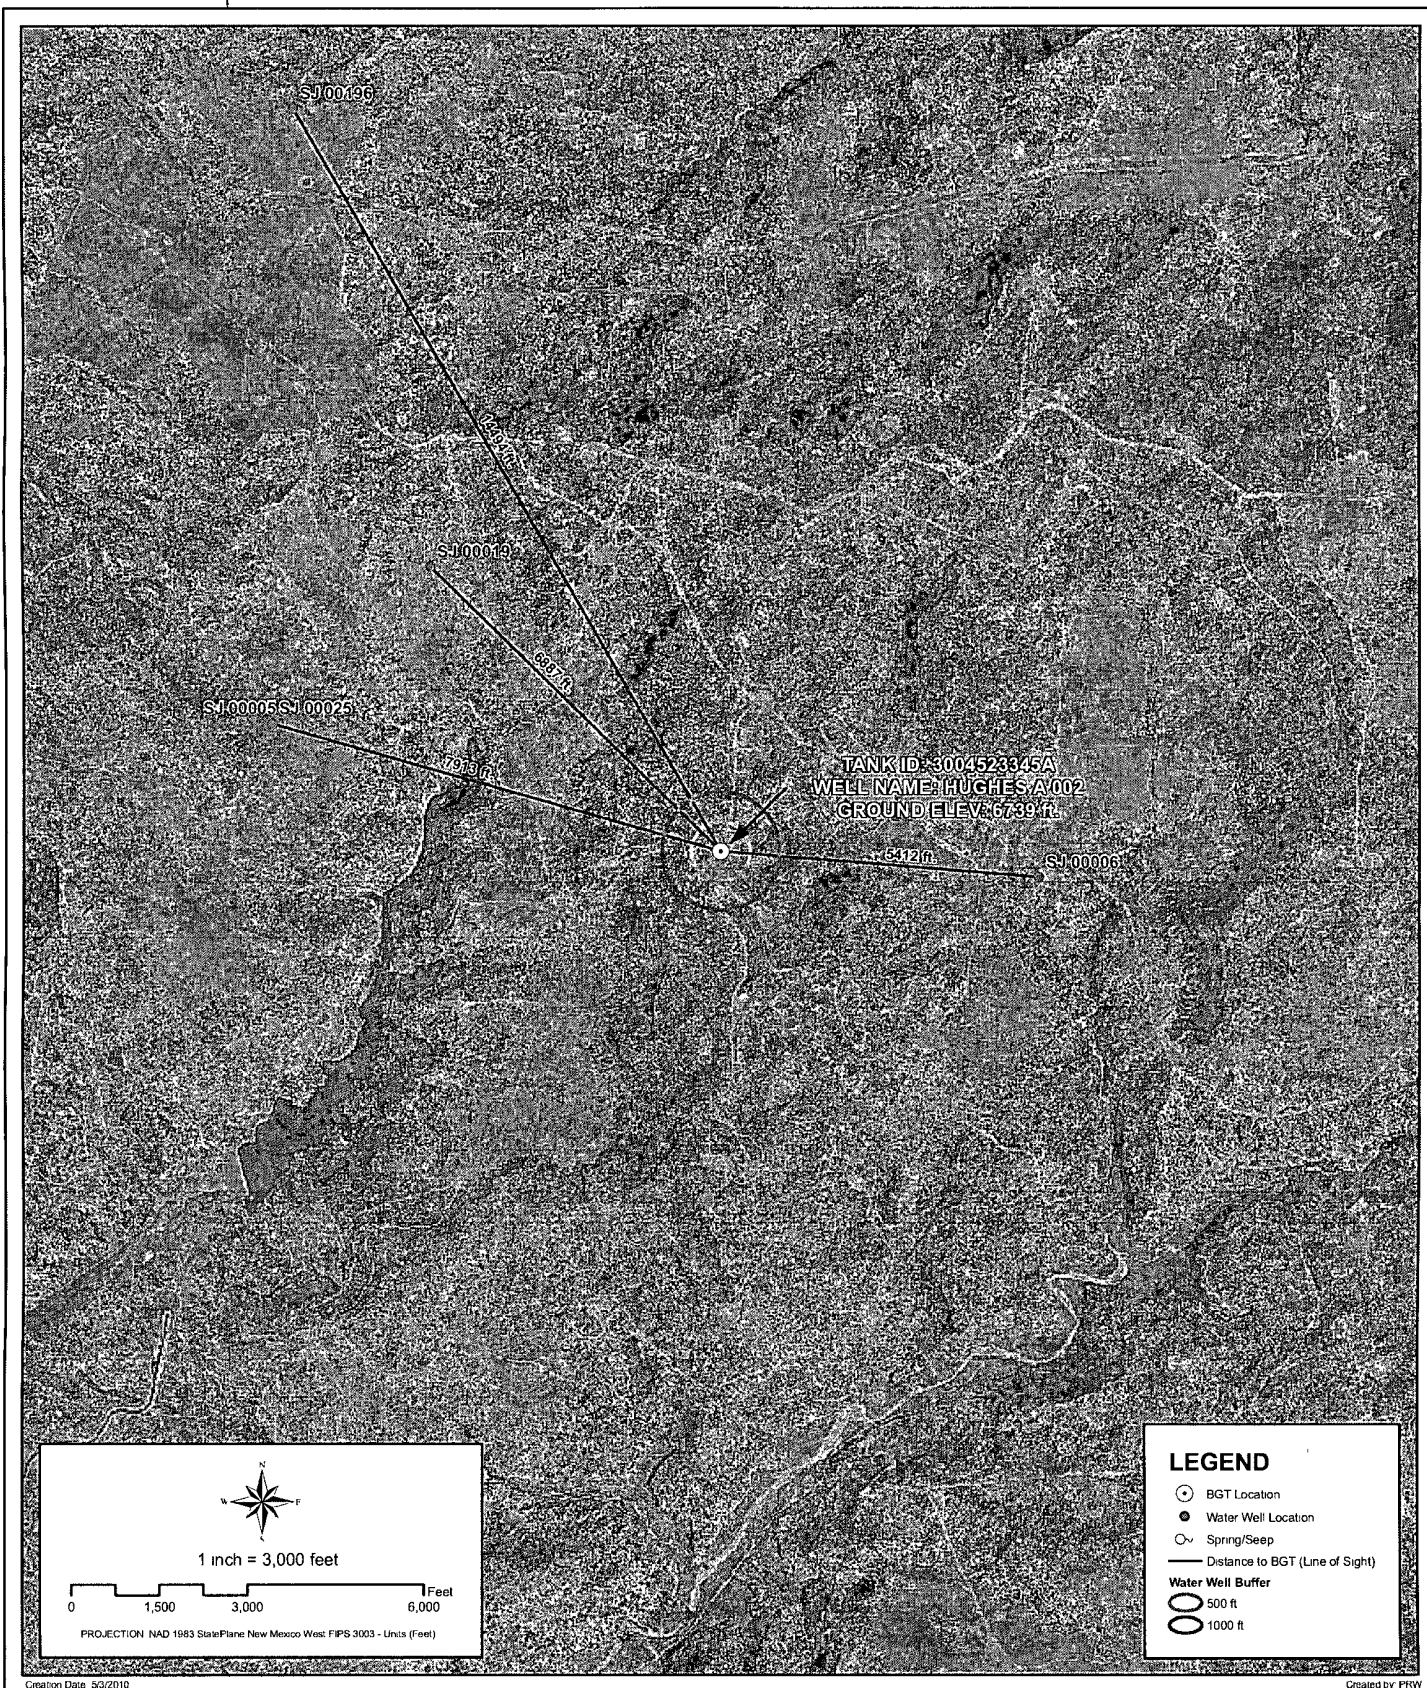
FIGURE

## PROXIMITY TO WATER WELLS

#### **Figure 4: Proximity to Water Wells**

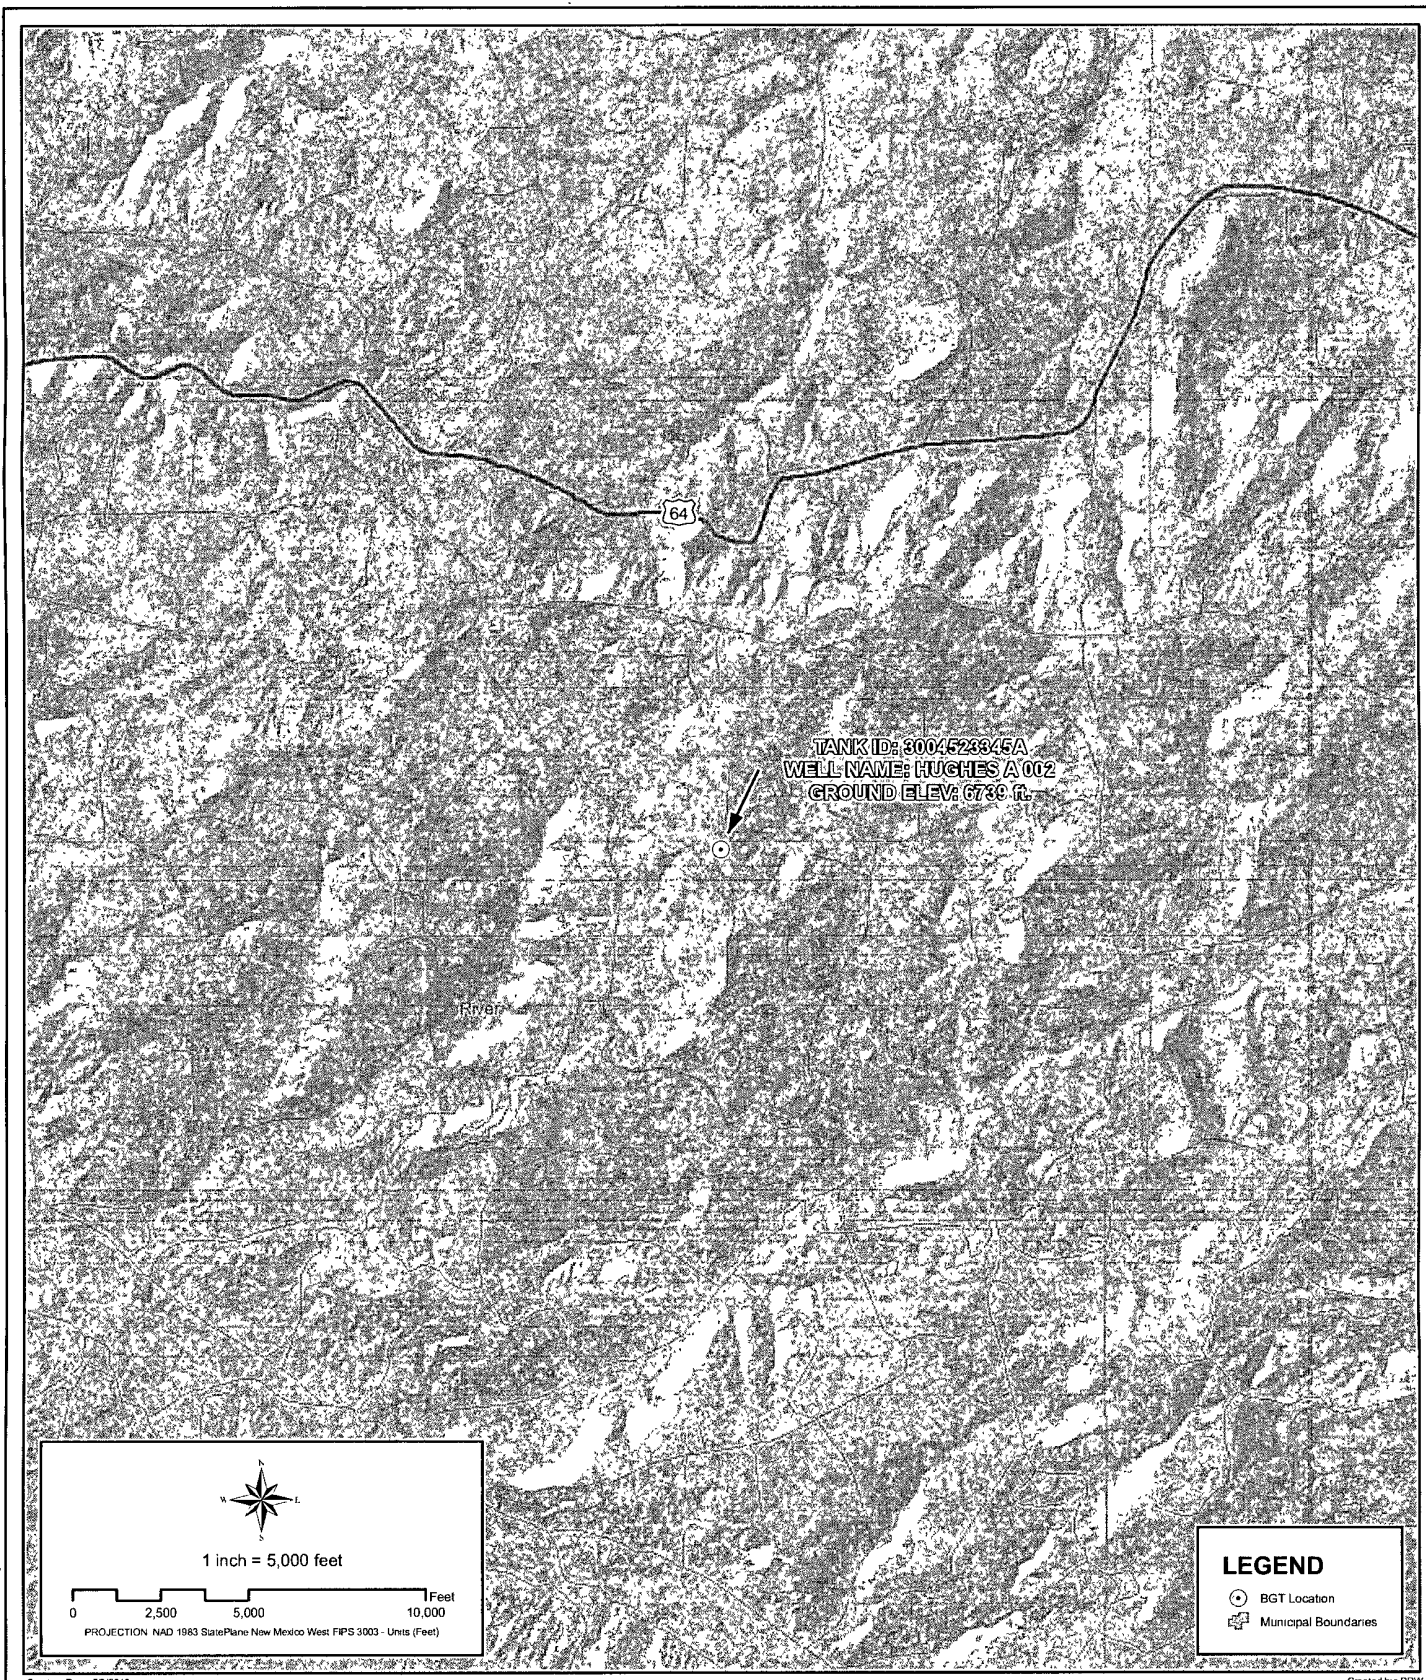
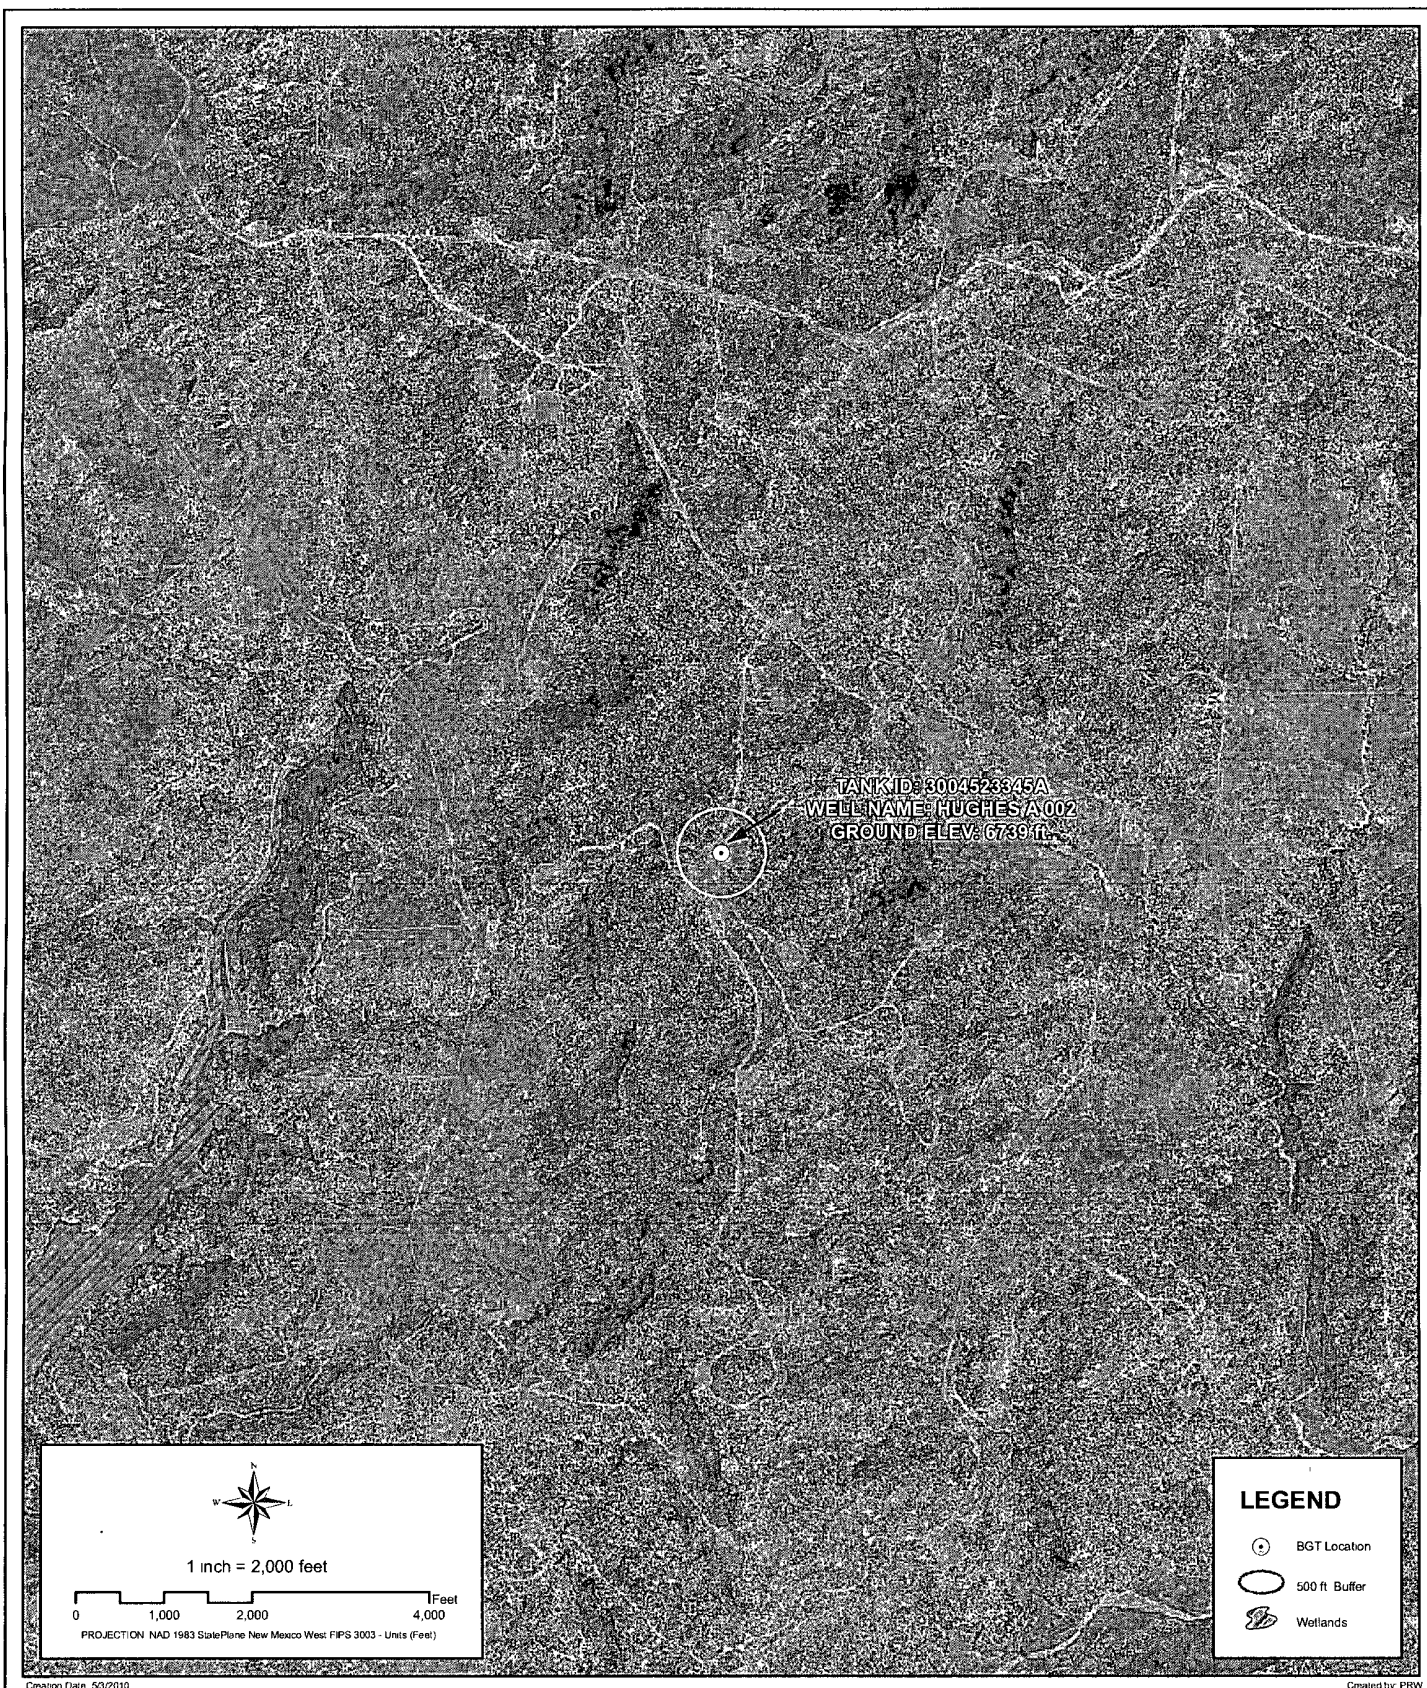
<p><b>PROXIMITY TO MUNICIPAL BOUNDARY</b></p> <p><b>WELL NAME: HUGHES A 002</b></p> <p>API NUMBER: 3004523345    TANK ID: 3004523345A</p> <p><b>SECTION 27, TOWNSHIP 29.0N, RANGE 08W, P.M. NM23</b></p>	<p><b>FIGURE</b></p> <p><b>5</b></p>
--	--	--------------------------------------

#### **Figure 5: Proximity to Municipal Boundary**

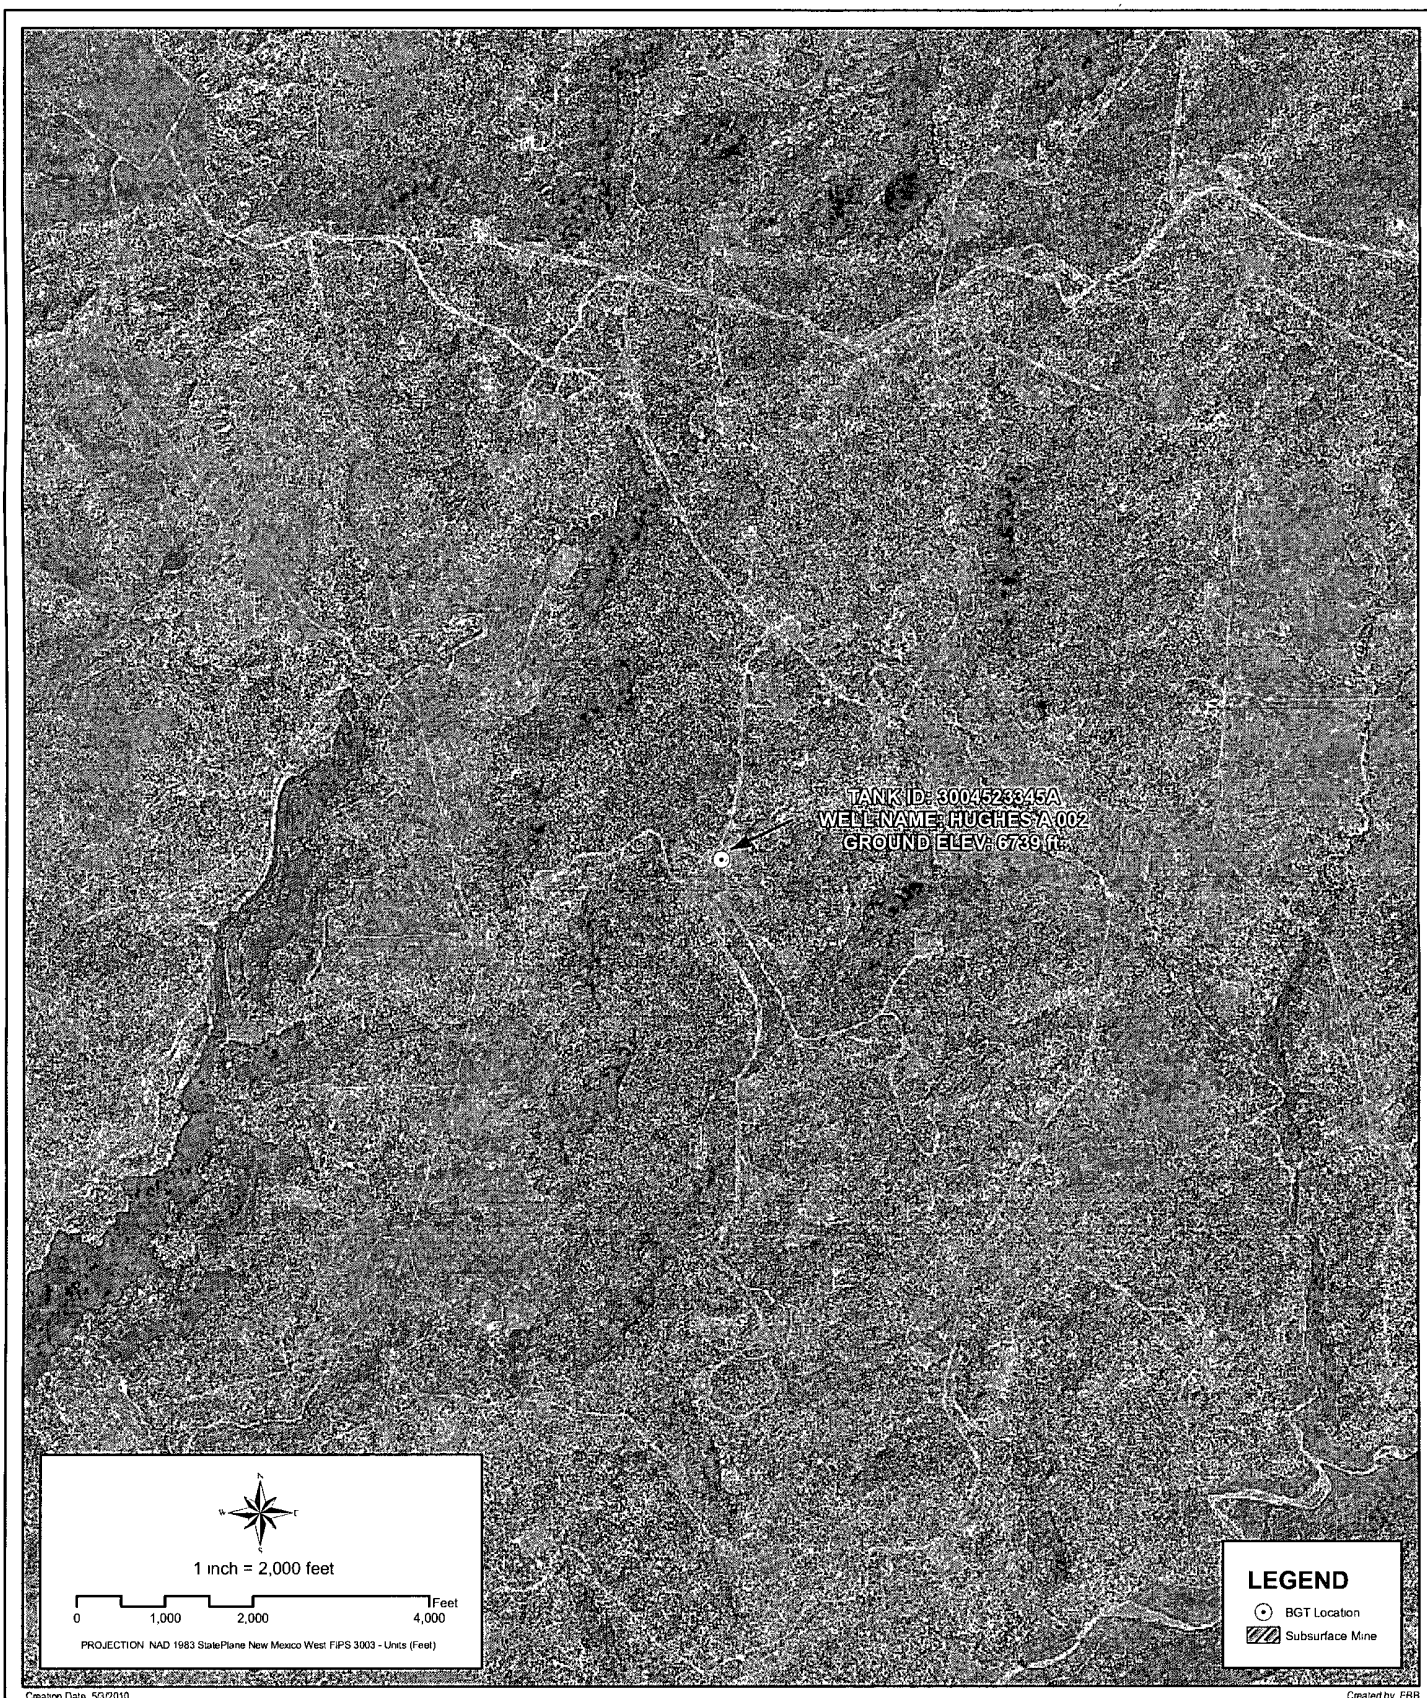
FIGURE

## PROXIMITY TO WETLANDS

### **Figure 6: Proximity to Wetlands**
