Proposed Alternative Method Permit or Closure Plan Application
Type of action: Permit of a pit, closed-loop system, below-grade tank, or proposed alternative method Closure of a pit, closed-loop system, below-grade tank, or proposed alternative method Modification to an existing permit Closure plan only submitted for an existing permitted or non-permitted pit, closed-loop system, below-grade tank, or proposed alternative method
Instructions: Please submit one application (Form C-144) per individual pit, closed-loop system, below-grade tank or alternative request
Please be advised that approval of this request does not relieve the operator of liability should operations result in pollution of surface water, ground water or the environment. Nor does approval relieve the operator of its responsibility to comply with any other applicable governmental authority's rules, regulations or ordinances.

Operator: Four Star Oil & Gas Company OGRID #: 131944
Address: Post Office Box 36366, Houston, TX 77236
Facility or well name: <u>licarilla C 34</u>
API Number: <u>30-039-22840</u> OCD Permit Number:
U/L or Qtr/Qtr Otr/Qtr Section 22 Township 25N Range 5 W County: Rio Arriba
Center of Proposed

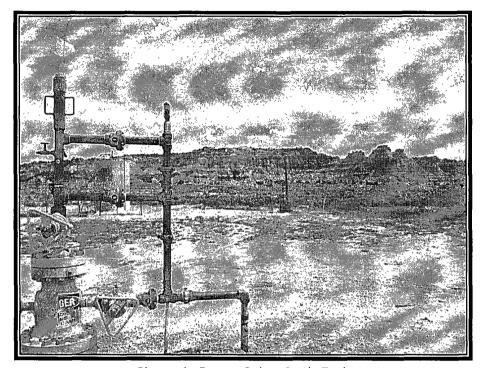
Picture 1: Former Below Grade Tank

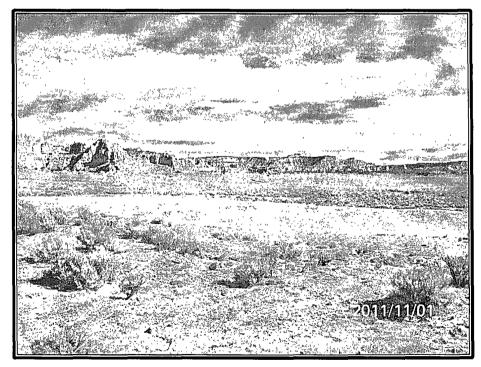
Picture 2: Backfilled, Re-contoured, and Re-vegetated Below Grade Tank Pit (View to East)
