## Pit, Closed-Loop System, Below-Grade Tank, or Proposed Alternative Method Permit or Closure Plan Application

# Koch Exploration Company, LLC San Juan County, NM Below-Grade Tank Closure Report August 15, 2012

Well Name: Dryden 1 Well API Number: 30-045-24214 S/T/R: S28, T38N, R8W Unit D

## Koch Exploration Company, LLC Dryden #1 and #2

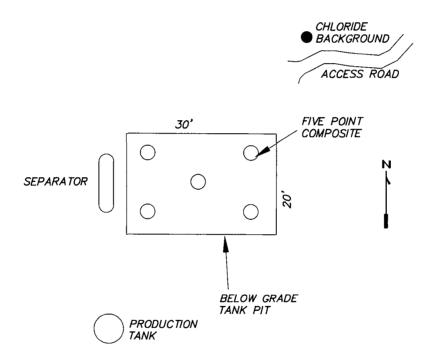
# KOCH EXPLORATION COMPANY, LLC DRYDEN #1 D-28-T28N-R08W API #30-045-24214

Traveled to the KEC Dryden #1, D-22-T28N-R08W, API# 24214 arrived at 10:10, proceeded to sample the BGT pit which was 4 feet deep and 20'X30' in dimensions. A five point composite sample was taken from approximately one foot below the bottom of the BGT pit in a pattern with points toward each corner and one point located near the pit center. The BGT pit is east of the separator. No staining was obvious in the pit. There was rain in the area July 25, 2012, the night before sampling.

A Total Chloride background sample was collected 1 foot below the surface off the location site. The sample location is north of the access road and east of the location.
