## Release Notification and Corrective Action

| Facility Name: <b>San Juan 30-6 Unit 476</b> | Facility Type: <b>Gas Well</b> | |

## Contaminated Cleanup

**SAN JUAN 30-6 #476**

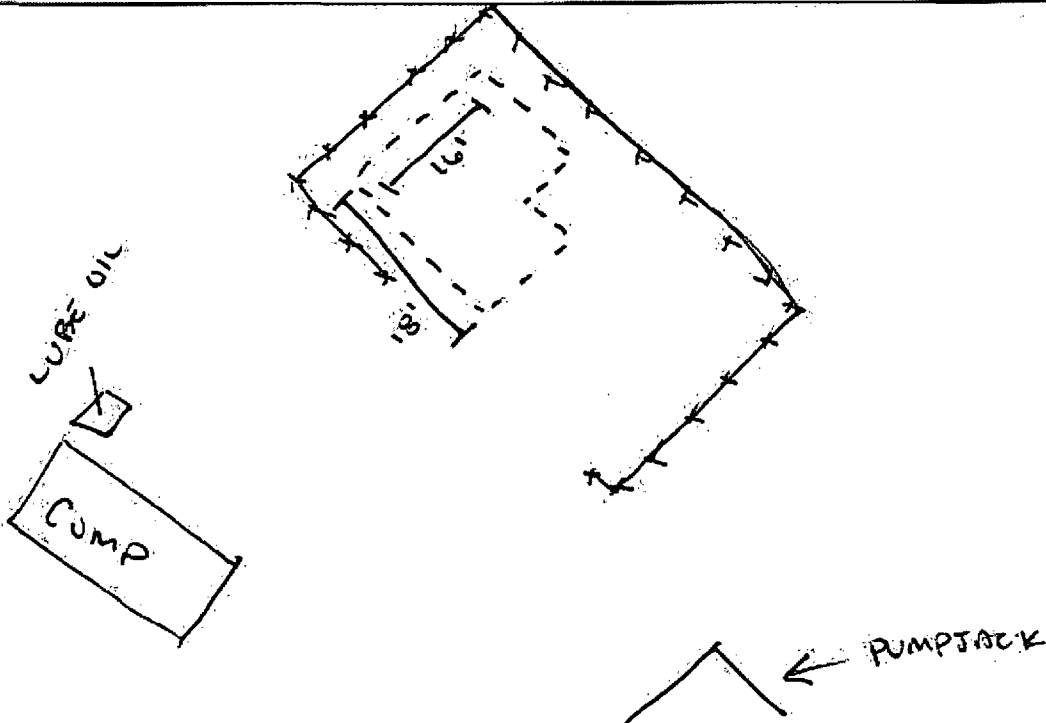
Site Diagram

- Comments
- COMPOSITE SAMPLES TAKEN FROM WALLS.
  - COMPOSITE SAMPLE TAKEN FROM FLOOR

Starting January 7, 2013 Nelson Reveg sent a hydroexcavation truck to location to start the cleanup. Due to temperatures well below freezing progress was slower than expected. On the third day of excavating a historical release was found at a depth of 3ft. The change in color to a dark black soil and strong odor gives reason to believe this stained soil was unrelated to the produced water release originally reported. Nelson Reveg excavated all of the visually contaminated soil, hauling the material to IEI Landfarm for disposal. The final excavation was approximately 18'x16'x7ft deep and was completed on January 21, 2013. On January 22, 2013 samples from the wall and floor were taken to Hall Environmental and ran for 8015 and 8021.

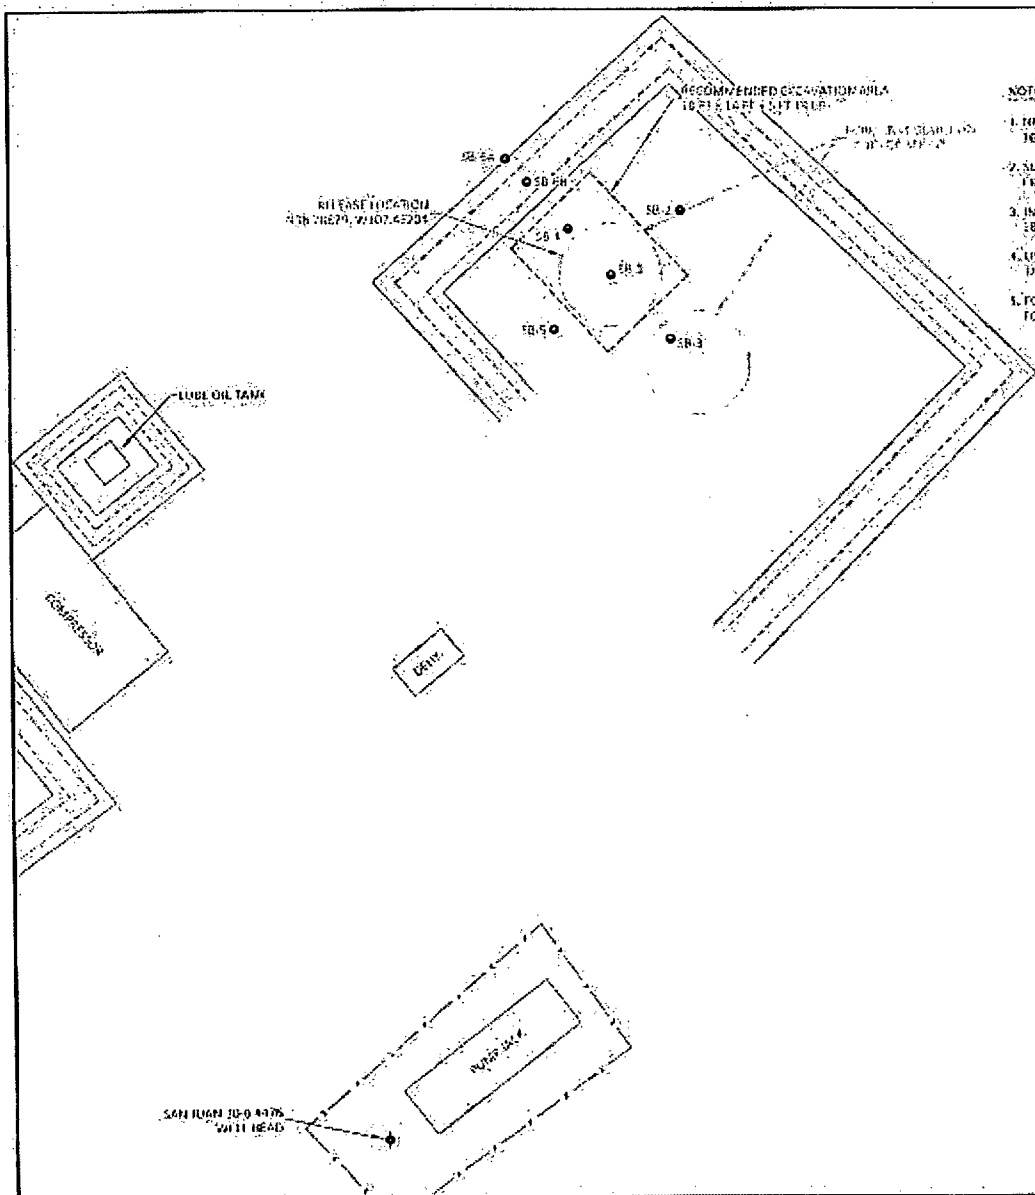
### FIGURE 3

- INITIAL RISK RANK IS "20", RISK RADIATION STANDARD IS 1,000 mg/kg TPH, 10 mg/kg BENZENE AND 50 mg/kg TOTAL BTEX.
- SOIL BODIES SB-5A AND SB-6A WERE ATTEMPTED SOIL BODIES. DUE TO FROZEN SURFACE, AUGER REFUSAL WAS ENCOUNTERED AT 1 INCH.
- INITIAL RECOMMENDED EXCAVATED AREA WOULD BE APPROXIMATELY 18 FEET x 14 FEET x 1 FT DEEP.
- USE EPA-PID ACTION LEVEL OF 100 ppm ANTH IN WETTED SCREENING TO DETERMINE FINAL EXCAVATION EXTENTS.
- FOLLOWING COMPLETION OF EXCAVATION, COLLECT ADDITIONAL SAMPLES FOR CONFIRMATION.

#### INITIAL ASSESSMENT SOIL SAMPLE LOCATIONS, RESULTS, AND RECOMMENDATIONS, DECEMBER 2012
