Release Notification and Corrective Action

Name of Company ConocoPhillips Company	Contact Crystal Tafoya
Address 3401 East 30th St, Farmington, NM	Telephone No. (505) 326-9837
Facility Name: San Juan 31-6 Unit 205R	Facility Type: Gas Well

**RE: Release Assessment and Confirmation Sampling Report
San Juan 31-6 #205R
Rio Arriba County, New Mexico**

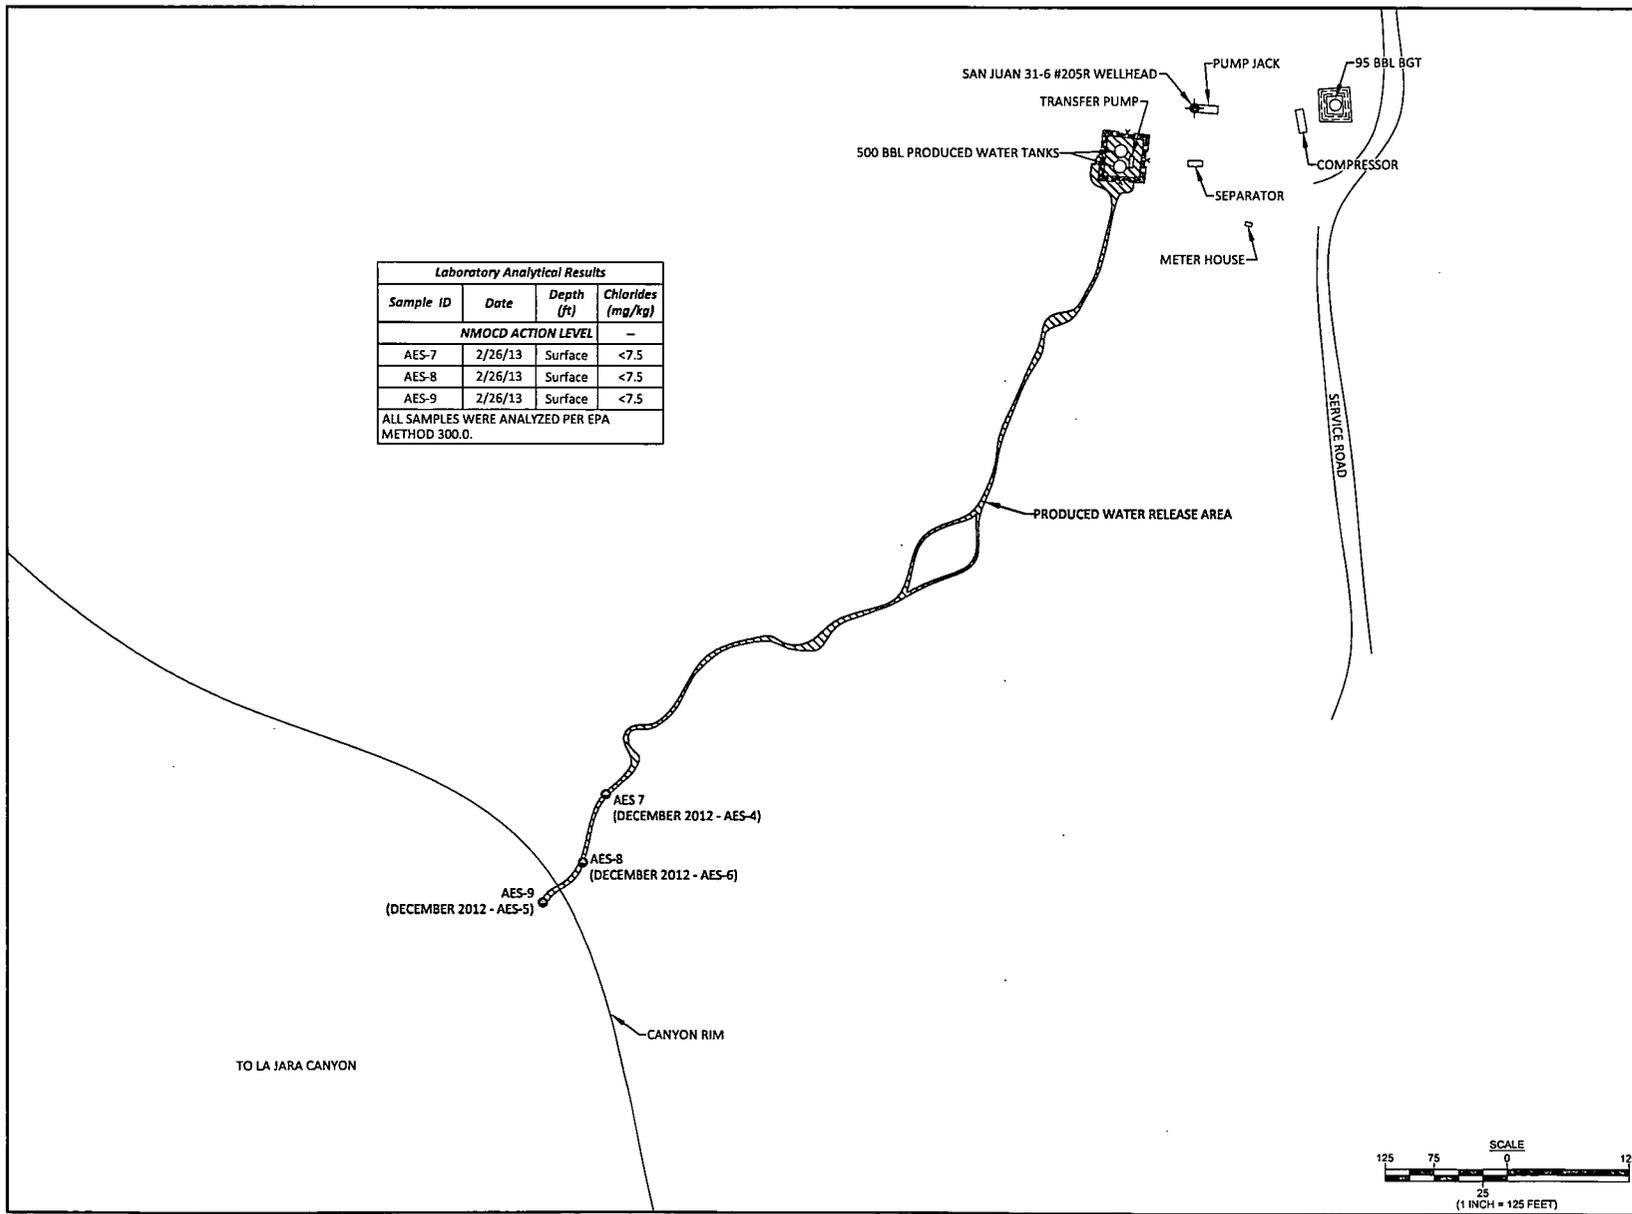
FIGURE 4

CONFIRMATION SOIL SAMPLE LOCATIONS AND RESULTS FEBRUARY 2013
 ConocoPhillips
 SAN JUAN 31-6 #205R
 RIO ARRIBA COUNTY, NEW MEXICO
 SW¼ NE¼ SECTION 4, T30N, R6W
 N36.84194, W107.46552

Laboratory Analytical Results			
Sample ID	Date	Depth (ft)	Chlorides (mg/kg)
NMOC ACTION LEVEL			
-			
AES-7	2/26/13	Surface	<7.5
AES-8	2/26/13	Surface	<7.5
AES-9	2/26/13	Surface	<7.5

On February 26, 2013, confirmation sampling laboratory analytical results for AES-7 through AES-9 reported chloride concentrations below the laboratory detection limit of 7.5 mg/kg in each sample. Results are tabulated in Table 2 and on Figures 3 and 4. The laboratory analytical reports are attached.

On February 26, 2013, AES returned to the location following removal of produced water impacted soils and collected three offsite confirmation samples (AES-7 through AES-9). Laboratory analytical results reported chloride concentrations below the laboratory detection limit of 7.5 mg/kg in each sample.
