Release Notification and Corrective Action

**RE: Initial Release Assessment and Final Excavation Report
San Juan 27-4 Com #137
Rio Arriba County, New Mexico**

TOPOGRAPHIC SITE LOCATION MAP
ConocoPhillips
SAN JUAN 27-4 COM #137
RIO ARRIBA COUNTY, NEW MEXICO
NE¼ NE¼, SECTION 34, T27N, R4W
N36.53483, W107.23351

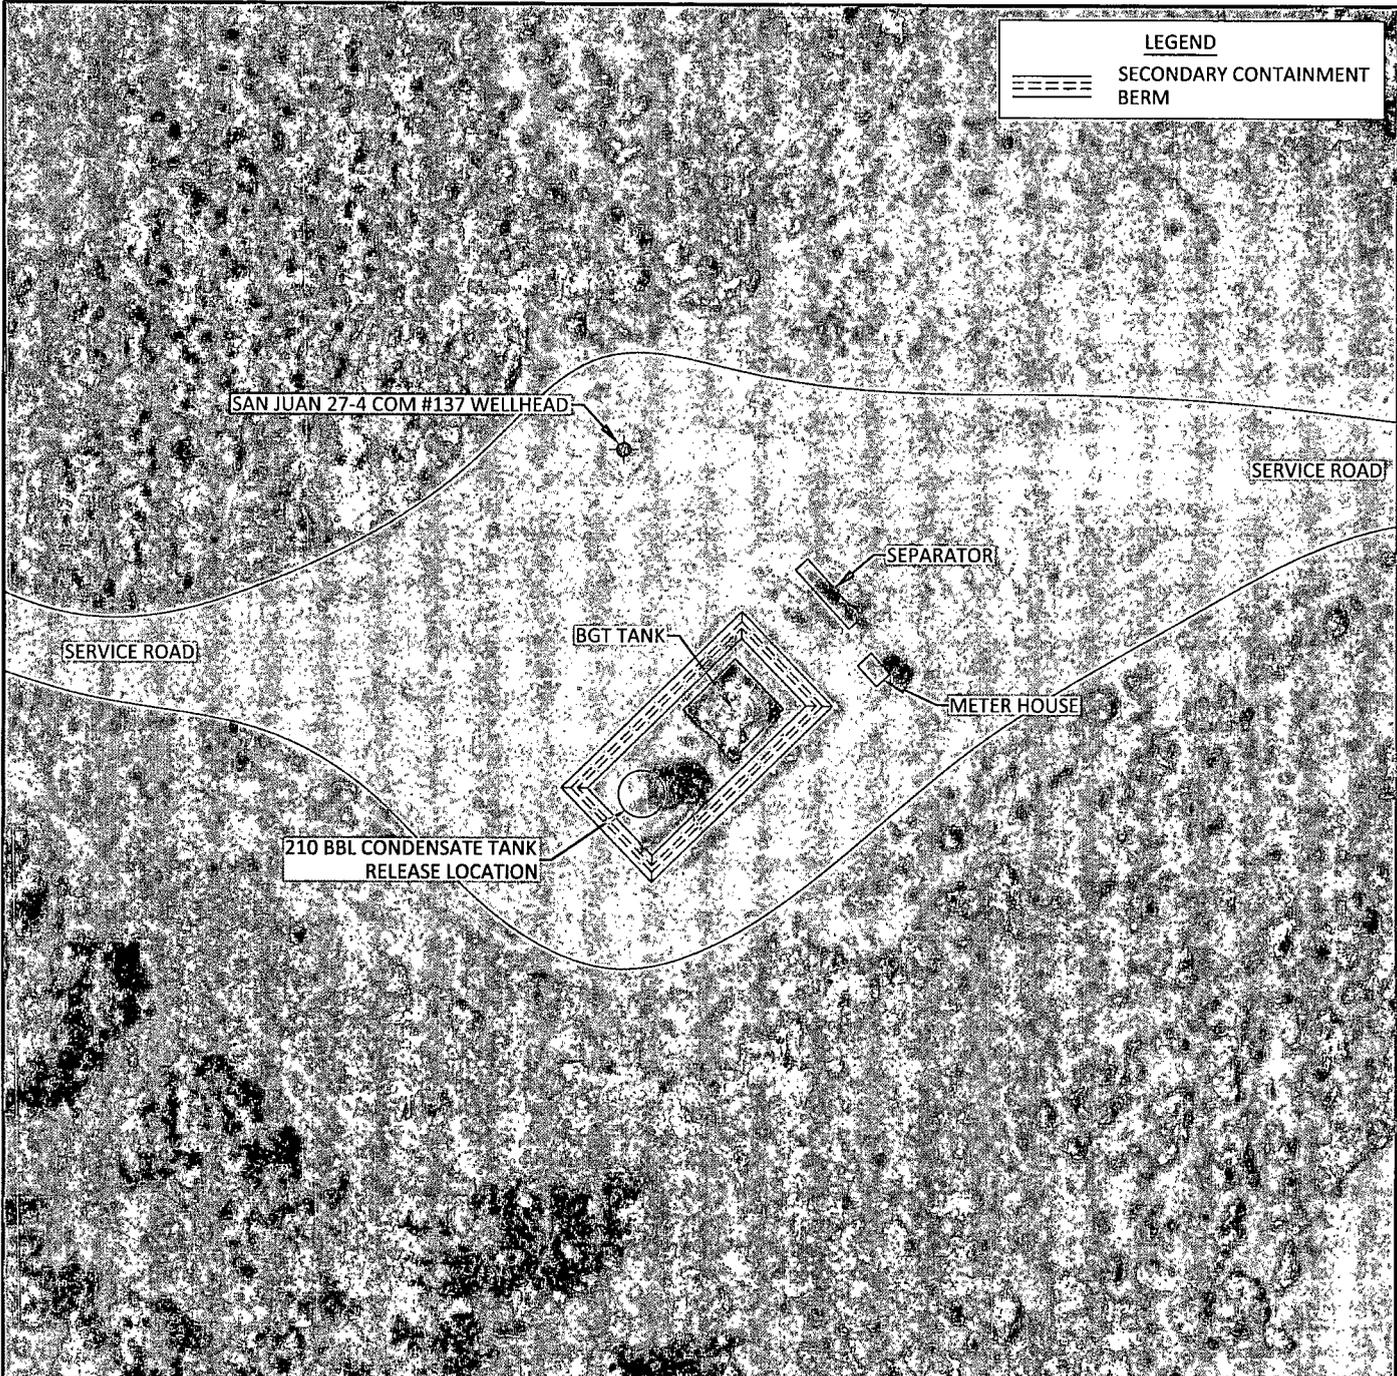
FIGURE 2

**AERIAL SITE MAP
 OCTOBER 2012**

SAN JUAN 27-4 COM #137
WELL MONUMENT

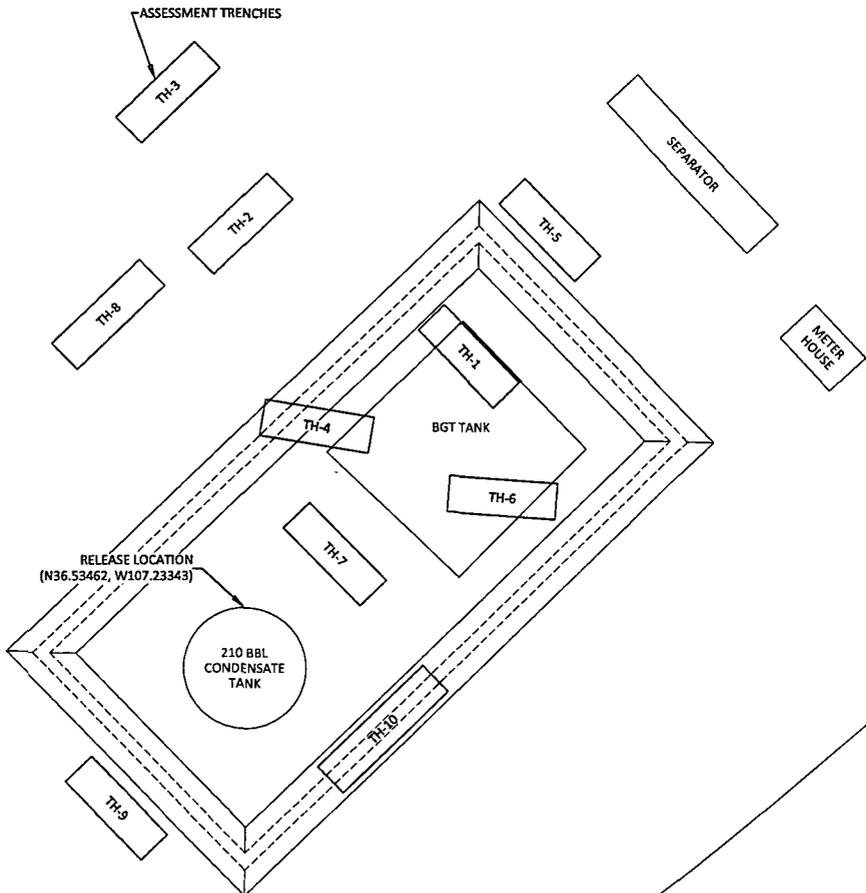
FIGURE 3

AES was initially contacted by Bruce Yazzie of CoP on October 22, 2012, and on October 23, 2012, Heather Woods and Zachary Trujillo of AES completed the release assessment field work. The assessment included collection and field screening of a total of 41 soil samples from 10 test holes (TH-1 through TH-10) within the vicinity of the release. Based on the field screening results, AES recommended excavation of the release area. Sample locations are shown on Figure 3.

On October 23, 2012, initial assessment field screening readings for VOCs via OVM ranged from 3.2 ppm in TH-10 up to 4,736 ppm in TH-2. Field TPH concentrations ranged from 104 mg/kg in TH-2 up to 1,140 mg/kg in TH-4.

INITIAL ASSESSMENT SAMPLE LOCATIONS AND RESULTS
OCTOBER 2012
ConocoPhillips
SAN JUAN 27-4 COM #137
RIO ARriba COUNTY, NEW MEXICO
NE¼ NE¼, SECTION 34, T27N, RAW
N36.53483, W107.23351

Laboratory analyses for TH-2, TH-4, and TH-7 were used to confirm field screening results from the initial assessment. Benzene concentrations ranged from below laboratory detection limits in TH-2 and TH-7 to 0.19 mg/kg in TH-4, and total BTEX concentrations ranged from 63 mg/kg in TH-2 up to 127 mg/kg in TH-4. TPH

concentrations (as GRO/DRO) ranged from 1,070 mg/kg in TH-4 up to 2,800 mg/kg in TH-2.

On October 23, 2012, AES conducted an initial assessment associated with a historical release from the former condensate tank at the San Juan 27-4 Com #137. Action levels for releases are determined by the NMOCD ranking score per *NMOCD Guidelines for Leaks, Spills, and Releases* (August 1993), and the site was assigned a ranking score of 10. Field screening showed concentrations above the NMOCD action levels of 100 ppm VOCs in TH-2, TH-4, and TH-7, with the highest VOC concentration reported in TH-2 with 4,736 ppm. Field screening also showed TPH concentrations above the NMOCD action level of 1,000 mg/kg in TH-4 with a concentration of 1,140 mg/kg. Laboratory analytical results from October 23, 2012, reported total BTEX above the applicable NMOCD action levels in TH-2, TH-4, and TH-7. TPH concentrations as GRO/DRO exceeded the NMOCD action level of 1,000 mg/kg in TH-2 (2,800 mg/kg), TH-4 (1,070 mg/kg), and TH-7 (1,810 mg/kg).

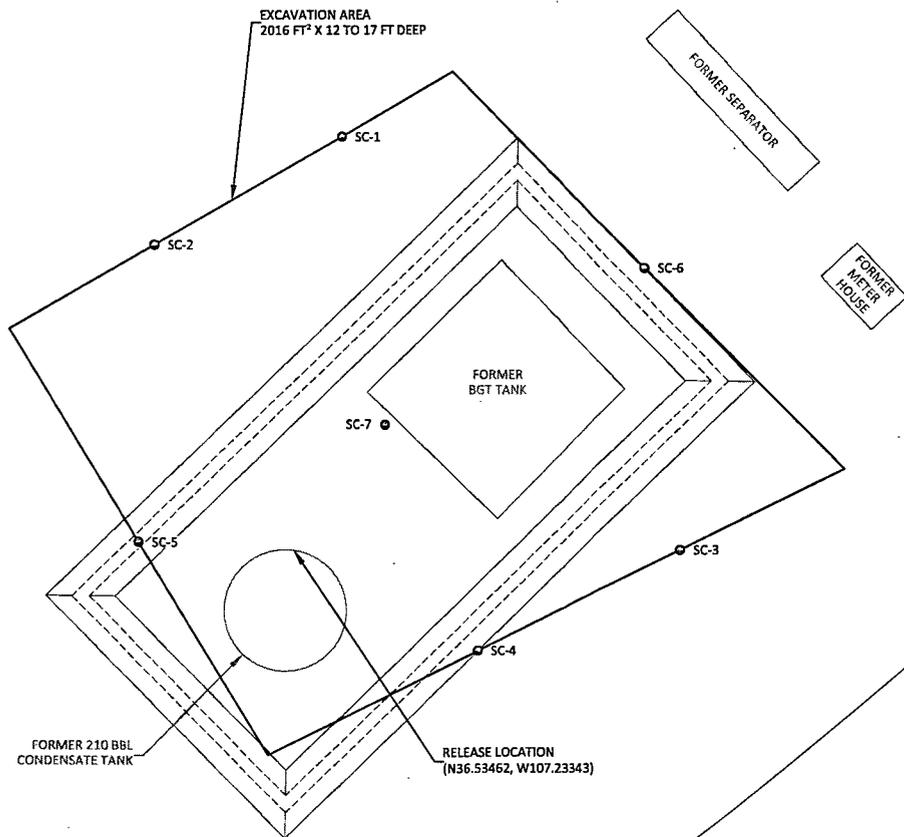
FIGURE 4

On May 9, 2013, AES returned to the location to collect confirmation soil samples of the final excavation. The field screening activities included collection of seven confirmation soil samples (SC-1 through SC-7) of the walls and base of the excavation. The final excavation was approximately 2,016 square feet by 12 to 17 feet in depth. Note that the base of the excavation was terminated on sandstone. Sample locations and final excavation extents are presented on Figure 4.

On May 9, 2013, final excavation field screening results for VOCs via OVM showed concentrations ranging from 4.4 ppm in SC-4 to 746 ppm in SC-7. Field TPH concentrations ranged from 70.4 mg/kg in SC-4 up to 304 mg/kg in SC-1. Results are included below in Table 1 and on Figures 3 and 4. The AES Field Screening Reports are attached.

FINAL EXCAVATION SAMPLE LOCATIONS AND RESULTS MAY 2013
 ConocoPhillips
 SAN JUAN 27-4 COM #137
 RIO ARriba COUNTY, NEW MEXICO
 NE¼ NE¼, SECTION 34, T27N, R4W
 N36.53483, W107.23351

During final clearance in May 2013, laboratory analyses for SC-1 and SC-7 were used to confirm field screening during excavation activities. Benzene concentrations were reported below laboratory detection limits of 0.25 mg/kg (SC-1) and 0.050 mg/kg (SC-7). Total BTEX concentrations were reported as 0.65 mg/kg (SC-1) and 0.67 mg/kg (SC-7). Results are presented in Table 2 and on Figures 3 and 4. Laboratory analytical reports are attached.

On May 9, 2013, final assessment of the excavation area was completed. Field screening results of the excavation extents showed that VOC concentrations were reported below applicable NMOCD action levels for all of the final four walls of the excavation, except the northeast corner which had a VOC concentration of 743 ppm (SC-1). The base of the excavation (SC-7), which was terminated on sandstone, also had a VOC concentration above the NMOCD action level (746 ppm). However, laboratory analytical results for benzene and total BTEX in SC-1 and SC-7 were reported below the NMOCD action levels of 10 mg/kg and 50 mg/kg, respectively. Field screening results for each of the final four walls and base of the excavation reported TPH concentrations below the NMOCD action level of 1,000 mg/kg.

Based on excavation of petroleum contaminated soils, field screening, and laboratory analytical results for VOCs, benzene, total BTEX, and TPH, no further work is recommended at the San Juan 27-4 Com #137.
