Release Notification and Corrective Action

Name of Company ConocoPhillips	Contact Lisa Hunter
Address 3401 East 30th St, Farmington, NM	Telephone No. (505) 326-9786
Facility Name: San Juan 31-6 #205R	Facility Type: Gas Well

**RE: Release Assessment Report
San Juan 31-6 #205R
Rio Arriba County, New Mexico**

RELEASE ASSESSMENT SAMPLE LOCATIONS AND RESULTS OCTOBER 2013
 ConocoPhillips
 SAN JUAN 31-6 #205R
 RIO ARRIBA COUNTY, NEW MEXICO
 SW¼ NE¼, SECTION 4, T30N, R6W
 N36.84194, W107.46552

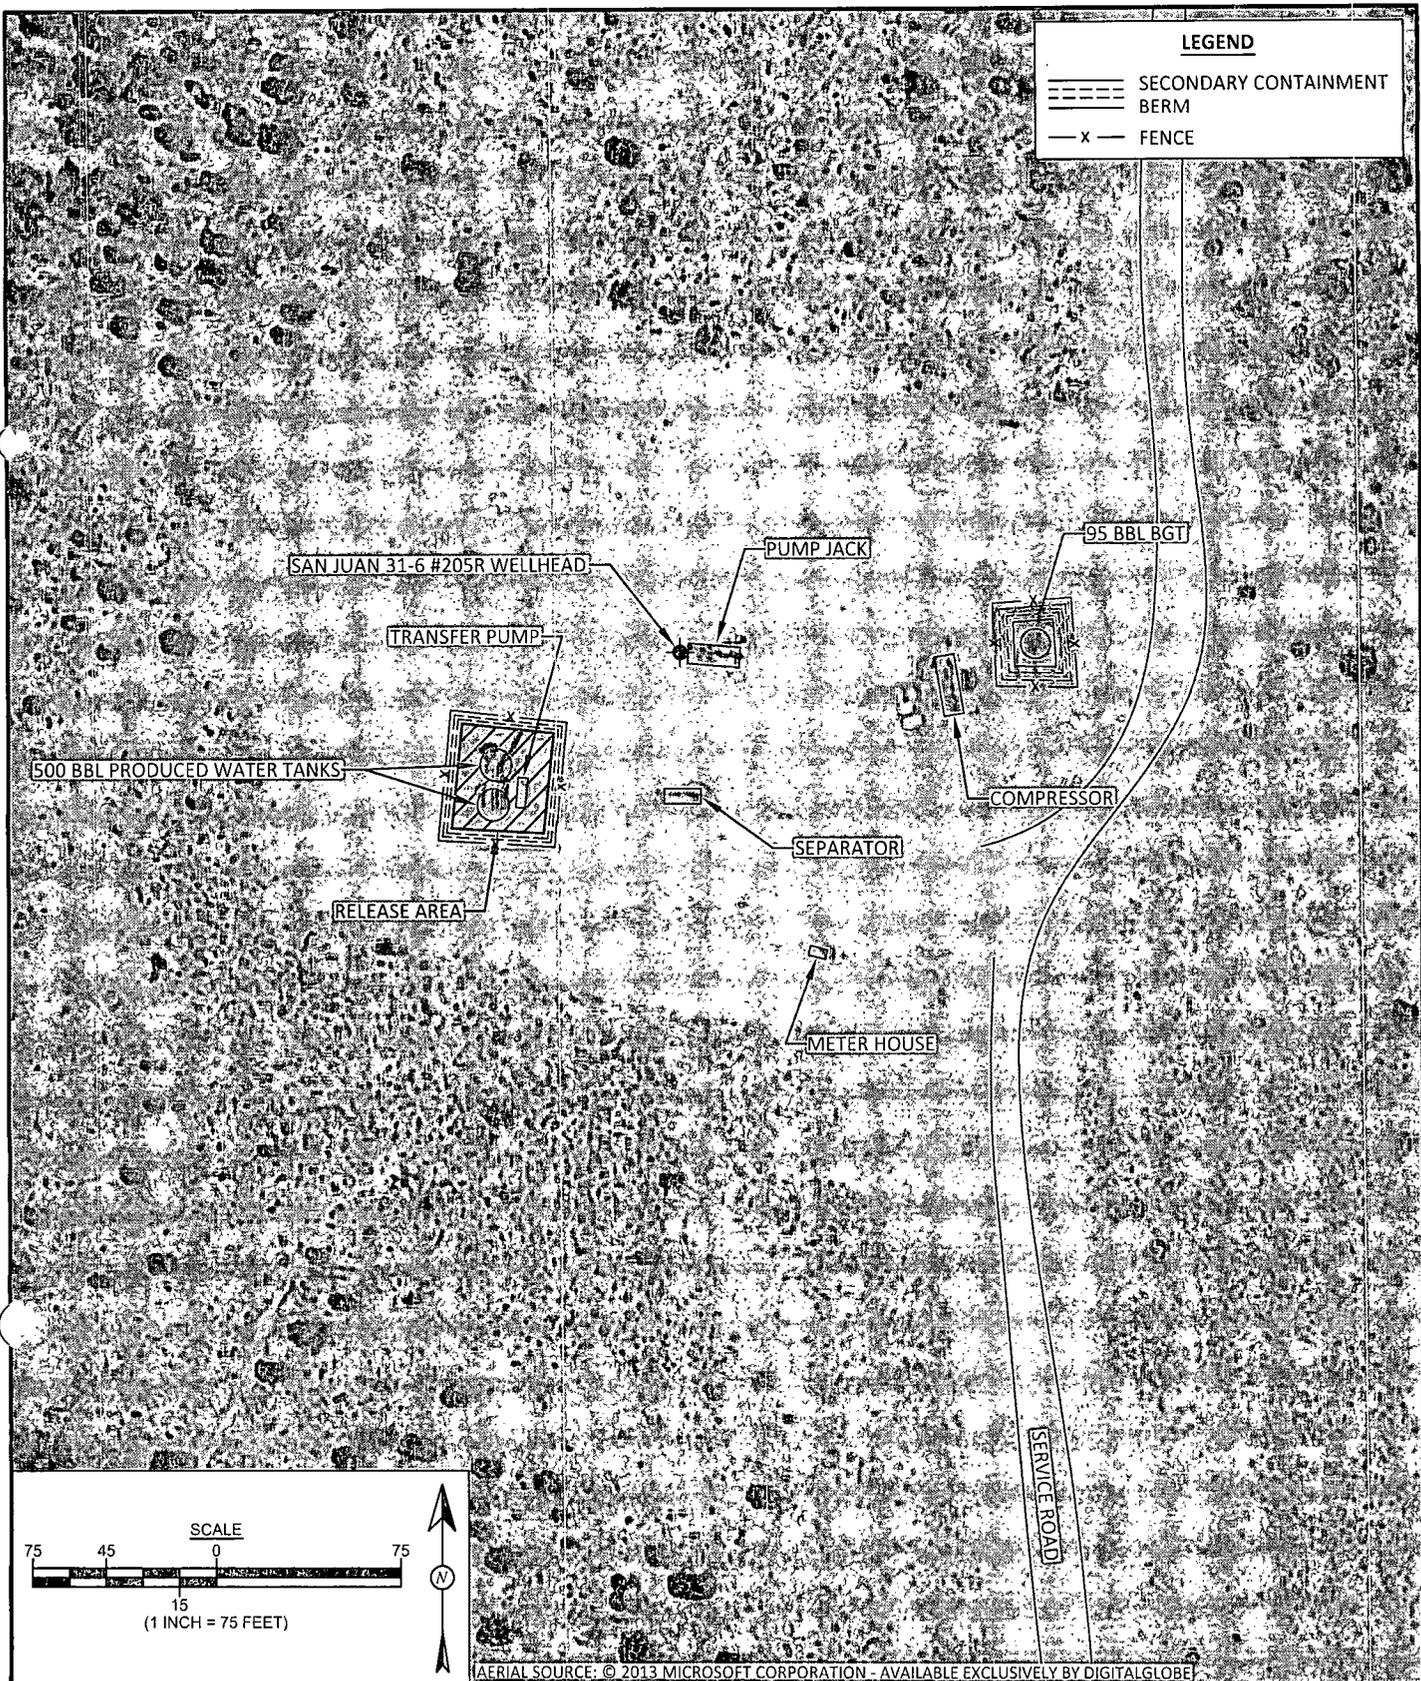
FIGURE 2

**AERIAL SITE MAP
OCTOBER 2013**

ConocoPhillips
SAN JUAN 31-6 #205R
RIO ARRIBA COUNTY, NEW MEXICO
SW¼ NE¼, SECTION 4, T30N, R6W
N36.84194, W107.46552

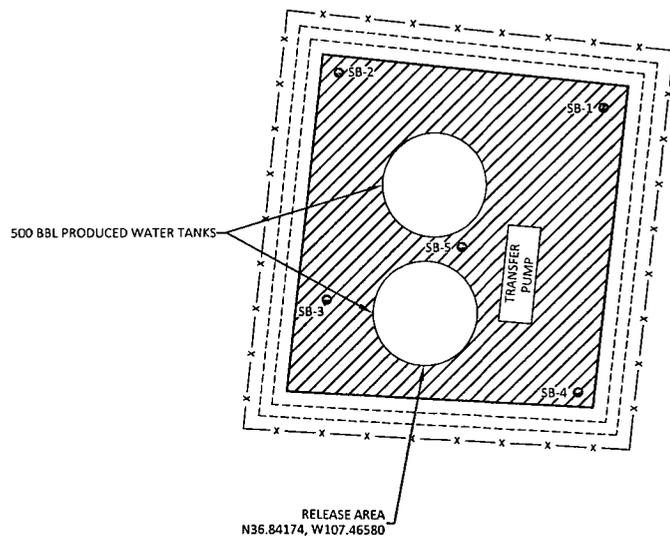
FIGURE 3

AES was initially contacted by Lisa Hunter of CoP on October 21, 2013, and on October 24, 2013, Deborah Watson and Jesse Christopherson of AES completed the release assessment field work. The assessment included collection and field screening of 11 soil samples from the 5 soil borings (SB-1 through SB-5) within the release area. One 5-point composite sample (SC-1) was created from equal portions of samples collected within SB-1 through SB-5 at the surface. Sample locations are presented on Figure 3.

Field screening results for VOCs via OVM were reported between 0.0 ppm and 0.4 ppm. Field TPH concentrations ranged from 25.3 mg/kg in SB-3 up to 45.3 mg/kg in SB-1. Results are included below in Table 1 and on Figure 3. The AES Field Screening Report is attached.

laboratory analytical result is included on Figure 3. The laboratory analytical report is attached.

SC-1 WAS A COMPOSITE OF SB-1 THROUGH SB-5.
SAMPLE WAS ANALYZED PER EPA METHOD 300.0.

- SOIL BORING SAMPLE LOCATIONS
- ===== SECONDARY CONTAINMENT BERM
- X - FENCE

Based on field screening results of produced water impacted soils at the San Juan 31-6 #205R, VOCs and TPH concentrations were reported below applicable NMOCD action levels. The chloride concentration in SC-1 was reported at 150 mg/kg. Therefore, no further work is recommended at the San Juan 31-6 #205R.
