Release Notification and Corrective Action

Name of Company ConocoPhillips Company	Contact Lisa Hunter
Address 3401 East 30th St, Farmington, NM	Telephone No. (505) 326-9786
Facility Name: San Juan 29-6 Unit 66	Facility Type: Gas Well

**RE: Initial Release Assessment and Final Excavation Report
San Juan 29-6 #66
Rio Arriba County, New Mexico**

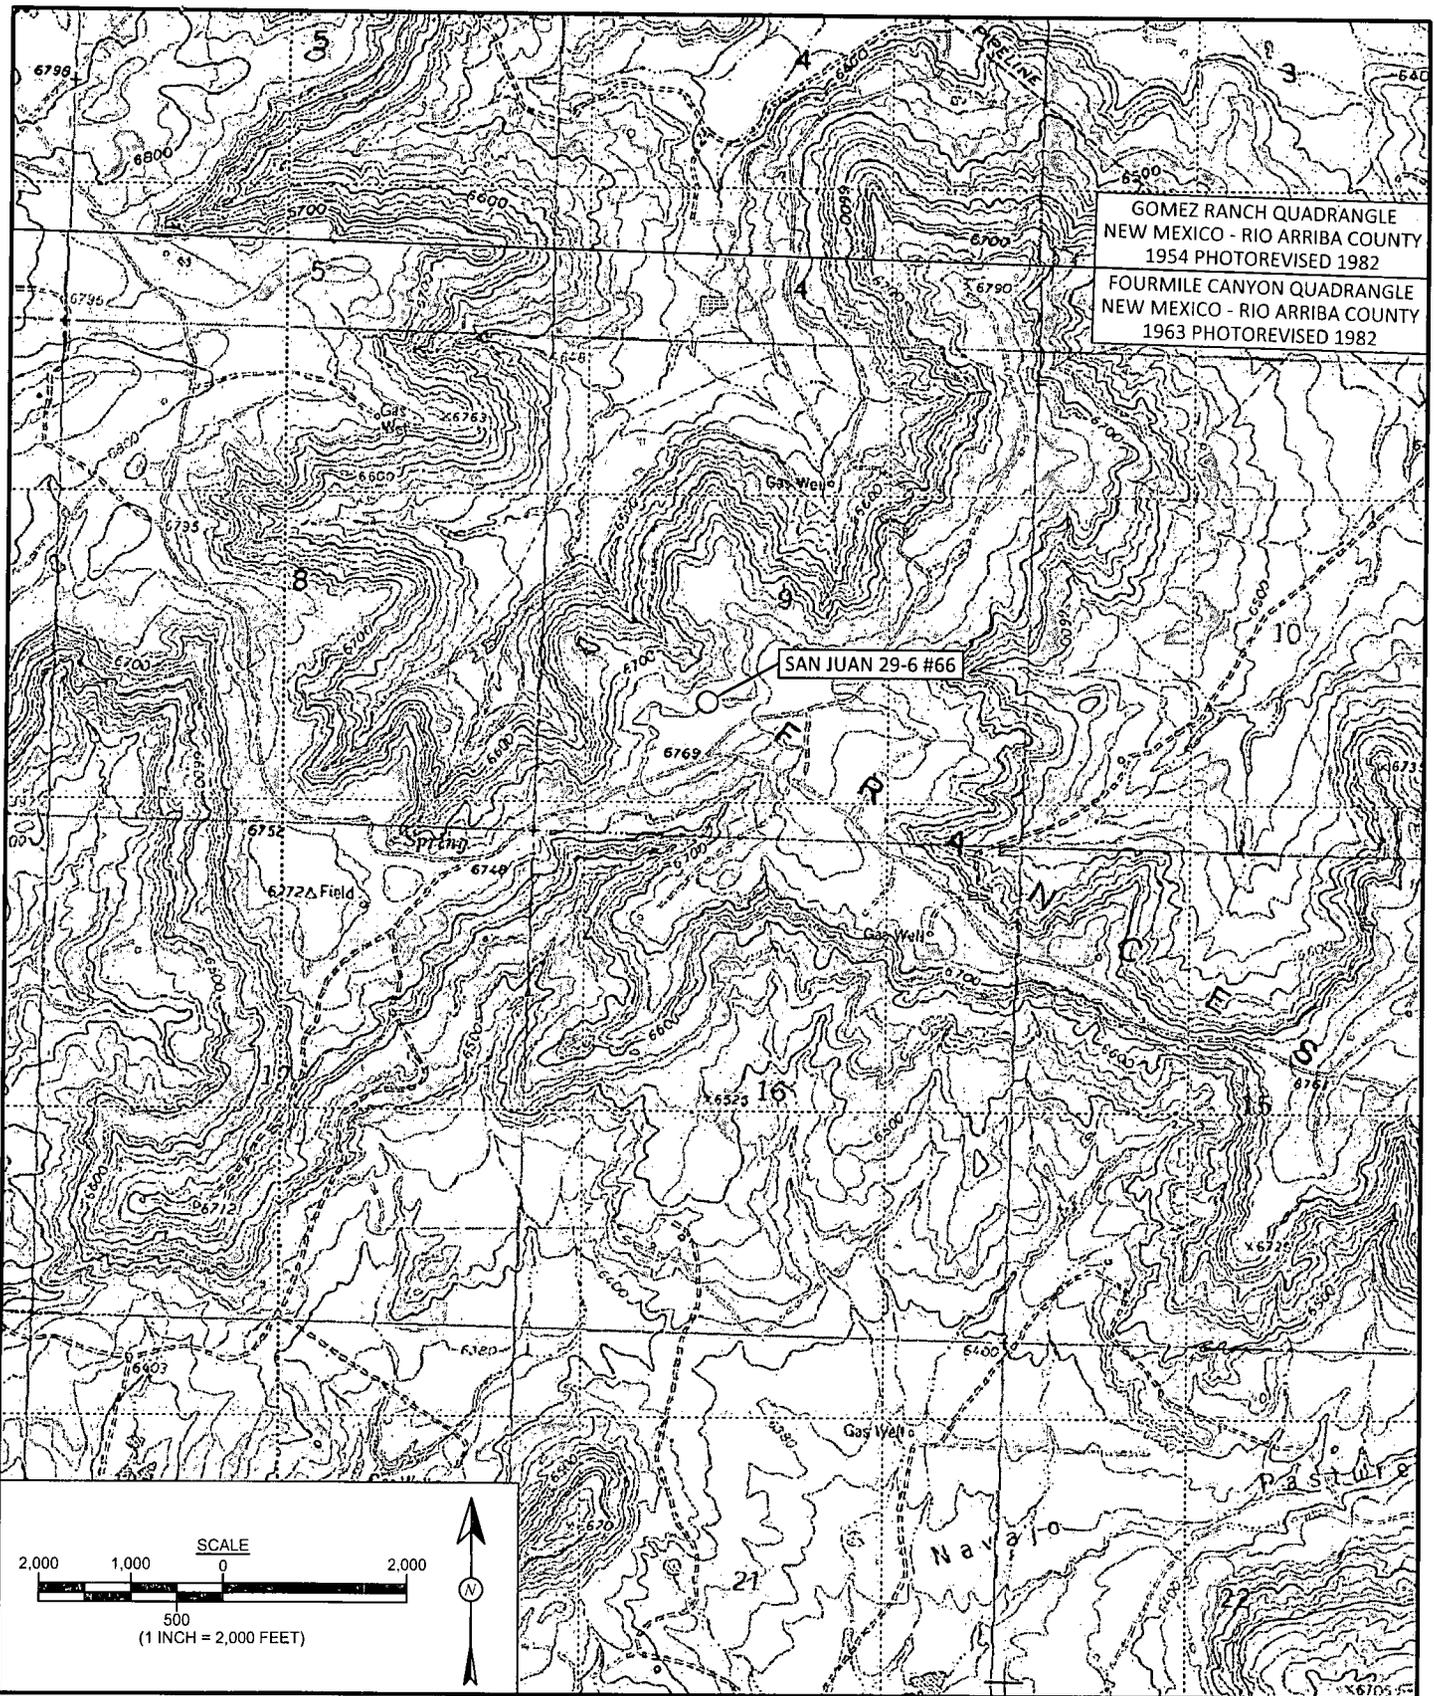
FIGURE 1

TOPOGRAPHIC SITE LOCATION MAP

ConocoPhillips
 SAN JUAN 29-6 #66
 NE 1/4 SW 1/4, SECTION 9, T29N, R6W
 RIO ARRIBA COUNTY, NEW MEXICO
 N36.73691, W107.47097

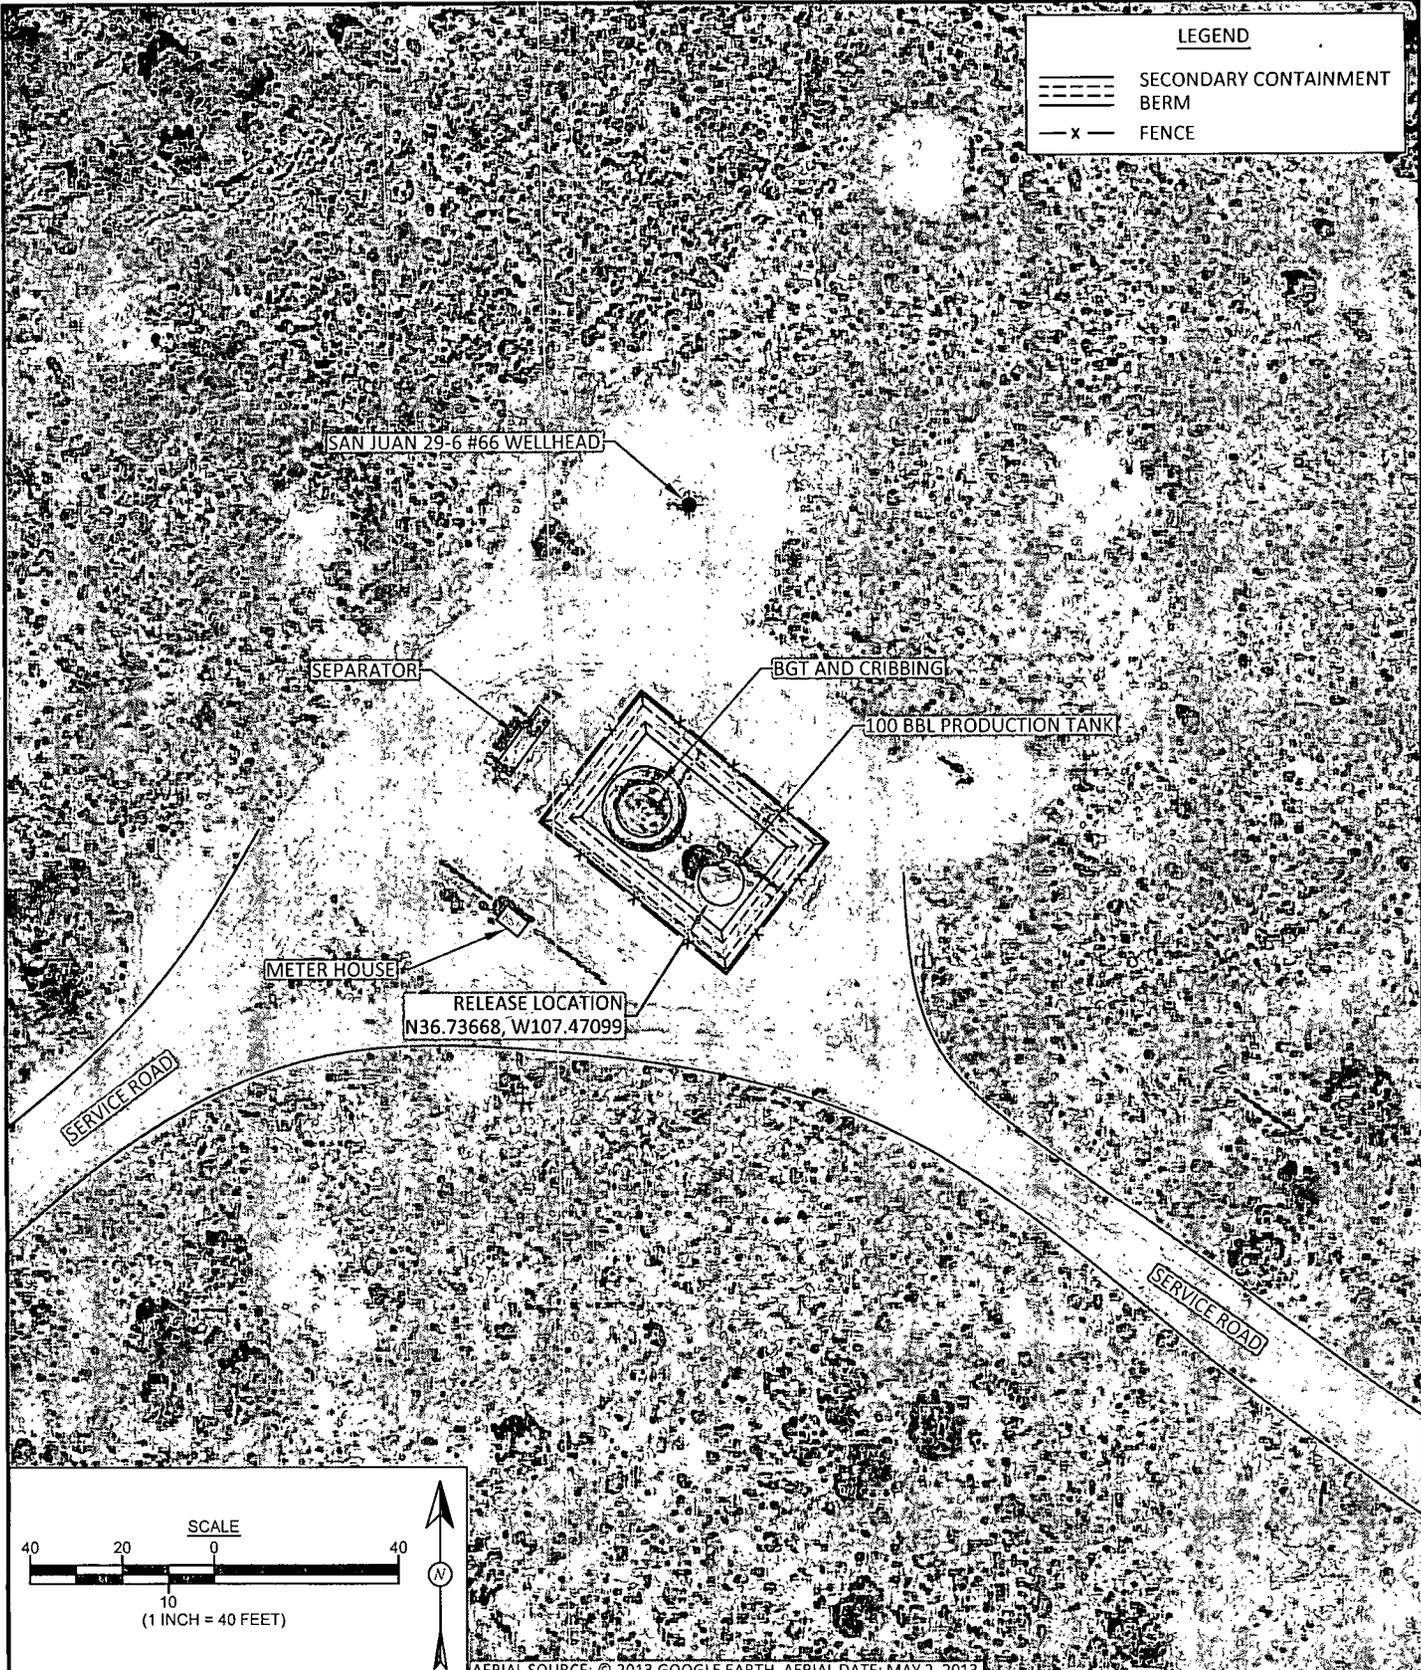
FIGURE 2

**AERIAL SITE MAP
JANUARY 2014**

ConocoPhillips
SAN JUAN 29-6 #66
NE¼ SW¼, SECTION 9, T29N, R6W
RIO ARRIBA COUNTY, NEW MEXICO
N36.73691, W107.47097

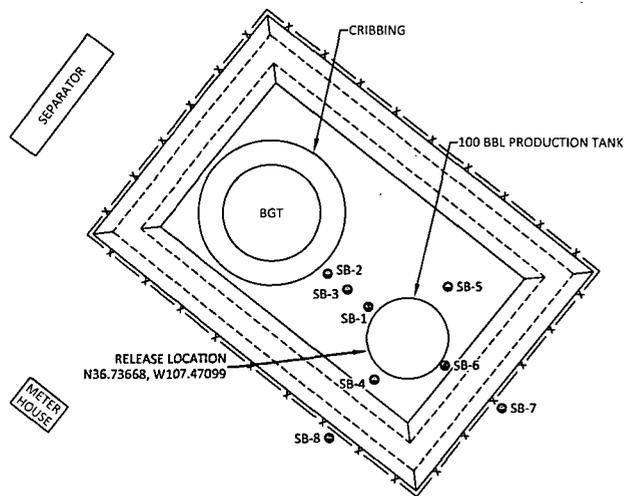
FIGURE 3

AES was initially contacted by Lisa Hunter of CoP on January 23, 2014, and on January 27, 2014, Deborah Watson and Emilee Skyles of AES completed the release assessment field work. The assessment included collection and field sampling of 17 soil samples from 8 borings in and around the release area. Soil borings were terminated between 3 and 4 feet where the ground was not frozen. Based on the field sampling results, AES recommended further excavation of the release area. Sample locations are shown on Figure 3.

On January 27, 2014, initial assessment field screening results for VOCs via OVM showed concentrations ranging from 1.7 ppm in SB-7 up to 3,855 ppm in SB-1. Field TPH concentrations ranged from less than 20.0 mg/kg in SB-2 and SB-7 to greater than 2,500 mg/kg in SB-1.

INITIAL ASSESSMENT SAMPLE LOCATIONS AND RESULTS JANUARY 2014
 ConocoPhillips
 SAN JUAN 29-6 #66
 NE¼ SW¼, SECTION 9, T29N, R6W
 RIO ARRIBA COUNTY, NEW MEXICO
 N36.73691, W107.47097

Field Sampling Results				
Sample ID	Date	Depth (ft)	OVMPID (ppm)	TPH (mg/kg)
NMOCD ACTION LEVEL			100	100
SB-1	1/27/14	Surface	3,855	552
		1	3,803	NA
		2	3,192	NA
		4	3,150	>2,500
SB-2	1/27/14	Surface	39.6	<20.0
SB-3	1/27/14	Surface	11.1	NA
SB-4	1/27/14	Surface	769	NA
		1	3,130	NA
		3	3,197	2,020
SB-5	1/27/14	Surface	5.5	NA
SB-6	1/27/14	Surface	5.6	NA
		3	3,054	1,230
SB-7	1/27/14	Surface	32.8	NA
		2	11.2	NA
		3	1.7	<20.0
SB-8	1/27/14	Surface	1.8	NA
		3	3.0	NA

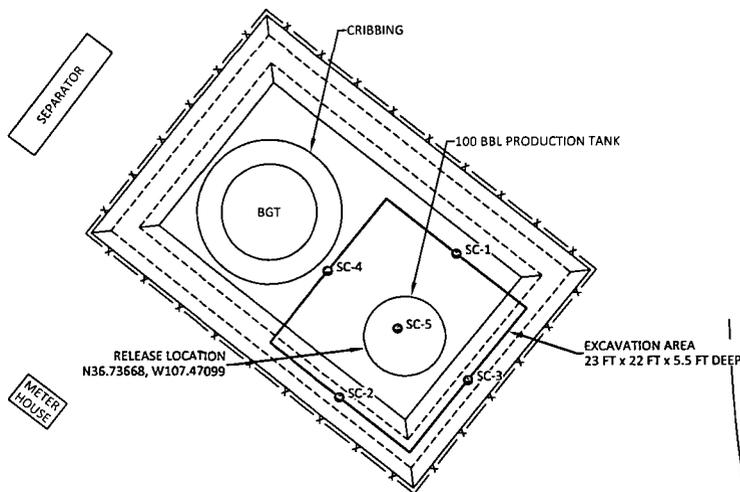
FIGURE 4

On April 21, 2014, AES returned to the location to collect confirmation soil samples of the excavation. The field sampling activities included collection of five confirmation soil samples from the walls and base of the excavation. The area of the final excavation measured approximately 23 feet by 22 feet by 5.5 feet in depth. A competent sandstone layer was encountered at 5 to 6 feet bgs. Sample locations and final excavation extents are presented on Figure 4.

On April 21, 2014, final excavation field screening results for VOCs via OVM ranged from 0.0 ppm in SC-1 up to 28.6 ppm in SC-5. Field TPH concentrations ranged from 37.8 mg/kg in SC-3 up to 53.3 mg/kg in SC-2. Results are included below in Table 1 and on Figures 3 and 4. The AES Field Sampling Reports are attached.

Laboratory analyses for SC-1 through SC-5 were used to confirm field sampling results from the final excavation. TPH concentrations as GRO/DRO were reported below laboratory detection limits in SC-1 through SC-4. Sample SC-5 reported TPH concentrations as GRO/DRO at 5.8 mg/kg and less than 9.8 mg/kg, respectively. Results are presented in Table 2 and on Figure 4. The laboratory analytical report is attached.

FINAL EXCAVATION SAMPLE LOCATIONS AND RESULTS
APRIL 2014
 ConocoPhillips
 SAN JUAN 29-6 #66
 NE 1/4 SW 1/4, SECTION 9, T29N, R6W
 RIO ARRIBA COUNTY, NEW MEXICO
 N36.73691, W107.47097

Sample ID	Date	Depth (ft)	Benzene (mg/kg)	Total BTEX (mg/kg)	TPH - GRO (mg/kg)	TPH - DRO (mg/kg)
NMOCED ACTION LEVEL			10	50	100	100
SC-1	4/21/14	1 to 5.5	NA	NA	<4.9	<10
SC-2	4/21/14	1 to 5.5	NA	NA	<5.0	<9.9
SC-3	4/21/14	1 to 5.5	NA	NA	<4.9	<10
SC-4	4/21/14	1 to 5.5	NA	NA	<4.7	<10
SC-5	4/21/14	5.5	NA	NA	5.8	<9.8

Sample ID	Date	Depth (ft)	OVM-PID (ppm)	TPH (mg/kg)
NMOCED ACTION LEVEL			100	100
SC-1	4/21/14	1 to 5.5	0.0	41.7
SC-2	4/21/14	1 to 5.5	8.8	53.3
SC-3	4/21/14	1 to 5.5	1.0	37.8
SC-4	4/21/14	1 to 5.5	4.7	43.0
SC-5	4/21/14	5.5	28.6	49.4

Based on final field sampling and laboratory analytical results of the excavation of petroleum contaminated soils at the San Juan 29-6 #66, VOC and TPH concentrations were below applicable NMOCD action levels for each of the sidewalls and base of the excavation. No further work is recommended.
