Release Notification and Corrective Action

Name of Company: ConocoPhillips Company	Contact Lisa Hunter
Address 3401 E. 30th Street, Farmington, NM 87402	Telephone No. 505-326-9786
Facility Name Jicarilla 20 #9	Facility Type Oil Well

**RE: Release Assessment Report
Jicarilla 20 #9
Rio Arriba County, New Mexico**

TOPOGRAPHIC SITE LOCATION MAP
 ConocoPhillips
 JICARILLA 20 #9
 NW¼ NW¼, SECTION 20, T25N, R4W
 RIO ARRIBA COUNTY, NEW MEXICO
 N36.39076, W107.28279

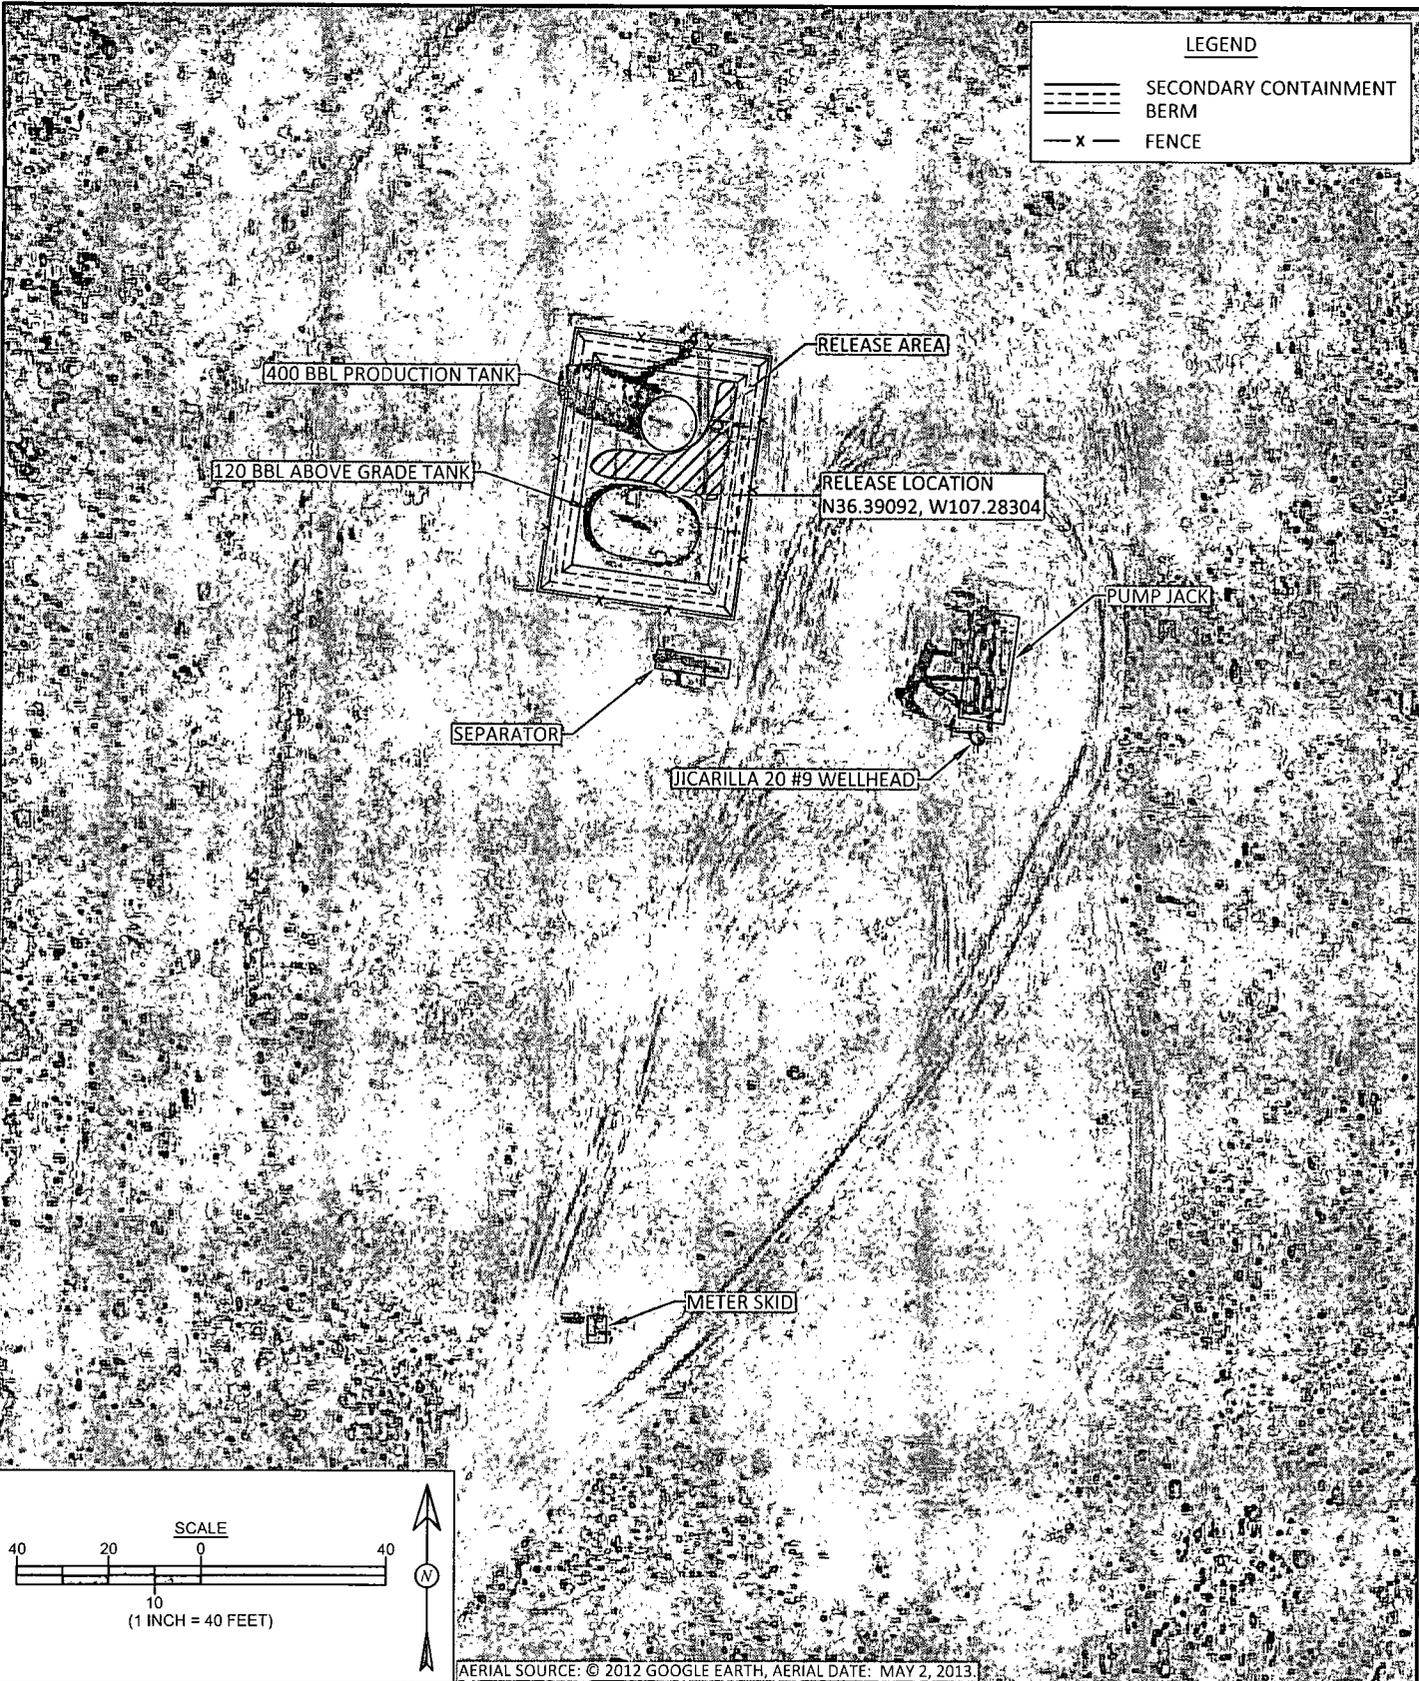
FIGURE 2

**AERIAL SITE MAP
SEPTEMBER 2013**
ConocoPhillips
JICARILLA 20 #9
NW¼ NW¼, SECTION 20, T25N, R4W
RIO ARRIBA COUNTY, NEW MEXICO
N36.39076, W107.28279
