**Release Notification and Corrective Action**

Name of Company <b>Burlington Resources Oil &amp; Gas Company</b>	Contact <b>Crystal Tafoya</b>	
Address <b>3401 East 30<sup>th</sup> St, Farmington, NM</b>	Telephone No. <b>(505) 326-9837</b>	
Facility Name: <b>Hartman Com 4A</b>	Facility Type: <b>Gas Well</b>	
Surface Owner <b>Fee</b>	Mineral Owner <b>Fee</b>	API No. <b>30-045-29508</b>

**RE: SPILL ASSESSMENT DOCUMENTATION FOR THE HARTMAN COM #4A (hBr) WELL SITE,  
SAN JUAN COUNTY, NEW MEXICO**

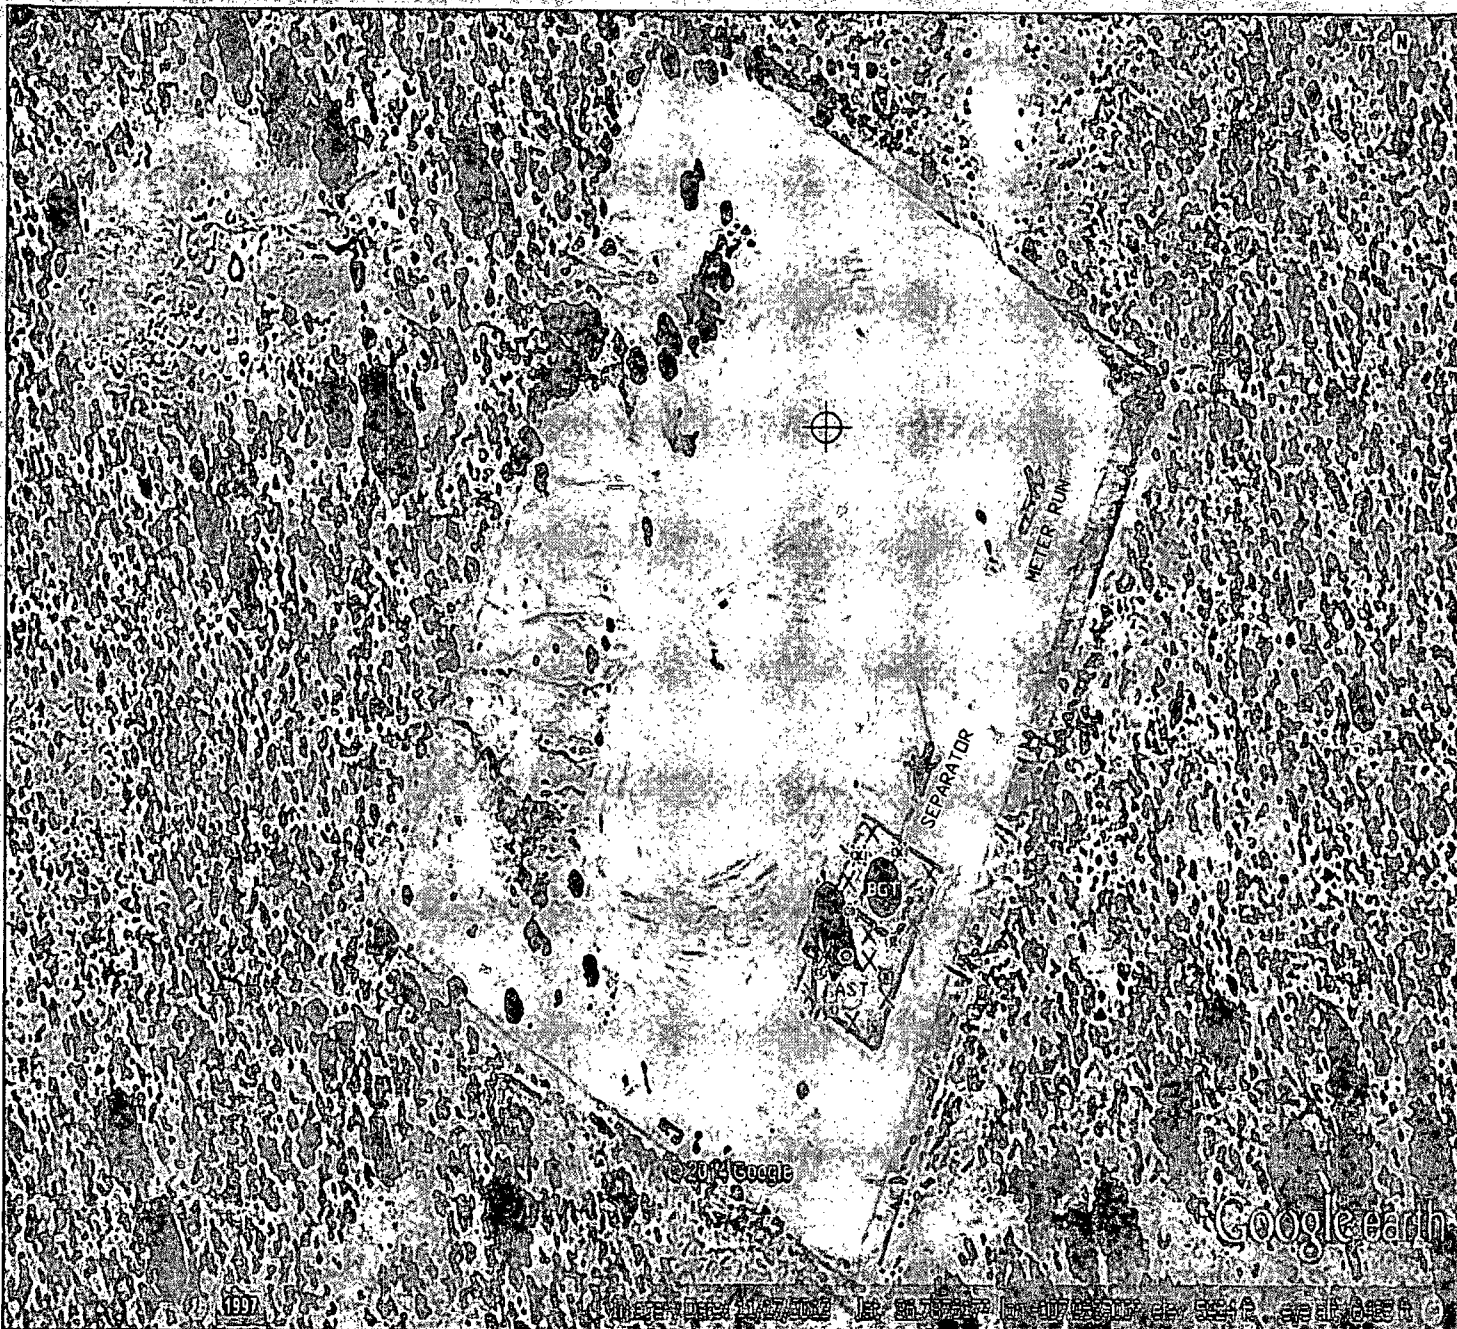
FIGURE NO. 2

At the above referenced well site, an above-ground storage tank (AST) is on the south end of the area between the berms and a below ground tank (BGT) is on the north end of the area between the berms; see enclosed *Site Map*. Two (2) five (5)-point composite samples were collected: one (1) sample from the surface of the south end, *AST Composite*, and one (1) sample from the surface of the north end, *BGT Composite*; see enclosed *Site Map* and *Field Notes* for sample locations. Both samples were analyzed in the field for TPH using USEPA Method 418.1 and for organic vapors using a photoionization detector (PID). Both samples returned results above the regulatory standard for TPH but below the regulatory standard for organic vapor; see enclosed *Field Notes, Analytical Results, and Summary of Analytical Results*.

- $\phi$  = WELL HEAD
- X = AST COMPOSITE
- $\otimes$  = 1' BGS AST
- X = BGT COMPOSITE
- $\otimes$  = BGT + 1' BGS

Therefore, Envirotech, Inc. recommends no further action in regards to this project.
