Release Notification and Corrective Action

| Facility Name: Mangum 8 | Facility Type: Oil | OIL CONS. DIV. |

**RE: CONFIRMATION SAMPLING DOCUMENTATION FOR THE MANGUM #8 (hBr) WELL SITE,
SAN JUAN COUNTY, NEW MEXICO**

Table 1, Summary of Analytical Results
 ConocoPhillips
 Mangum #8 (hBr)
 Confirmation Sampling Report
 San Juan County, New Mexico
 Project Number 92115-2582

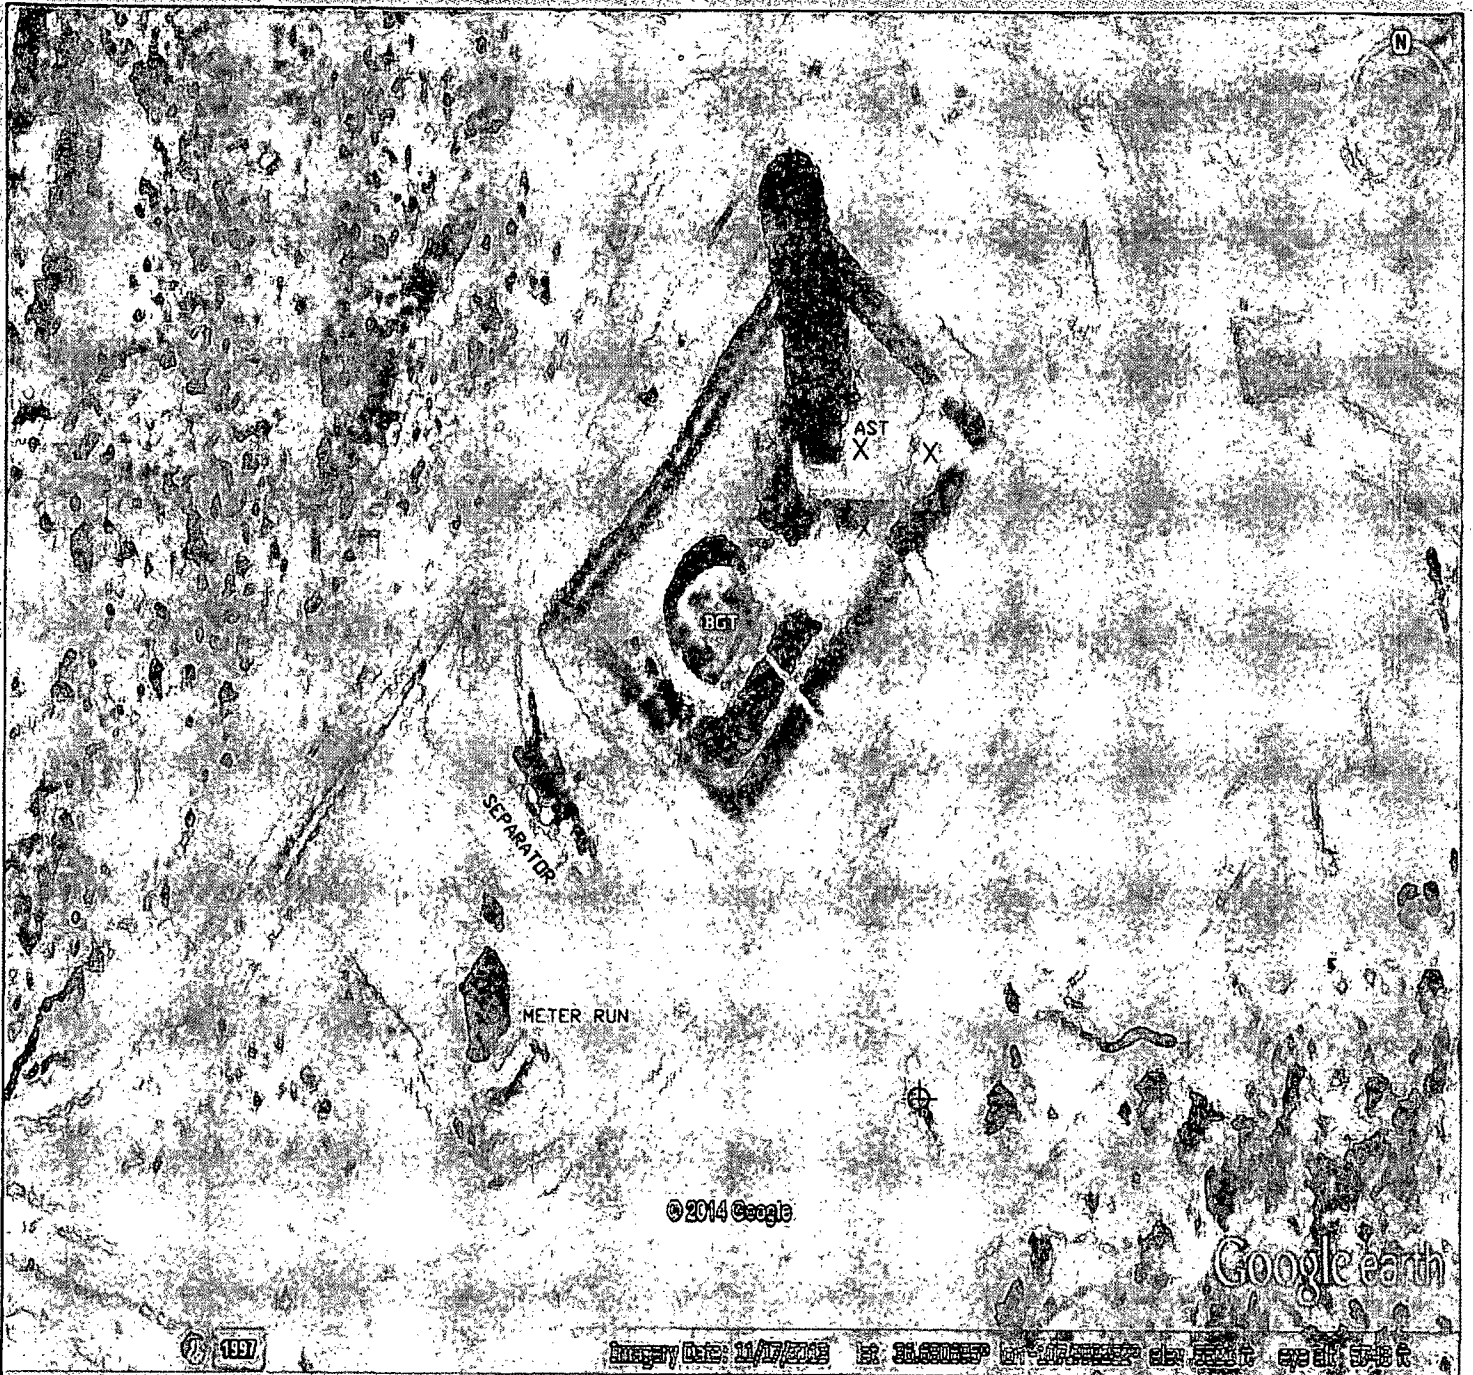
FIGURE NO. 1

The north half of the area between the berms, the area where the AST had previously been located, had been excavated to a depth of approximately five (5) feet below ground surface (BGS). One (1) five (5)-point composite sample was collected from the bottom of the previously mentioned excavation; see enclosed *Site Map* and *Field Notes* for sample location. The sample was analyzed in the field for TPH using USEPA Method 418.1 and for organic vapors using a photoionization detector (PID). The sample returned results below the regulatory standard for TPH and organic vapor; see enclosed *Field Notes*, *Analytical Results*, and *Summary of Analytical Results*. Additionally, the sample was placed into a four (4)-ounce glass jar, capped head space free, and transported on ice, under chain of custody, to Envirotech's Analytical Laboratory to be analyzed for TPH using USEPA Method 8015, benzene and total BTEX using USEPA Method 8021, and chlorides using USEPA Method 300.0. The sample returned a result

Mangum #8 (hBr)

SECTION 33, TWP 29 NORTH, RANGE 11 WEST
SAN JUAN COUNTY, NEW MEXICO

below the regulatory standard for all constituents analyzed; see enclosed *Analytical Results* and *Summary of Analytical Results*. Therefore, Envirotech, Inc. recommends no further action.
