Form C-144  
Revised June 6, 2013

**Burlington Resources Oil Gas Company, LP**  
**San Juan Basin**  
**Below Grade Tank Closure Report**  
**(Without Reclamation)**

**Lease Name: San Juan 32-9 Unit 230S**

**API No.: 30-045-33283**

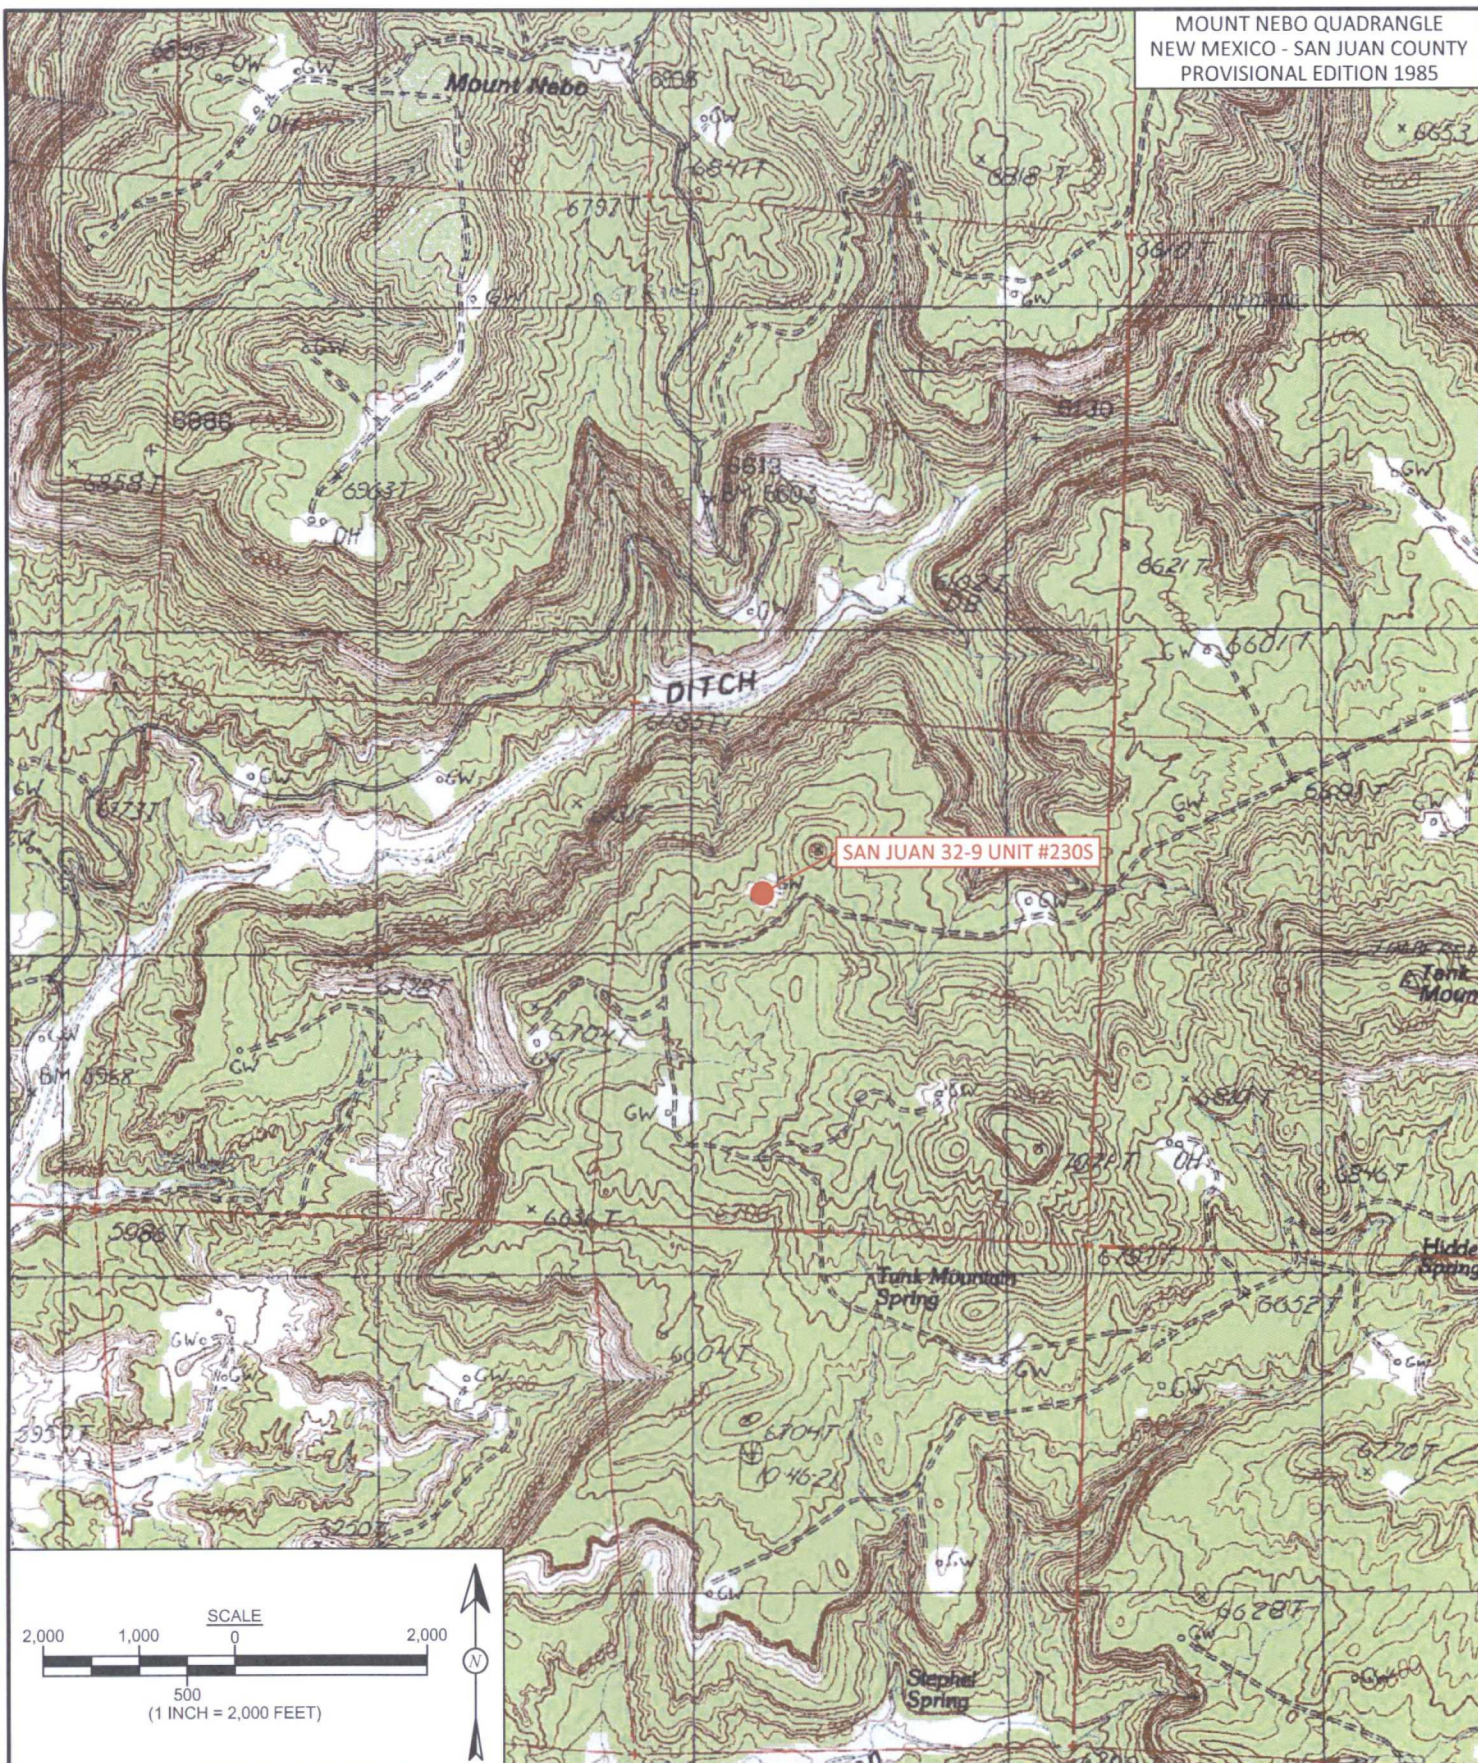
- Figure 1. Topographic Site Location Map
- Figure 2. Aerial Site Map, June 2015
- AES Field Sampling Report 061515
- Hall Analytical Report 1506720

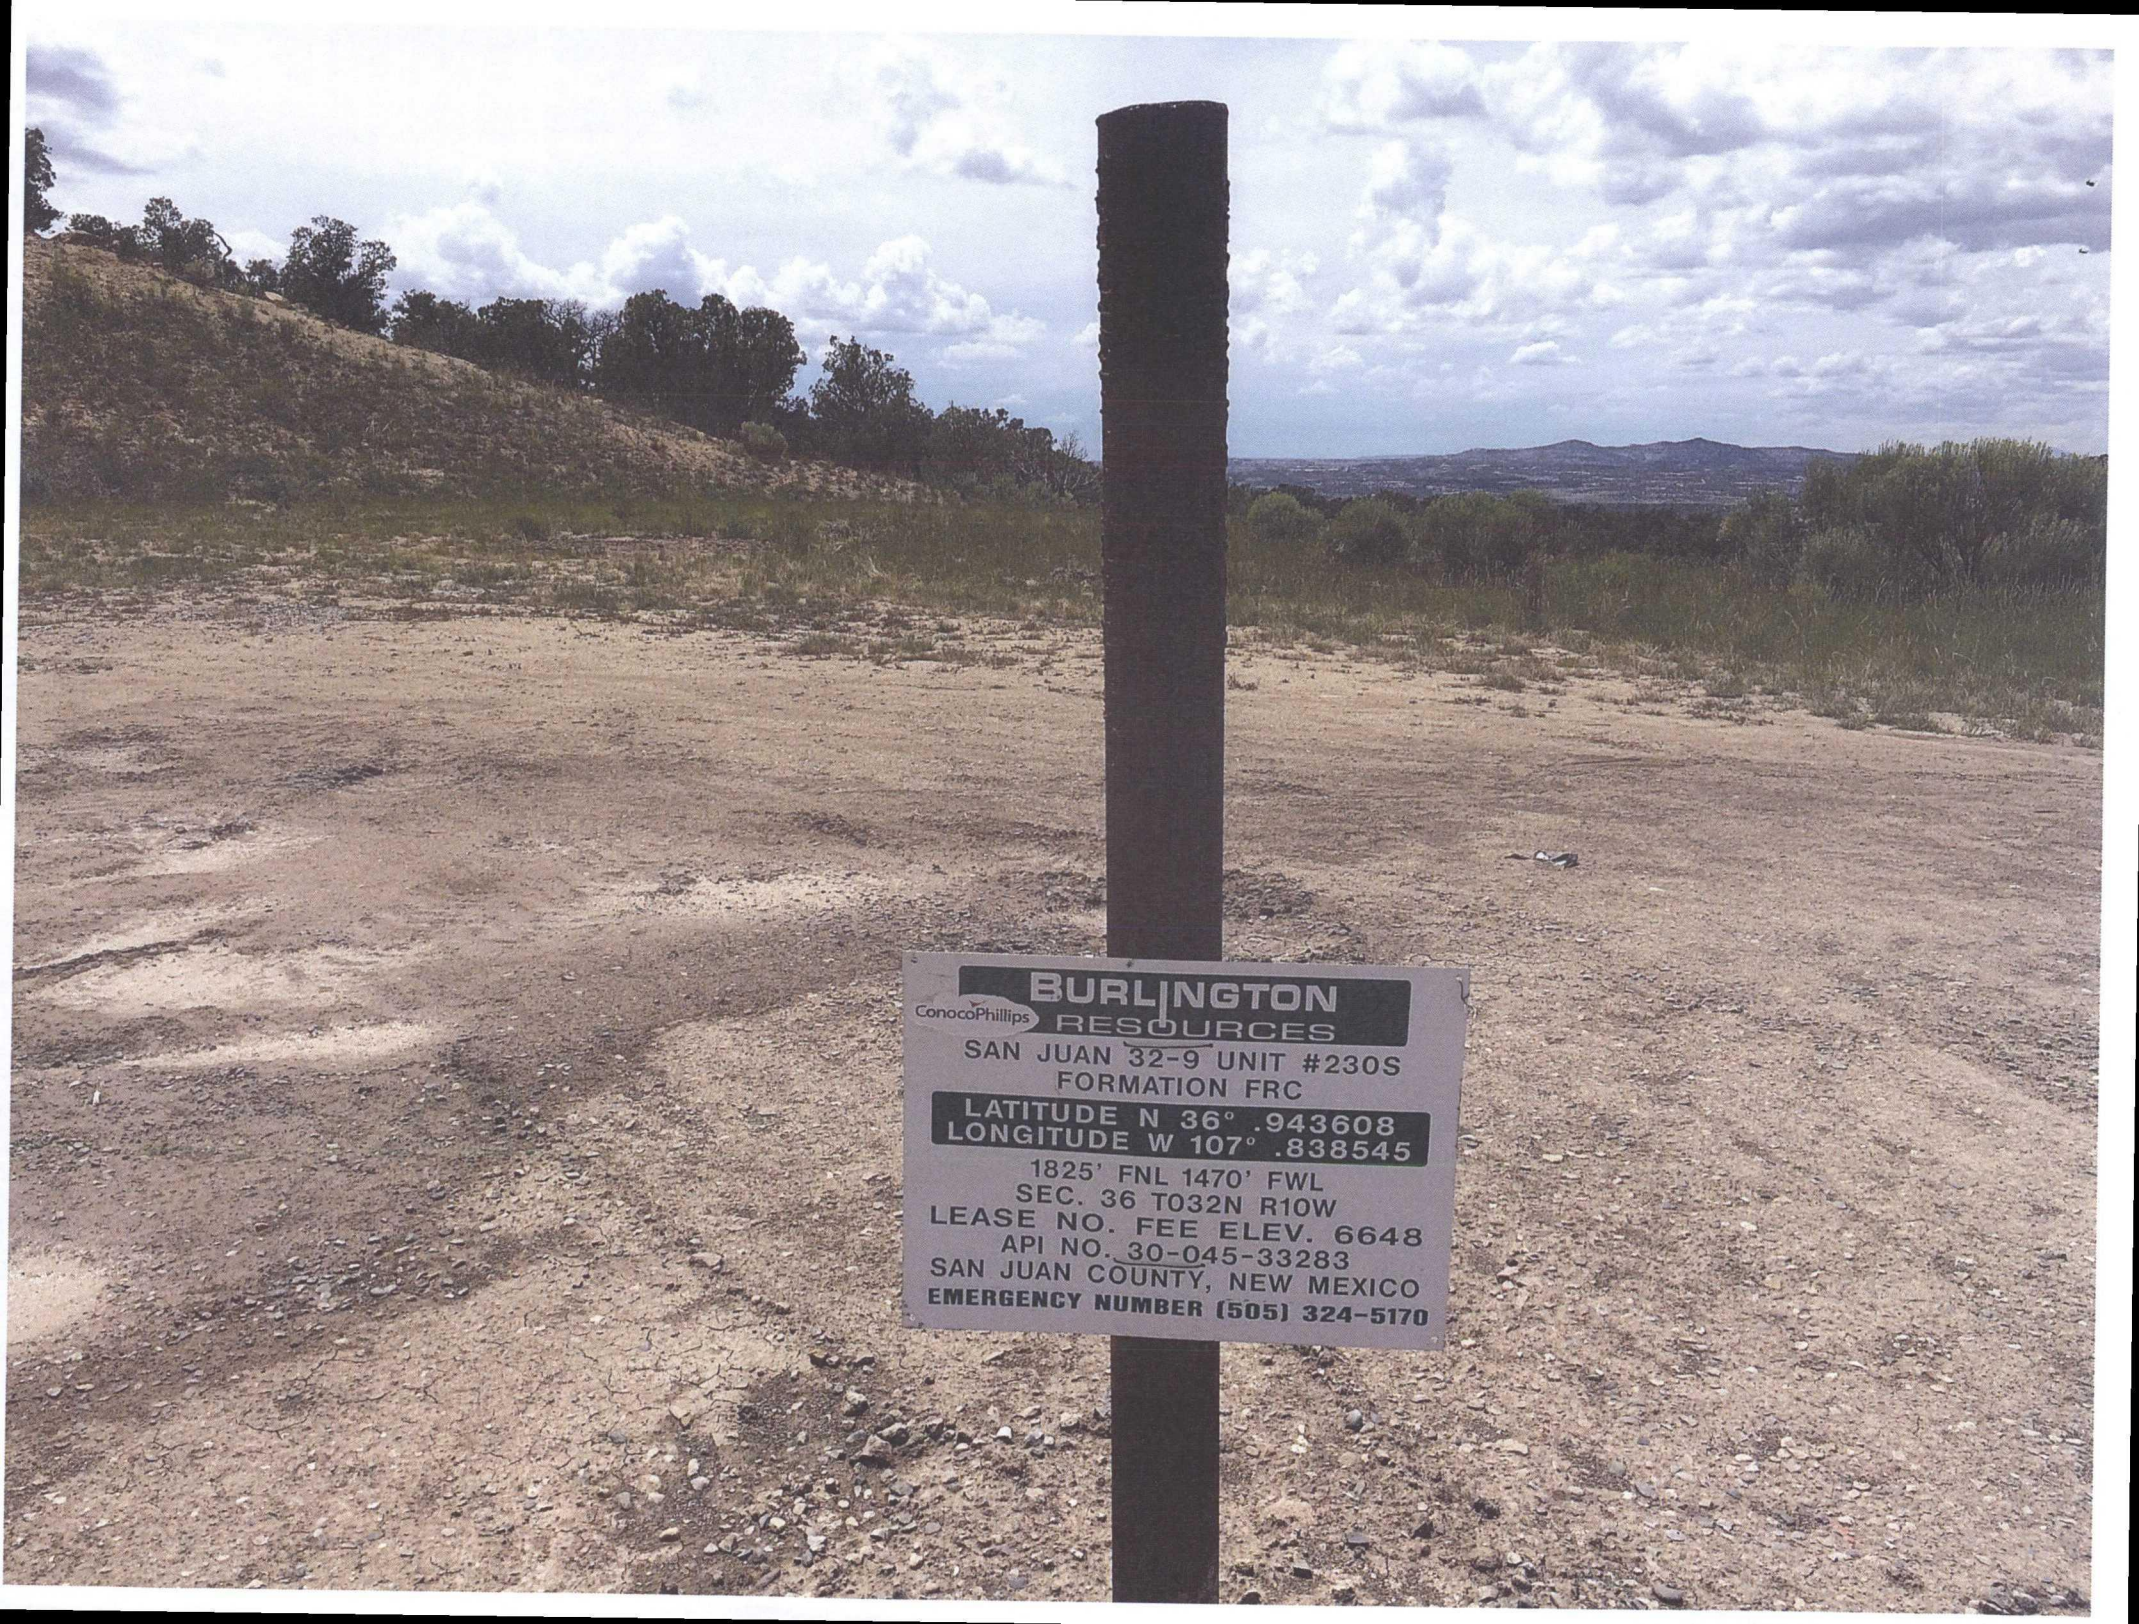
**BURLINGTON**  
ConocoPhillips **RESOURCES**  
SAN JUAN 32-9 UNIT #230S  
FORMATION FRC  
LATITUDE N 36° .943608  
LONGITUDE W 107° .838545  
1825' FNL 1470' FWL  
SEC. 36 T032N R10W  
LEASE NO. FEE ELEV. 6648  
API NO. 30-045-33283  
SAN JUAN COUNTY, NEW MEXICO  
EMERGENCY NUMBER (505) 324-5170
